Akhaldaba Landslide (Photo courtesy of GeoGraphics GIS and Remote Sensing Consulting Center)

Tbilisi Flood 2015

Initial Findings and Response Actions

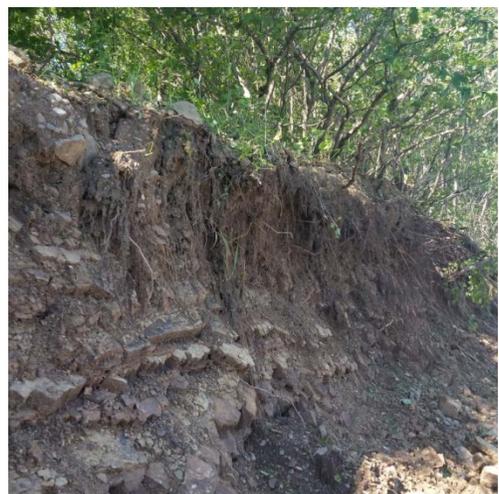
Figure 2: Interbedded layers of sandstone, siltstone and claystone are weak, easily decomposed and eroded.
