Reducing Landslide Risk Using Cut Slope Stability Maps:

Excavating for Safe Development in the British Virgin Islands

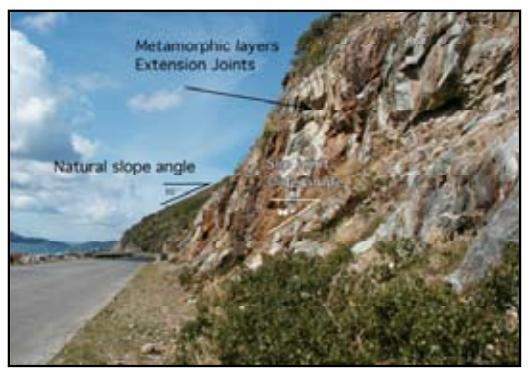
The cuts in the Coastal Road in Cox Heath, Tortola are plagued by rock falls and slides during major rain events. Photo 1 shows that the rocks are broken up and loosened into blocks by near vertical joints that form parallel and perpendicular to the metamorphosed sedimentary layers. The blocks of rock slide out on to the roadway along joint planes that are inclined out of the cut slope face at 35°. Note that the natural slope in the background has equilibrated to an angle a little less than the outward inclined joint set.

Photo 1: Road cut slopes and natural slopes on the west end of Tortola

This is a clear indication of joint control natural slope evolution. Coastal erosion and road cut excavation have undercut the slope and created the unstable and hazardous conditions. Blasting of the hard rock during the excavation worsened the problem by opening the joints and further fracturing the rocks.

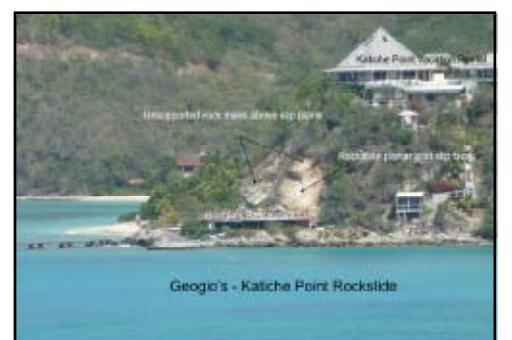
The landslide that occurred at Katiche Point is an excellent example of a planar rockslide, which was caused by undercutting steeply inclined joint planes in massive igneous rock (Photos 2 and 3). The slope cut was required to provide sufficient set back from the

shoreline to permit the construction of the restaurant at that location.

Obviously, the owner and the permitting authorities were unaware of the dire consequences of the required slope excavation.

Photo 2: Katiche Point rockslide on Savannah Bay Virgin Gorda BVI

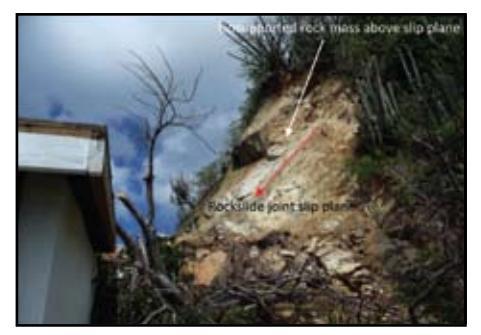
Photo 3: Planar joint slide surface of the Katiche Point rockslide above Giorgio's Restaurant

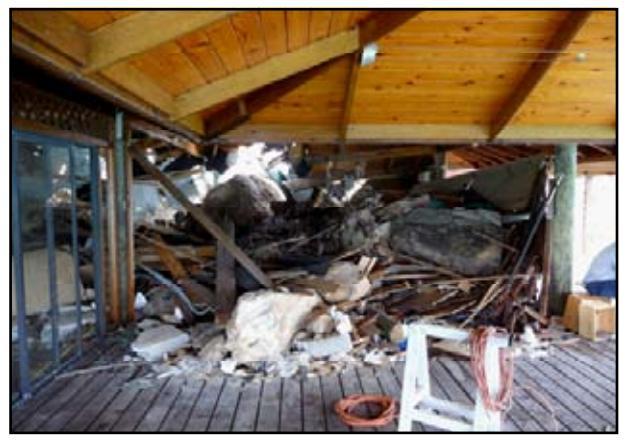
Numerous boulder size blocks created by intersecting joint planes slid down the outward inclined joint planes and into the restaurant (Photo 4). Fortunately it was unoccupied at that time and there were no casualties.

Photo 4: Boulders that crashed through the back of Georgio's Restaurant

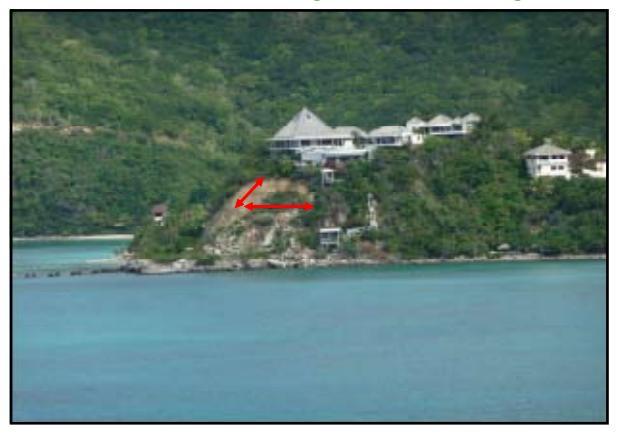
Photo 5: Subsequent enlargement of the Katiche Point rockslide

Enlargement and retreat of the rockslide towards the residence above occurred when the unsupported rock mass above the original slip plane failed during the attempt to reconstruct the restaurant.

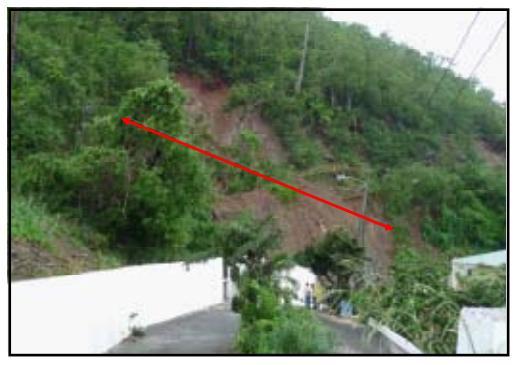
The Jean's Hill landslide occurred during a period of heavy rain in 2010 and is an example of a joint intersection wedge failure road cut slope. Disaggregated rock, colluvial soils and vegetation above the road cut were incorporated into the wedge failure to create a debris avalanche-flow. The rock, soil and debris covered over the roadway and continued down slope toppling a retaining wall and crushing and removing the outer portion of a residence on the slope below (Photos 6 and 7).

Photo 6: Debris Avalanche at Jean's Hill, Tortola in 2010

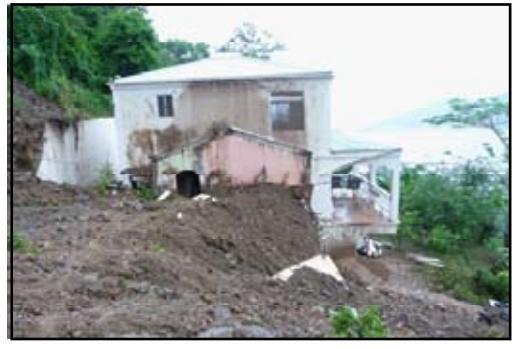
Photo 7: Residence damaged by the Jean's Hill debris avalanche

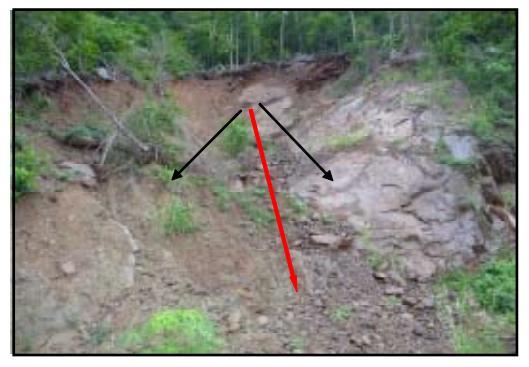
Photo 8: Jean's Hill debris avalanche scar

The Jean's Hill debris avalanche scar shows the 2 intersecting joint planes that created the joint wedge failure. The rock and debris slid along both planes in the direction of their intersection shown by the red arrow (Photo 8).

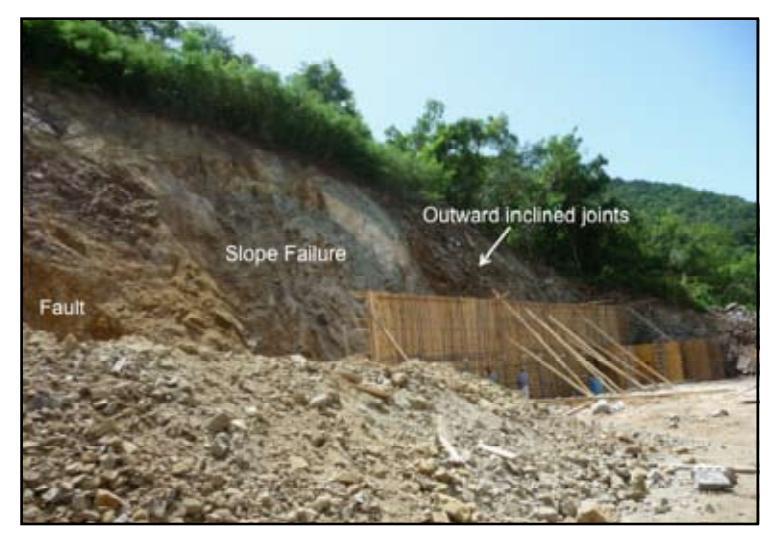
The Sea Cow's Bay construction site, shown in Photo 10, provided a great example of overcutting and inadequate cut slope and retaining wall design to address the obvious slope instability related to joint orientation and intense fracturing of the rock in the cut. The rock cut exposes a complex geology consisting of highly fractured and altered rock in a large fault zone on the left side of the cut and closely spaced, outward inclined systematic joints in more solid rock on the right. A rock fall - avalanche failure scar along the fault zone behind the wall attests to instability of the steep high cut.

Photo 10: Recently excavated cut slopes above Sea Cow's Bay, Tortola

Failure along the closely space outward inclined joint faces or of the unstable highly fractured rock above the undersized wall will overtop the wall and could lead to its collapse. A site-specific geotechnical and geological evaluation was strongly recommended before continuing with the construction.
