2015

# Climate Vulnerability and Capacity Assessment : A Baseline Report

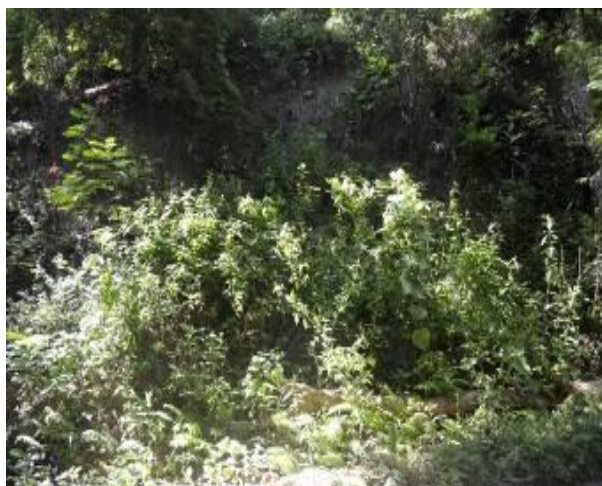
**Figure 1 – Roadside landslide. Buruma Suco, Baucau Aggregate Catchment**

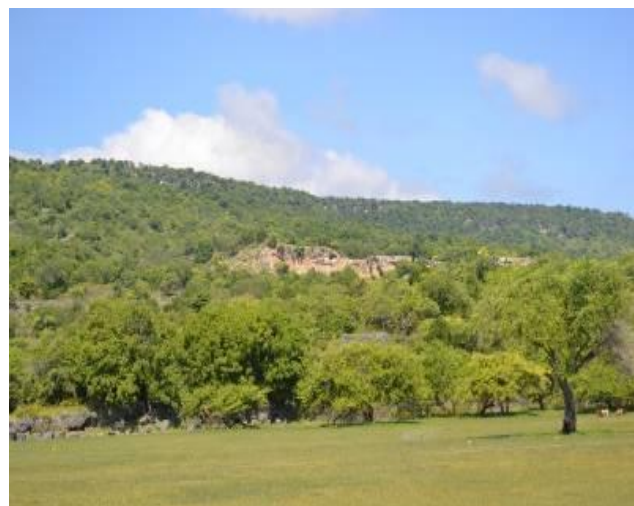
**Figure 2 – Limestone escarpment with medium-to-high exposure to landslide and erosion risk. Caibada Suco, Baucau Aggregate Catchment**

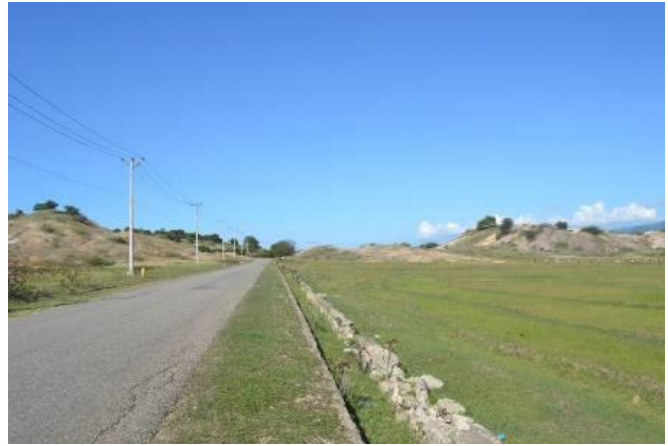
Figure 4 – Medium risk of erosion on poorly vegetated low hills. Seiçal Suco, Seiçal River Catchment

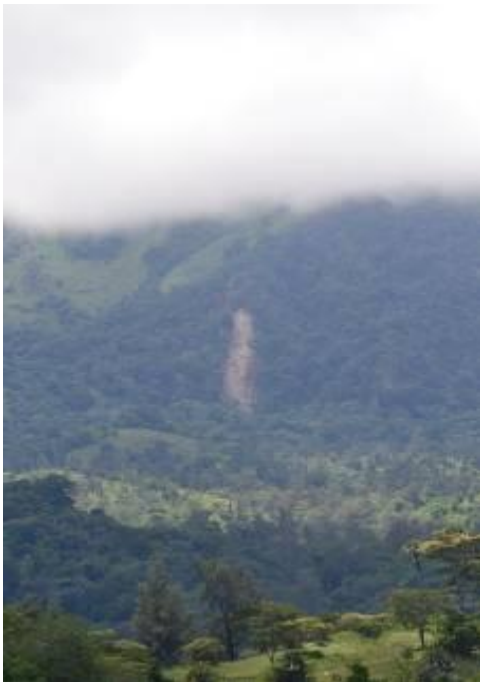
**Figure 7 – Landslide on very steep slope. Afaça Suco, Uai Muhi Catchment**

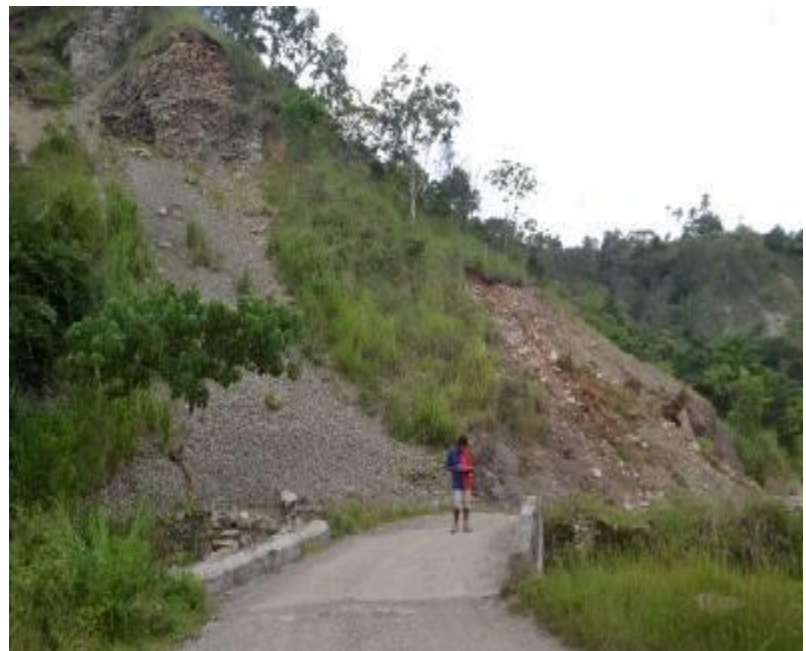
**Figure 8 – Landslide closing road and threatening bridge, caused by steep slope, unconsolidated rock, thin vegetation. Baguia Suco, Boro Uai Catchment**

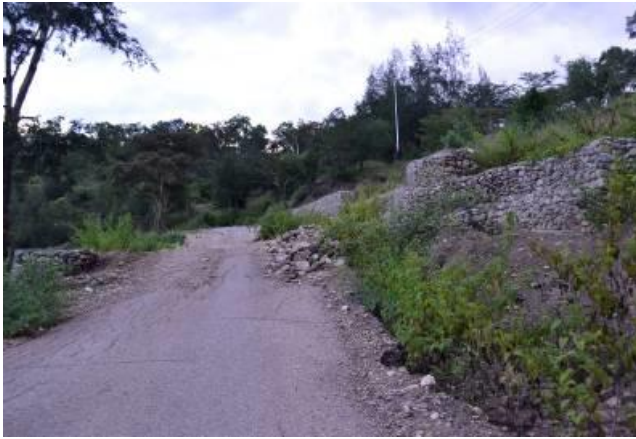
Figure 9 – Evidence of flash-floods, landslides and erosion, and engineering efforts to protect road.

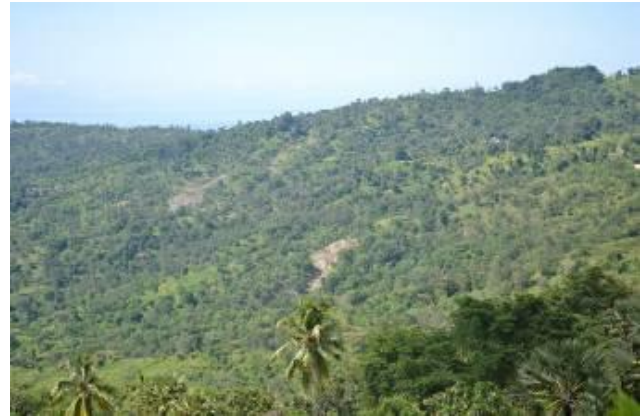
Figure 10 – Example of moderate slope and sparse vegetation contributing to the risk of landslides. Abafala Suco, Uai Muhi Catchment

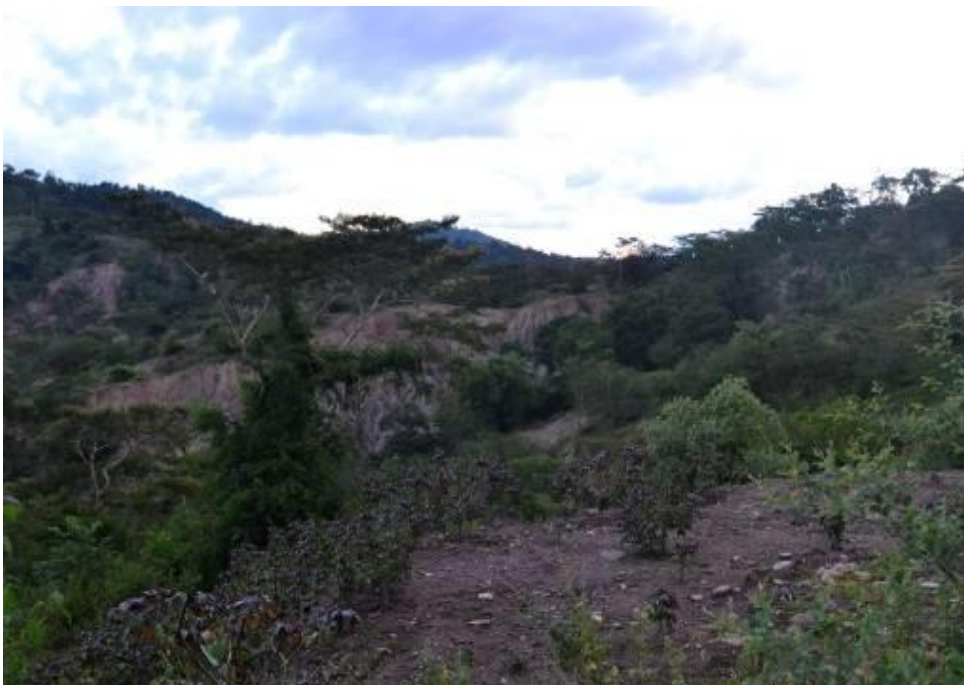
*Figure 11 –Erosion on moderate slopes with sparse vegetation to protect unconsolidated materials. Afaça Suco, Uai Muhi Catchment*

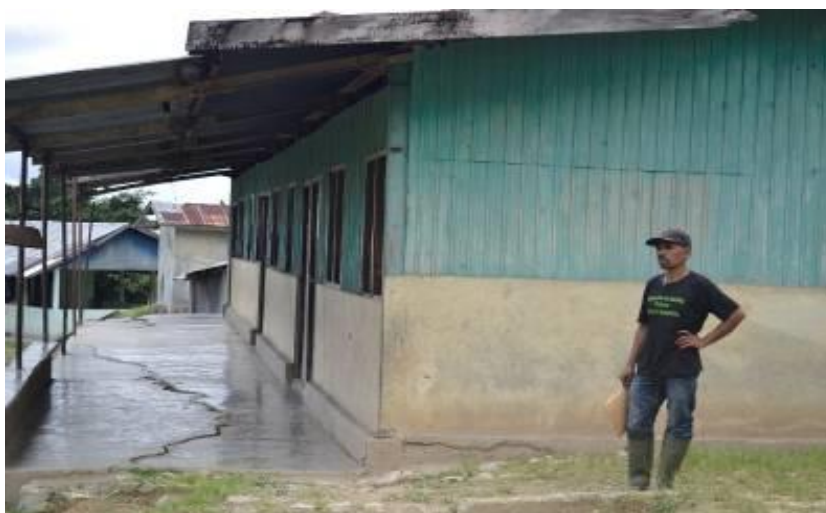
As pointed out in the previous section, most of the infrastructure is not considered to be at high-risk for landslides, but the field work confirmed that many structures suffer damage from various kinds of earth movements. The photographs on this page and in the previous section show clear evidence that Quelicai is a tough place in which to build schools, houses and roads strong enough to withstand the forces of nature. More than 80% of the houses in Quelicai are in areas with medium-to-high risks of erosion, whilst for roads, the percentage is even higher at almost 90%. Only 6 of the AP's 36 schools and 1 of its 5 health facilities are on land with low risk for erosion. Figure 12 shows the damage earth movement has caused to the primary school in Abo *Suco*.

**Figure 12 – Damage to primary school caused by erosion and slumping. Abo Suco, Seiçal River Catchment**

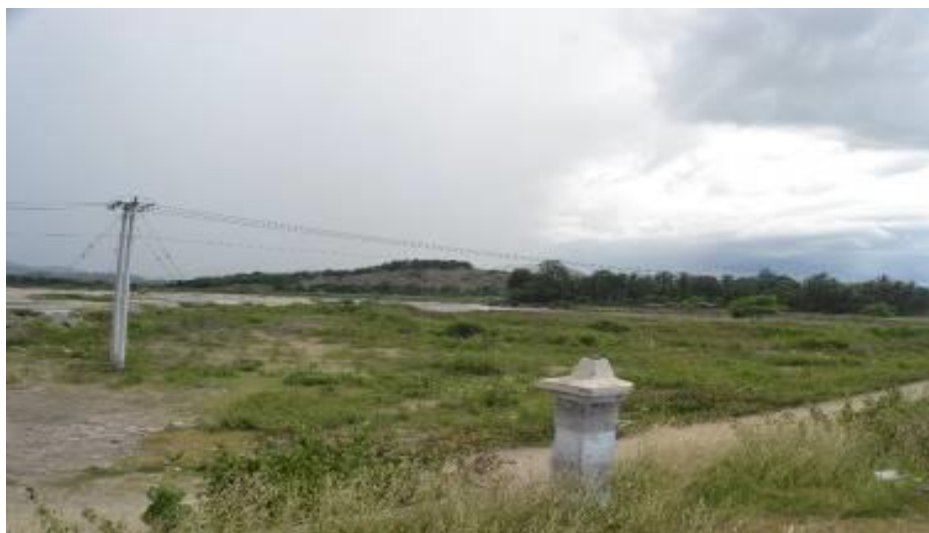
*Figure 13 – Regular flooding threatens roads and electricity infrastructure. Vemassee Suco, lower Vemassee River Catchment*

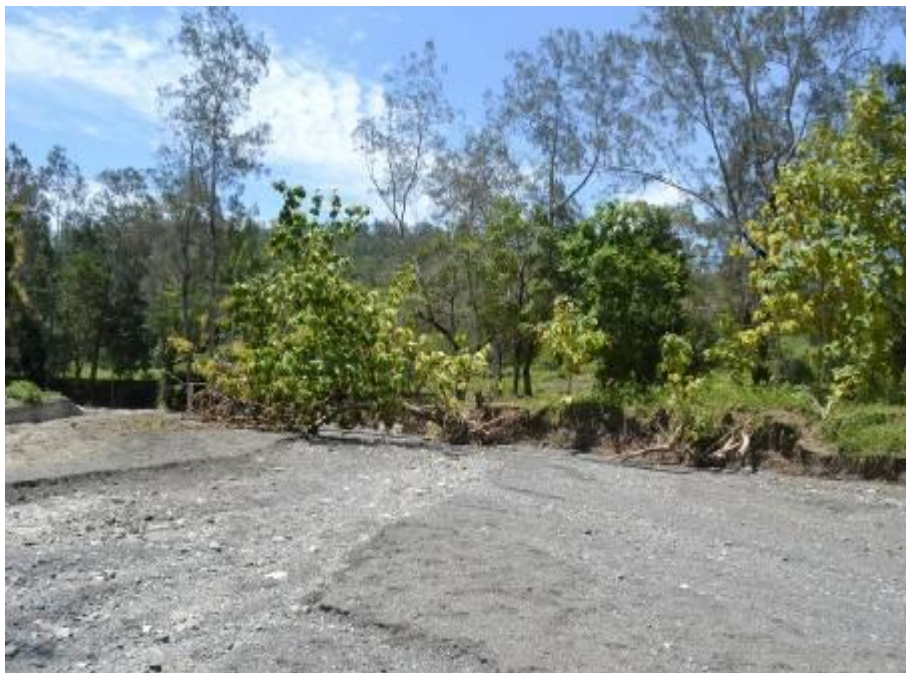
*Figure 14 – Flood damage and erosion close to houses in Ossouala Suco, upper Vemasse River Catchment*

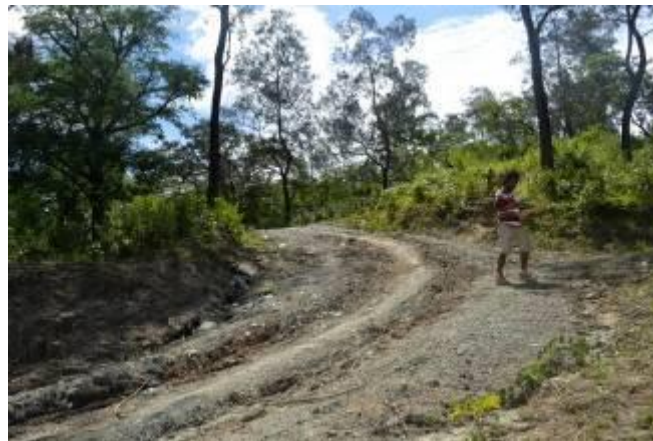
**Figure 15 – Road in poor condition in high-risk area for erosion. Ossouala Suco, upper Vemasse River Catchment**

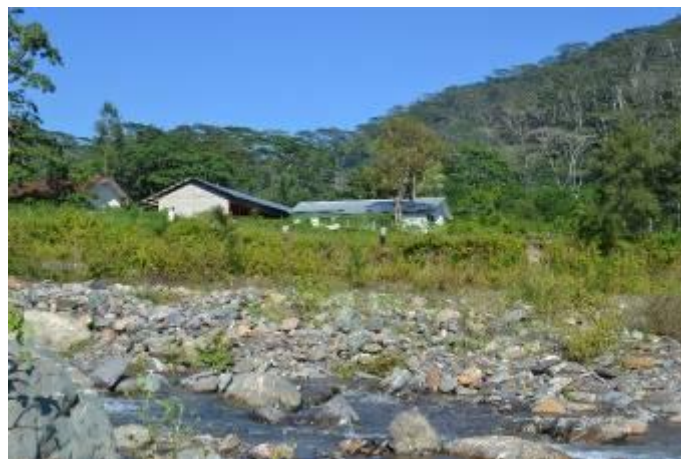
Mertutu *Suco* provides an example of an administrative area with very little flood-prone land – it has only 1 hectare at risk – but with a substantial threat to some key infrastructure. According to the analysis, 1 of the *suco's* 3 schools and its only health facility – the Lodudu Health Post – are both built on that 1 hectare site. This site was visited and verified that the two buildings are indeed at risk, with the river eating away at the bank and getting ever closer to the structures. Members of the community make great efforts to divert the river from its destructive course every year, but long term prevention is beyond their capacity – eventually the river bank will erode away and the buildings will be inundated.

*Figure 16 – School and health post threatened by river erosion and flooding. Mertutu Suco, Lois River Catchment*

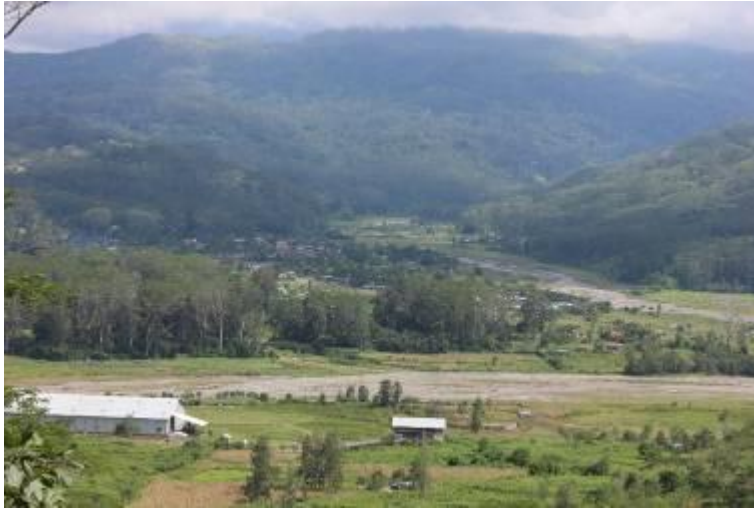
Figure 17 – Flood-prone area in Gleno, showing at-risk infrastructure. Riheu Suco, Lois River Catchment

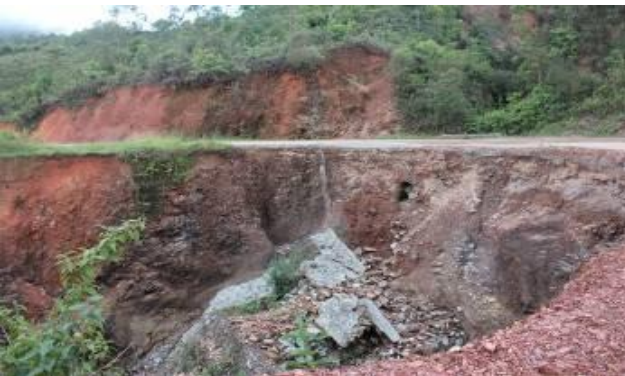
*Figure 19 – Part of main road from Letefoho to Gleno, removed by landslide. Humboe Suco, Lois*

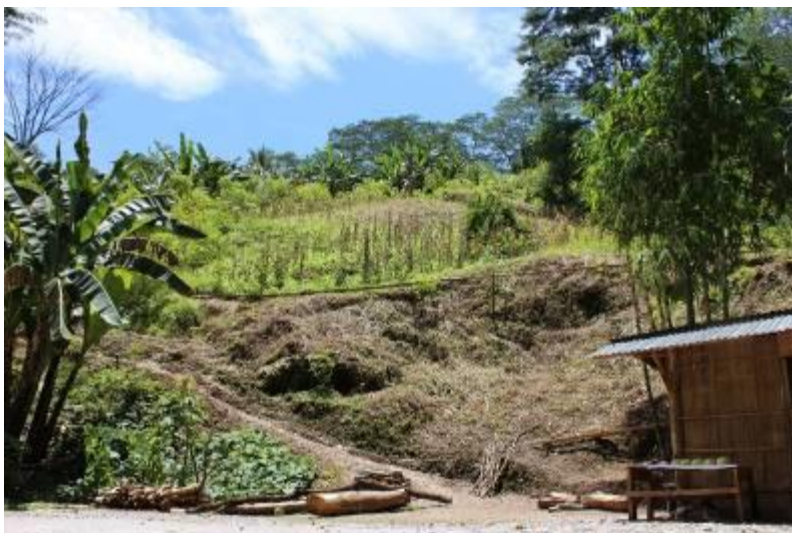
*Figure 21 – Cultivating maize and cassava on very steep, friable slopes. Mertutu Suco, Lois River Catchment*

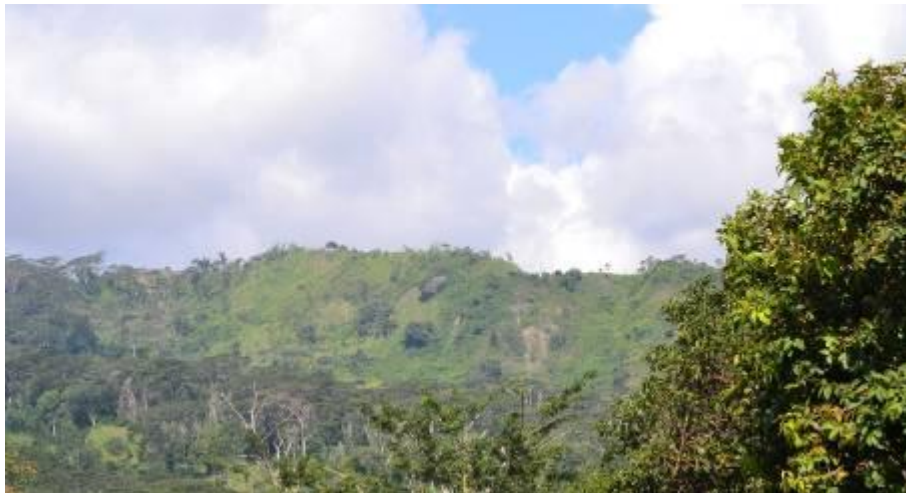
**Figure 26 – Very steep slope and sparse vegetation in high-risk landslide area. Hatulia Vila Suco, Lois River Catchment**

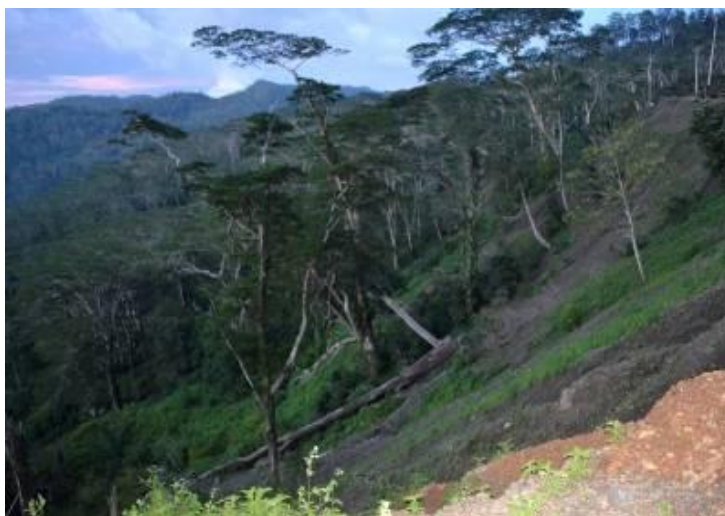
*Figure 27 –Landslide triggered by road construction on sparsely-vegetated moderate slope. Ailelo Suco, Lois River Catchment*

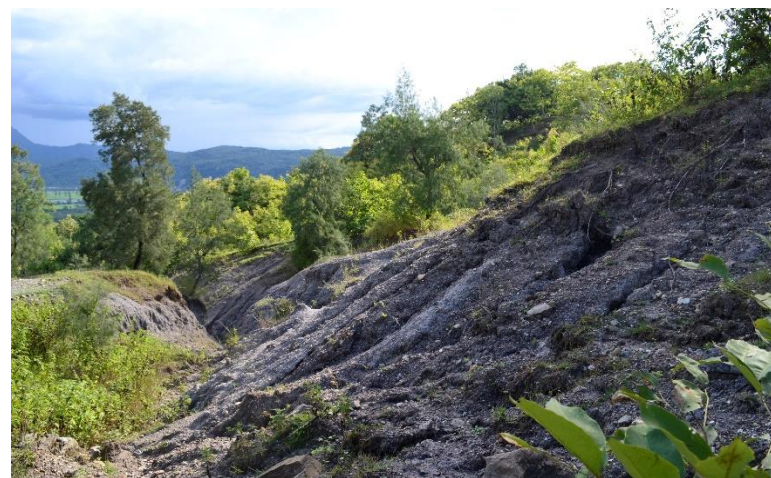
*Figure 28. Erosion on moderate slopes with sparse vegetation cover. In medium risk area for erosion. Samara Suco, Lois River Catchment*

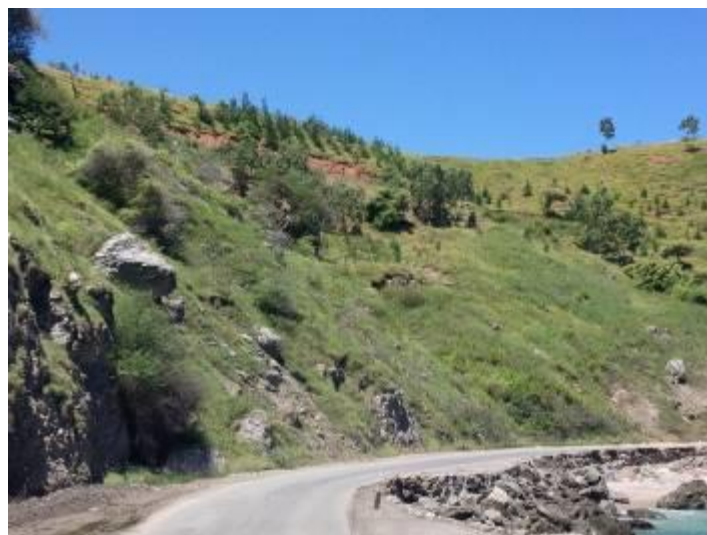
*Figure 30 --Stabilization efforts with tree-planting on landslide-prone slope. Ulmera Suco, Comluli Aggregate Catchment*

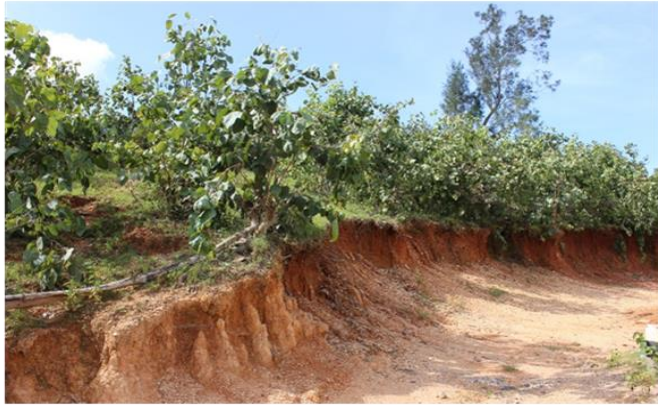
**Figure 34. Road itself eroding away. Ulmera Suco, Comoro River Catchment**

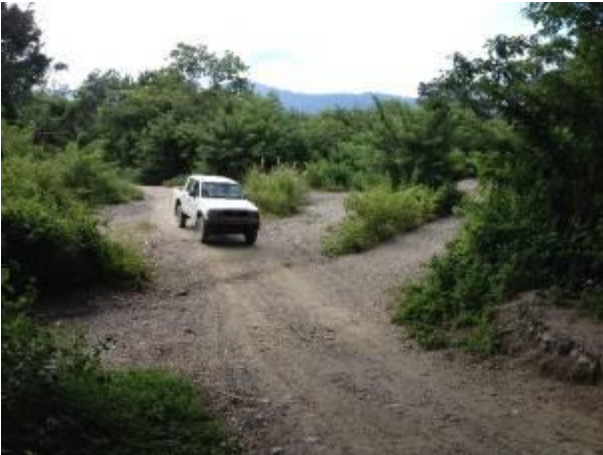
**Figure 42 – Flash floods cause erosion and deposit sediment, damaging roads and other infrastructure. Guiço Suco, Lois River Catchment**

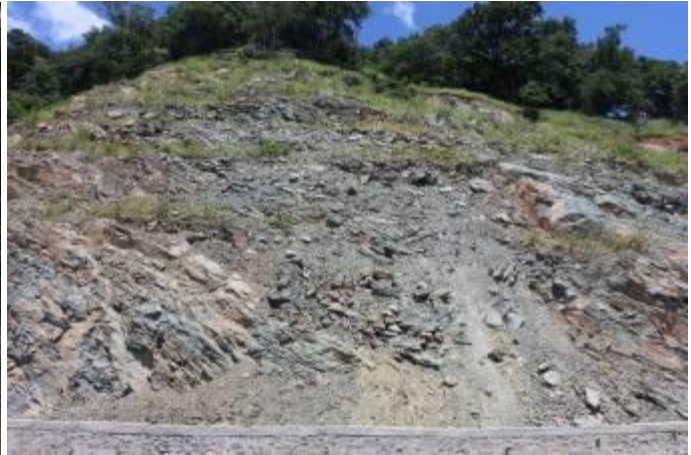
**Figure 43 – Severe erosion on steep slope with thin, friable soils and no vegetative cover. Vatuboro Suco, Sanakiana Aggregate Catchment**
