HOUSEHOLD BUILDING AND BUSINESS PREMISES DAMAGE ASSESSMENT

HBDA & BPDA IN KOSOVO FOLLOWING THE JANUARY 2023 FLOODS

APRIL 2023

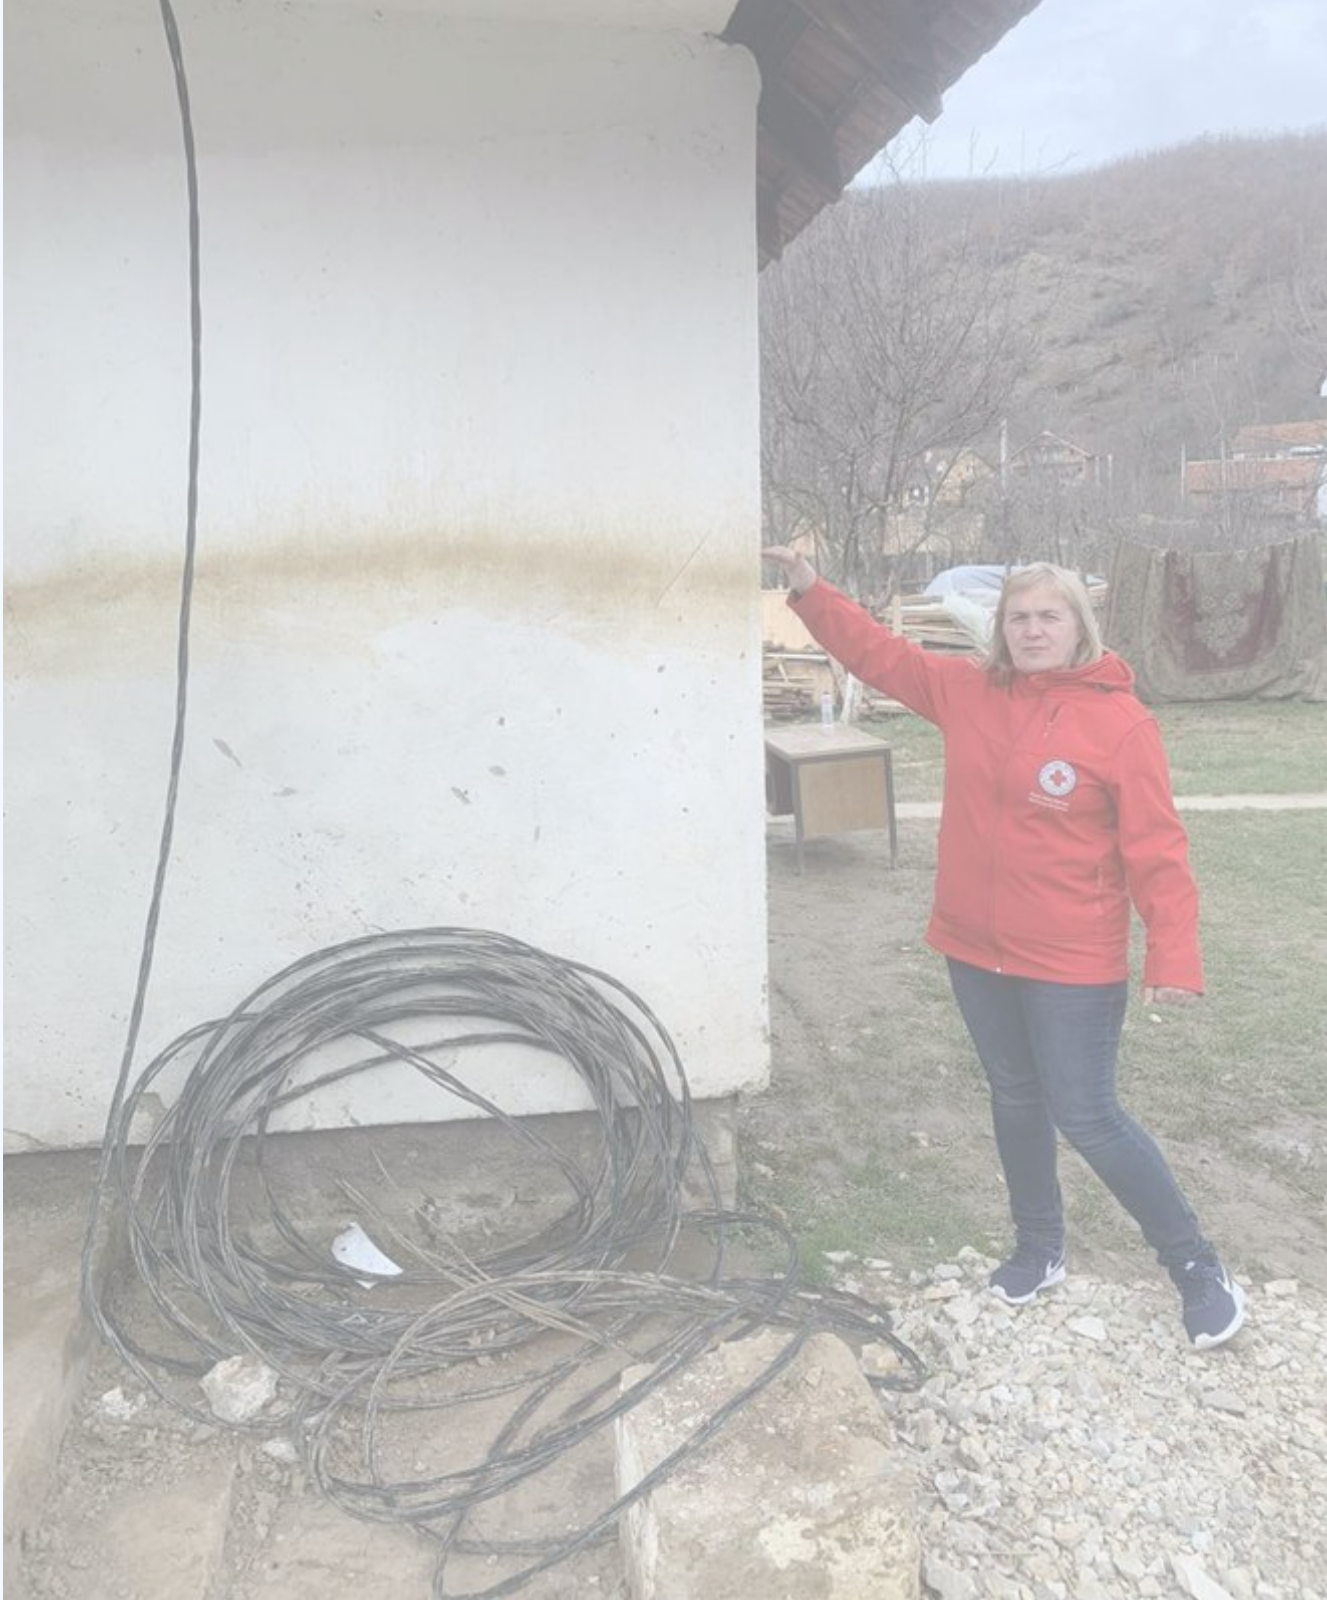
→ Red Cross volunteer displaying flood levels in Tushilë/Tušilje village, Skenderaj/Srbica municipality.
Photo credit: UNDP Kosovo.

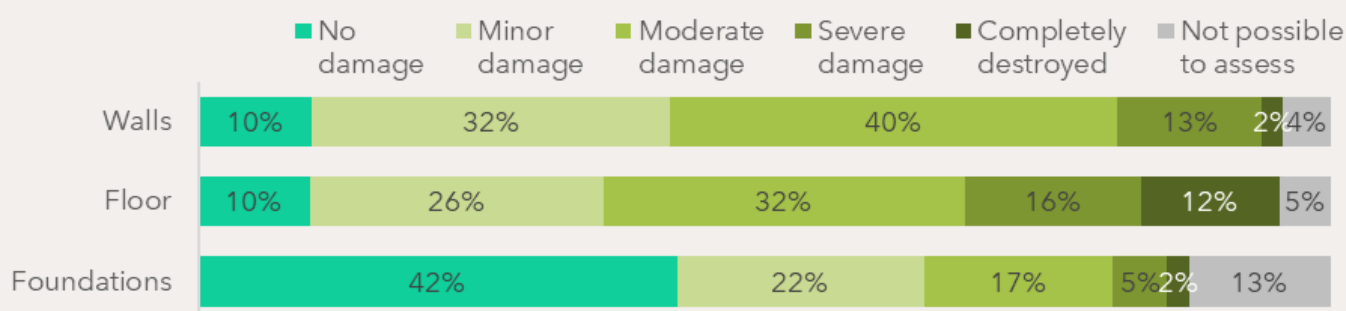
Figure 11: Damage to walls, floors and foundations of the buildings

As illustrated in Figure 11, the walls and floors of the assessed buildings are damaged more than the foundations. More than four out of every five households reported damage to the walls and floors, while fewer than one in two households reported damage to the foundations. These figures are interpreted in detail below, considering other possible data disaggregation factors (municipalities, family size or gender of the head of household).

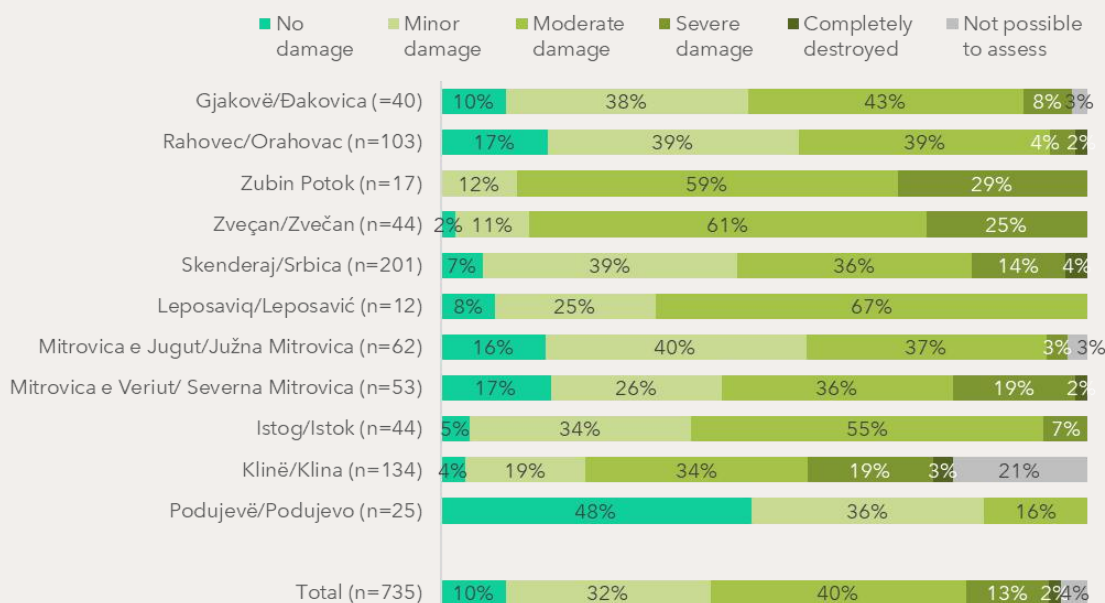
Figure 12: Damage to the walls of the building by municipalities

Approximately 4% of respondents were not able to assess if their walls were damaged. Therefore, municipal authorities need to go into the field to conduct a proper assessment. In terms of geographic differences, the municipality of Klinë/Klina had the highest share of respondents (21%) who were not able to assess the damage (see Figure 12).

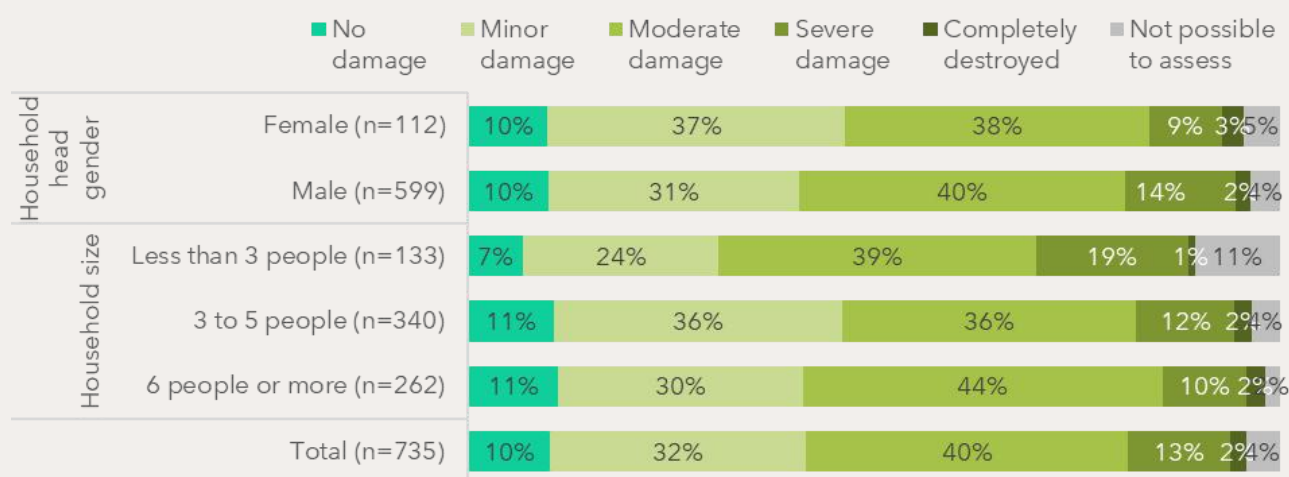
Figure 13: Damage to the walls of the building by gender of household head and household size

Even though the percentage of severely damaged and completely damaged walls is low, when considering the size of the household the number of affected people is substantial. **Therefore, immediate attention from municipal inspectors is needed.** Based on the analysis, it can be said that male-headed households report a higher level of severe damage to walls (14%) than female-headed households (9%) – see Figure 13.

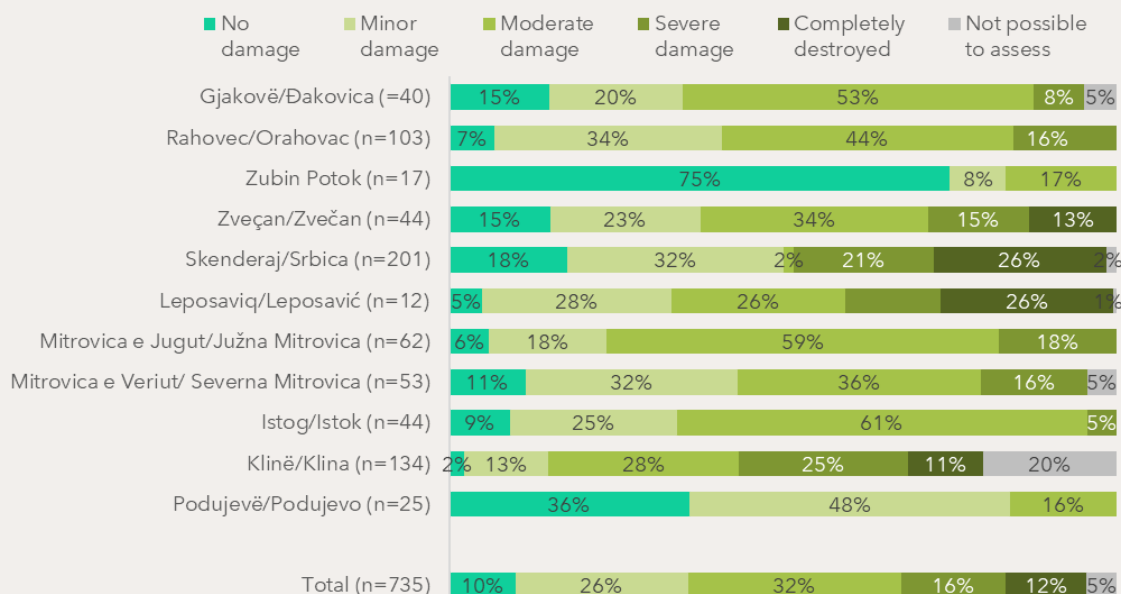
Figure 14: Damage to the floor of the building, by municipalities

The severity of floor damage was found to be higher in municipalities that experienced high flooding levels (see Figure 18). Approximately 95% of the affected households in Mitrovicë e Jugut/Južna Mitrovica reported some level of floor damage, followed by 93% of the affected households in the municipality of Rahovec/Orahovac and 91% in the municipality of Istog/Istok. **The municipality of Skenderaj/Srbica was found to be the most affected area in terms of floor damage severity**, with 47% of the affected households reporting either severe floor damage or complete floor destruction.

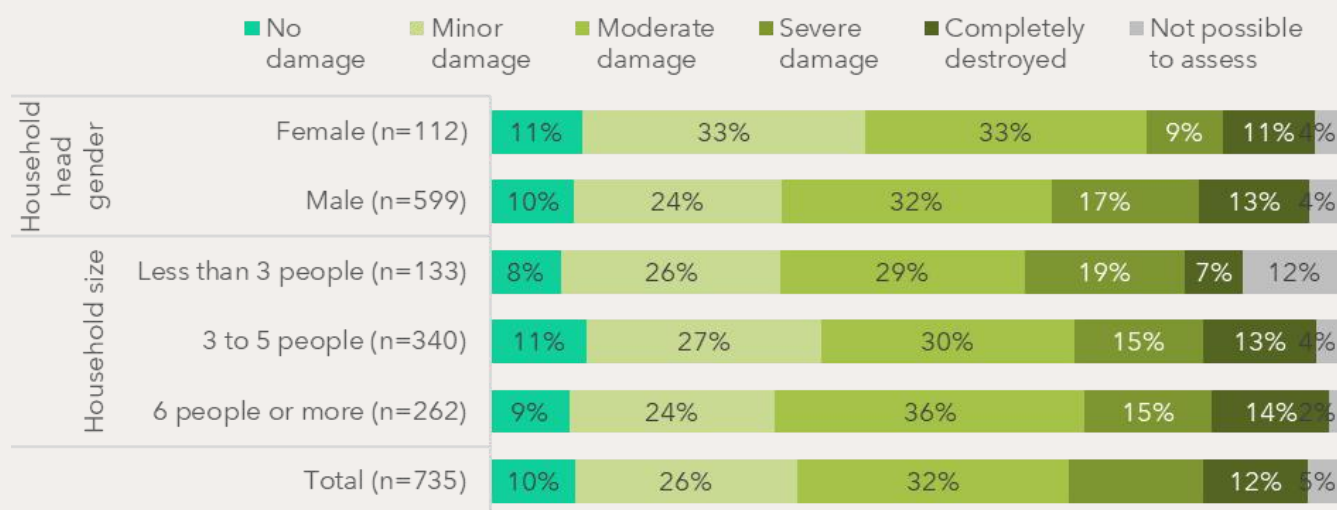
Figure 15: Damage to the floor of the building by gender of household head and household

As with damage to the walls, a greater proportion of male-headed households reported severe and complete floor destruction. Large household size translates into a higher share of the population living in at-risk premises which need to be evaluated by professionals (see Figure 15).

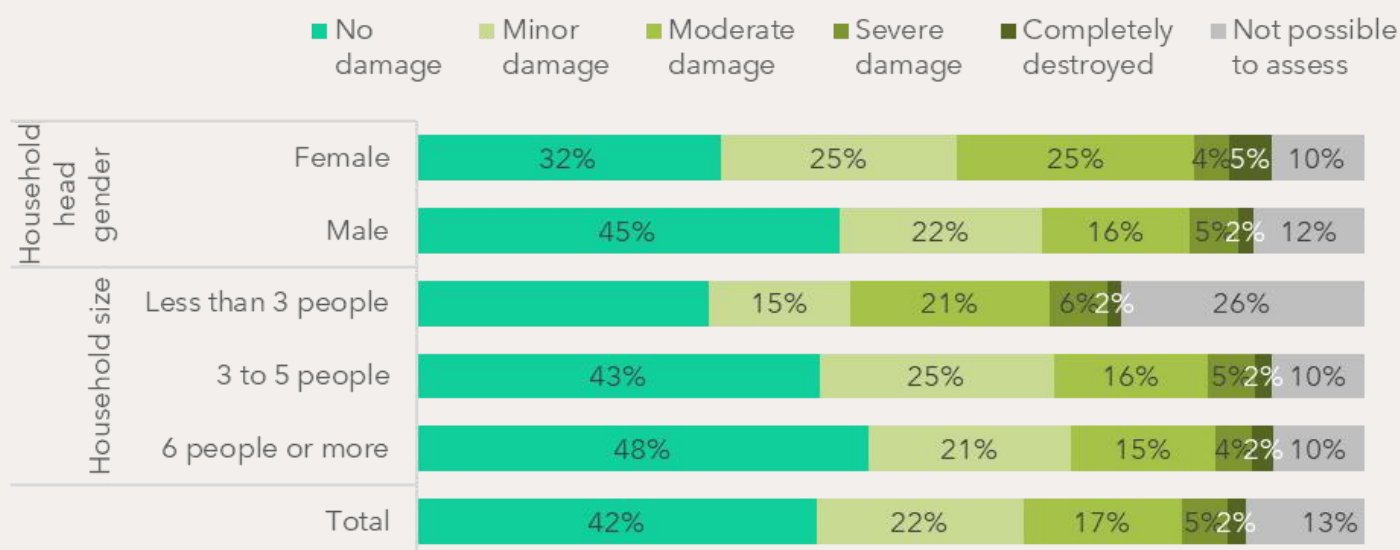
Figure 17: Damage in the foundation of the building by gender of the household head and household size

A higher proportion of households headed by males reported no damage to the foundation of the buildings (refer to Figure 17). **One out of every four households with fewer than 3 members reported being unable to assess the damage to the foundations**, indicating the need for professional assessment.

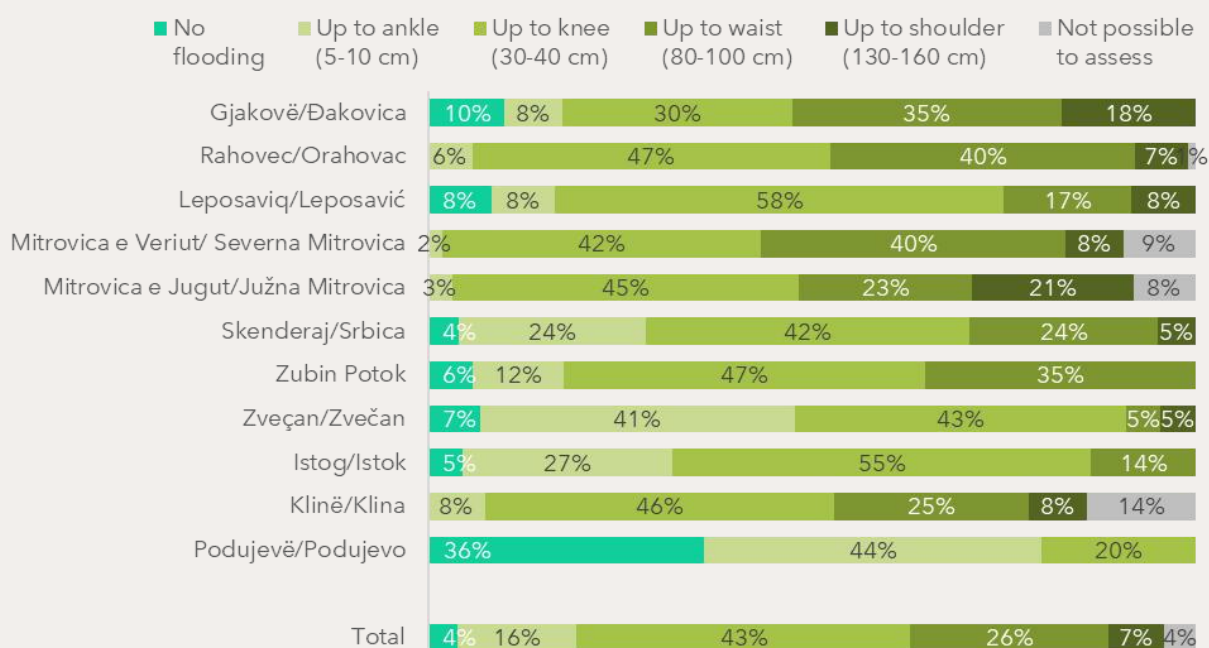
Figure 18: The flooded buildings by municipalities

This information provides valuable insights into the areas most vulnerable to flood damage and those that require targeted interventions to mitigate future risks.

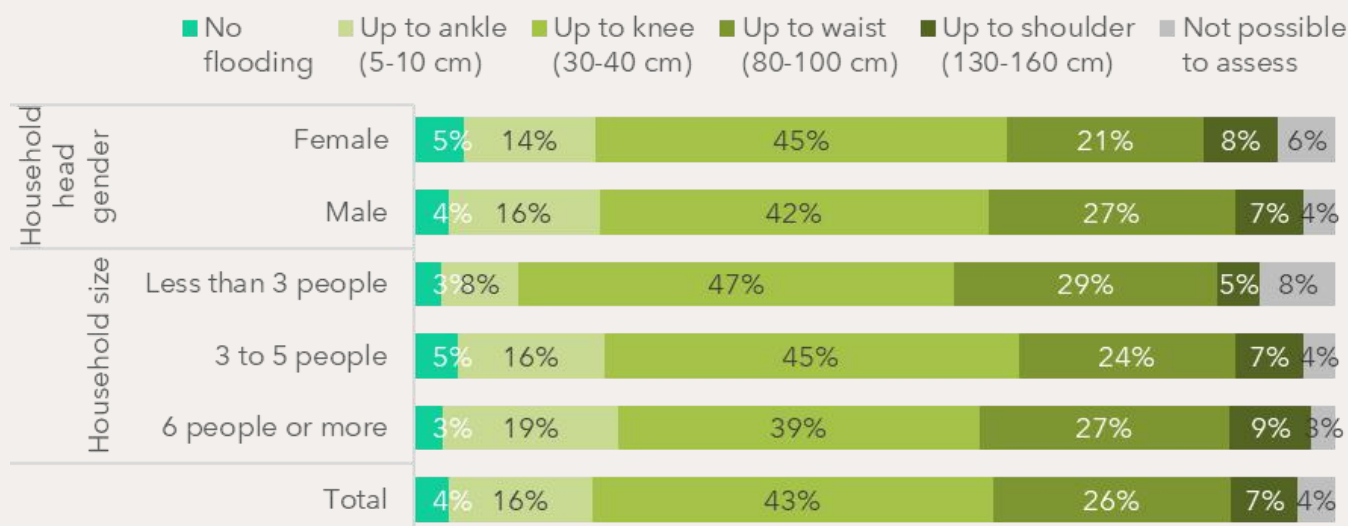
Figure 19: The flooded buildings by gender of household head and household size

The assessment did not reveal a significant difference between the height of water/flood level and the gender of the household head or household size (refer to Figure 19).

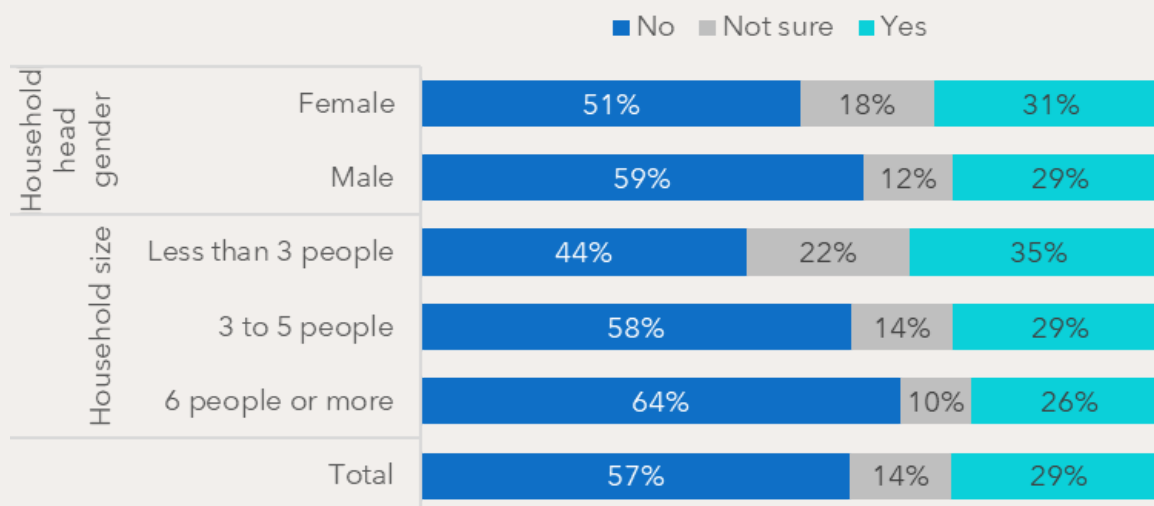
Figure 21: Urgent repairs for the building to prevent further damage in the future, by gender of household head and household size

The need for urgent repairs to prevent further damage to buildings was analyzed by gender of the household head and family size (illustrated in Figure 21). The results indicate that there is no significant difference between male- and female-headed households in terms of the need for urgent repairs.

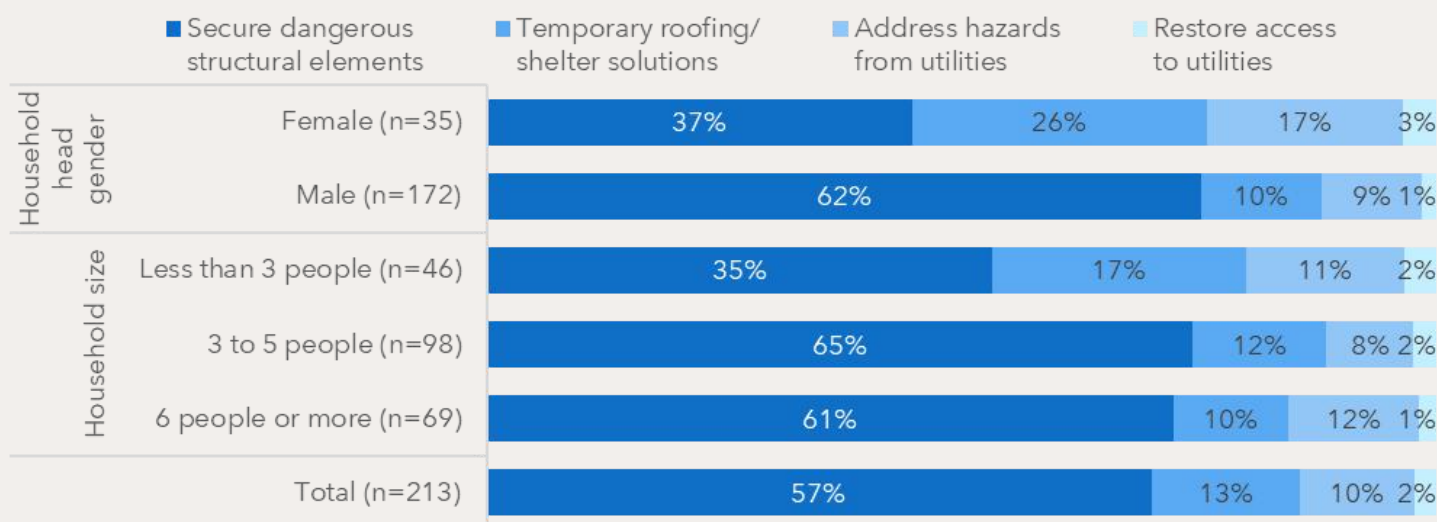
Figure 23: Type of the essential/urgent repairs to the building by gender of household head and household size

The data shows that 62% of male-headed households report the need to secure dangerous structural elements, while only 37% of female-headed households report the same need. In contrast, more females (26%) than males (10%) report the need for temporary roofing/shelter solutions. Additionally, 17% of female headed households report hazards from utilities, while only 9% of male-headed households report the same need.

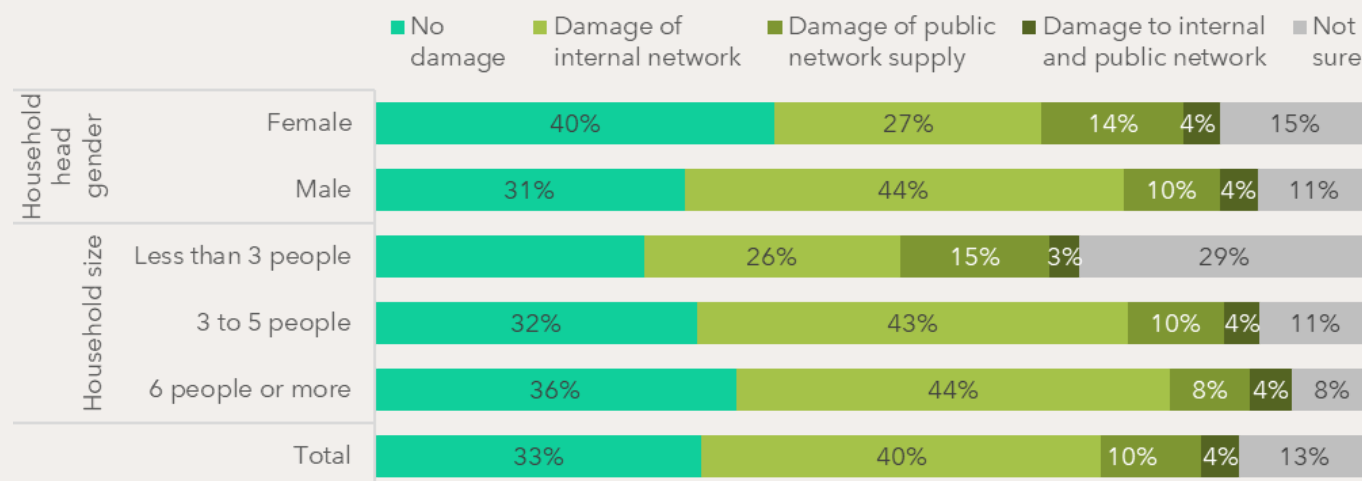
Figure 25: Type of damage to the electricity system as a result of flood by gender of the household head and household size

Figure 25 provides disaggregated data on the damage with respect to gender and family size. 40% reported no damage; 31% of those with male heads reported no damage. 44% of families with 6 or more members reported damage to the internal network, while 36% reported no damage to the electricity supply.

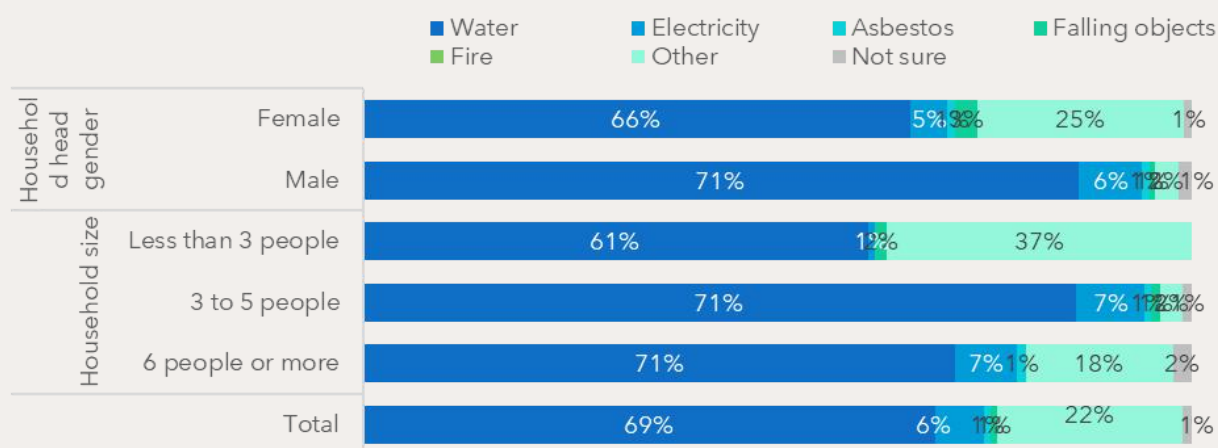
Figure 27: Building hazards by gender of household head and household size

No significant gender differences are observed in the responses related to building hazard exposure. 66% of female headed households face water building hazards, and 71% of male-headed households (see Figure 27).

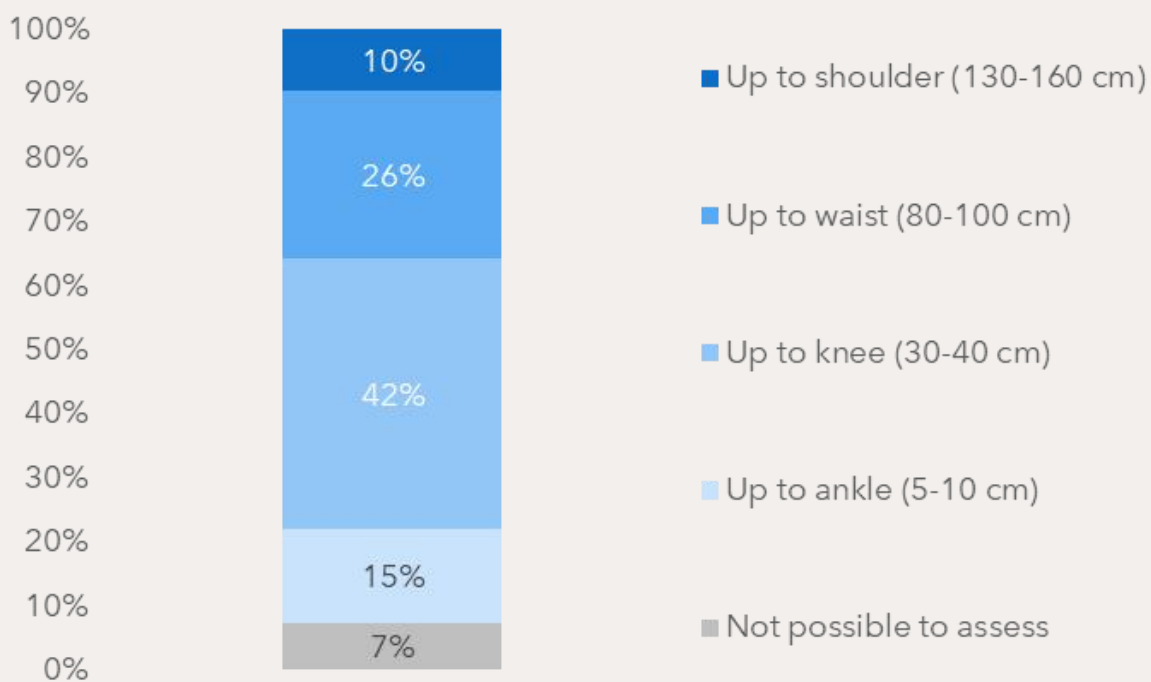
Figure 69: Has the building been flooded?

The most typical flooding was up to knee-level (30-40 cm), but 36% of businesses experienced flooding of 80-160 cm

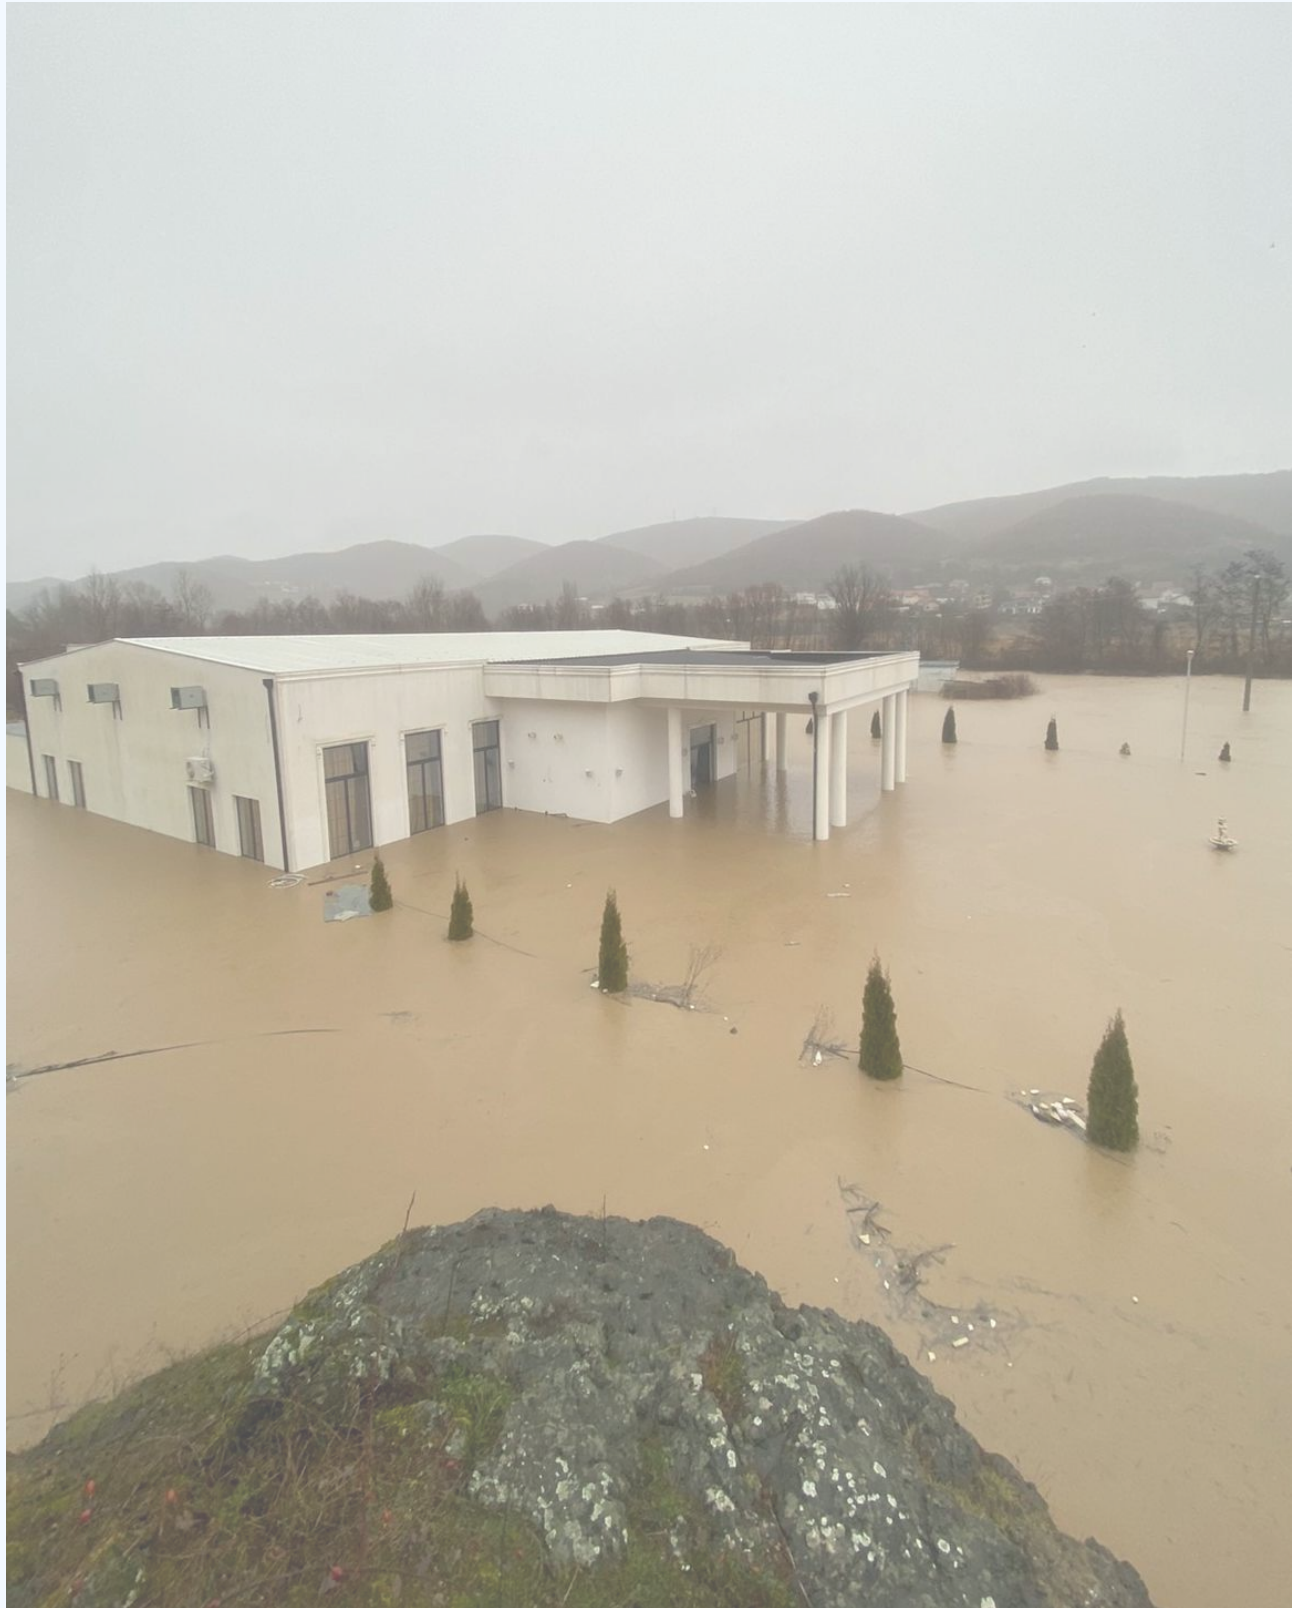
→ Flooded restaurant and water pump station in Koshtovë/Košutovo village.
The pump station provides drinking water for multiple villages.
Photo credit: Bashkim Kurti, Director of Regional Water Company "Mitrovica."
