Conservation Works at the Mosque in Kalavastos/Kalavason

PROJECT OVERVIEW

Type of intervention: Conservation works

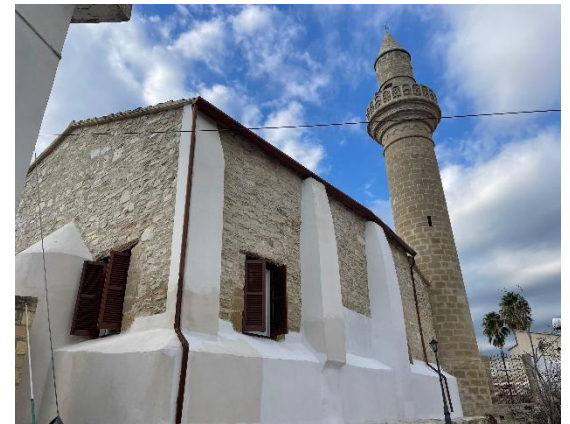
The Mosque is a single-storey stone masonry structure of rectangular layout; the building is aligned from north-east to south-west. There is a portico at the north-west side of the main building with pointy arches and tiled roof. The portico has the appearance of having been added to the mosque after its initial construction. The large minaret rises in the mosque's north-east corner where its doors open into the portico. Minaret's platform has solid stone banister with carved relief design on the outer face; with repeating patterns. This feature can only be found in two other minarets in Cyprus, therefore adding to the building's architectural value. There is also trace for an area of a school (not part of the yard).

The building stands on a sloping ground. The walls are strengthened by buttresses built right up to the roof. The pitched and tiled roof is constructed of rafters resting on beams.
