GEORGIA/TBILISI FLOOD ASSESSMENT MISSION

TECHNICAL ASSESSMENT REPORT OF EVENTS
WORLD BANK
20 JULY 2015

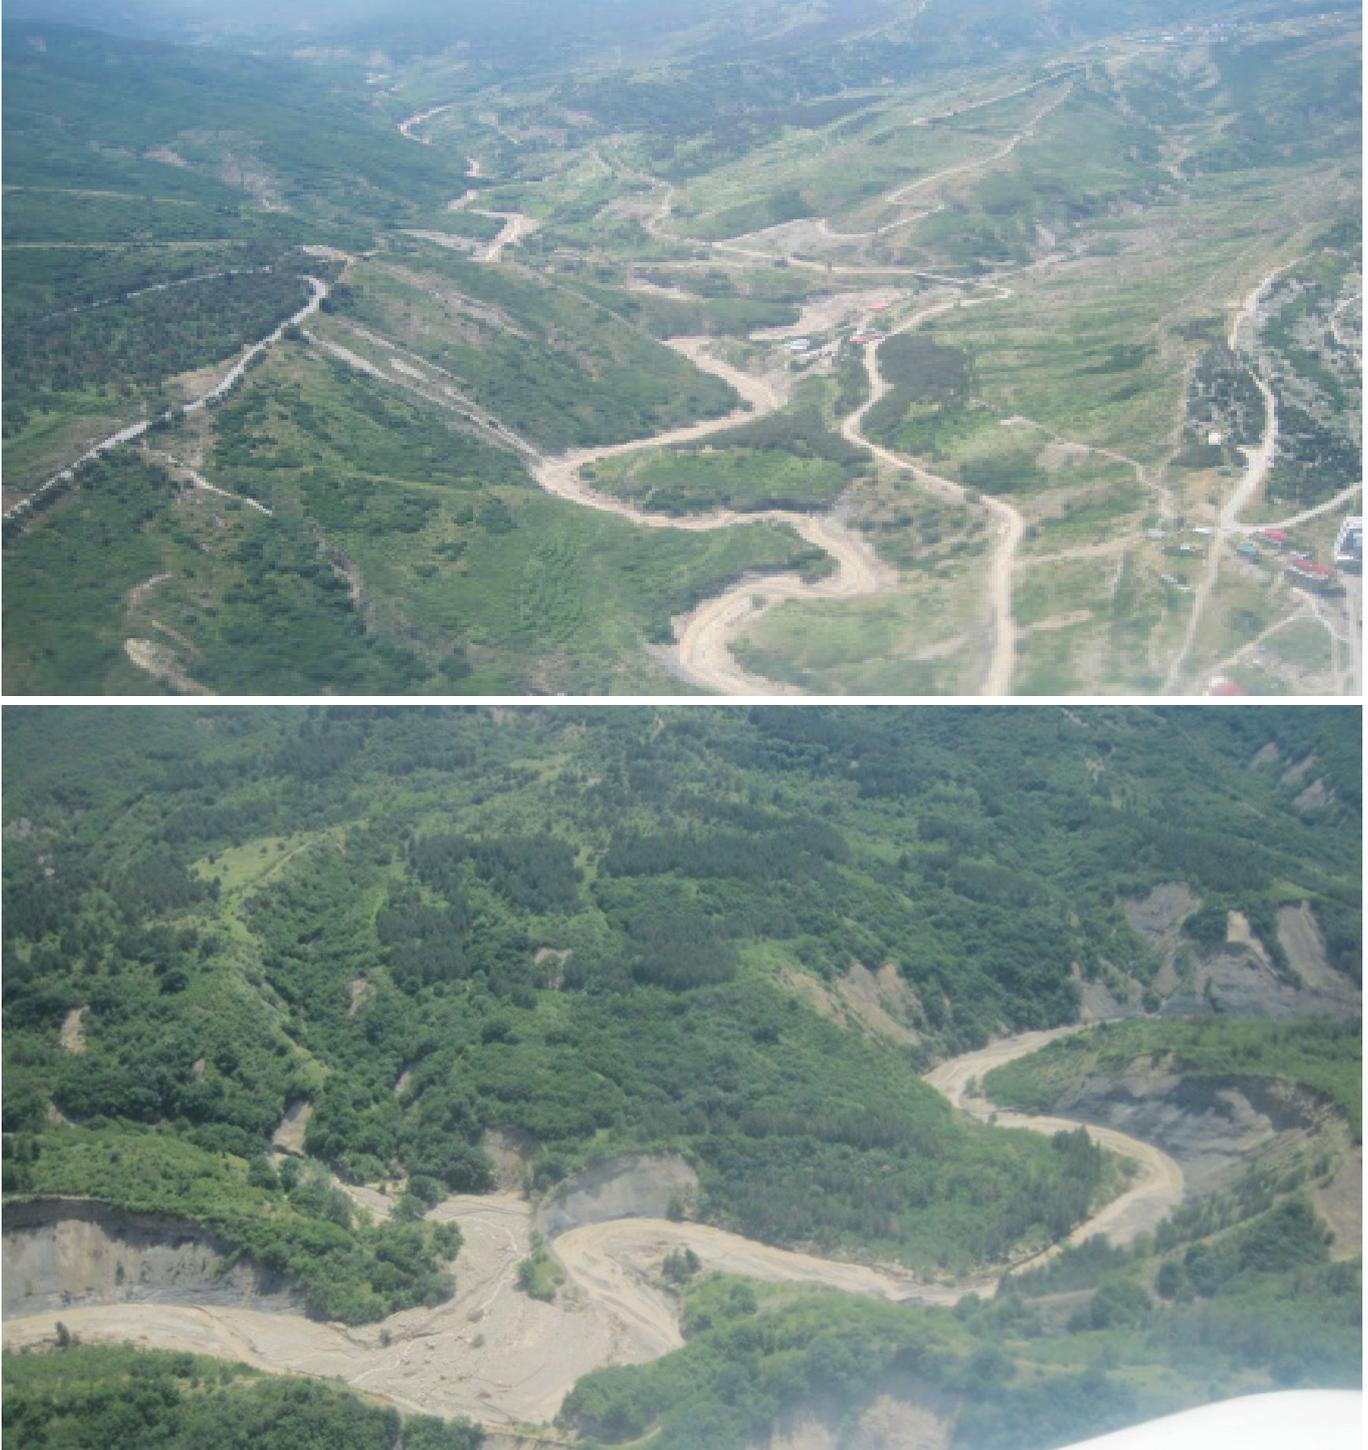
Figure 4. Vere River Upstream from Tbilisi - Possible locations for some River Training.

The Vere River upstream from Tbilisi city is confined by quite steep gorges and rock outcrops that permit some meandering but which are controlled by the outcrops (Figure 4).

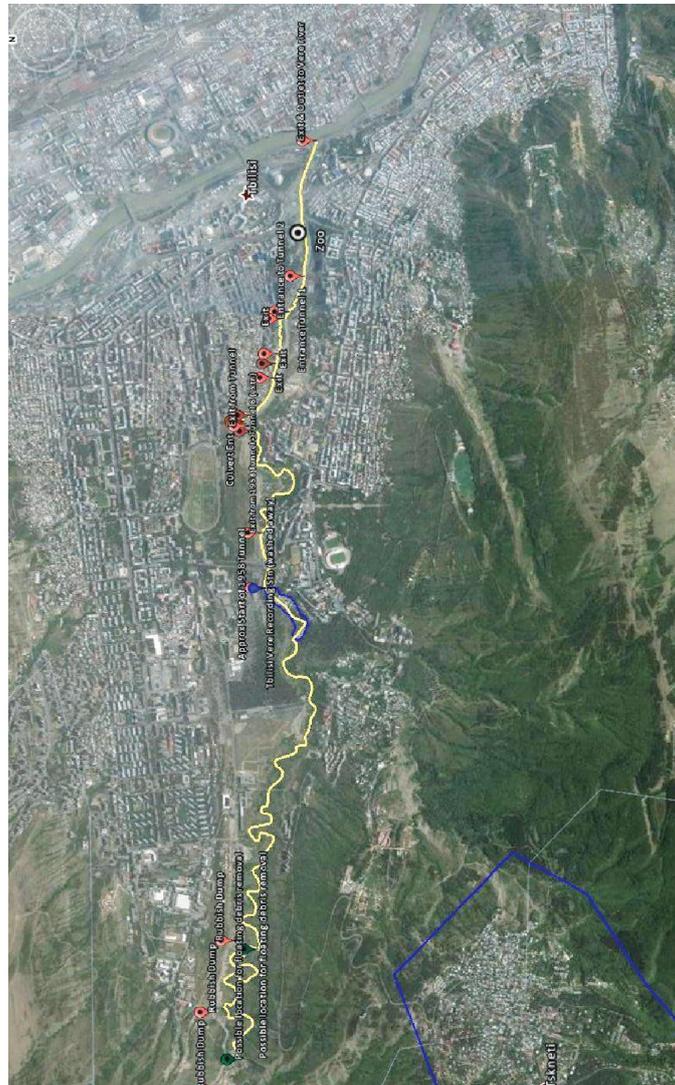
Figure 5. Course of Vere River in Tbilisi City

As it enters the city boundaries, the river starts to become constrained by the considerable urban buildings, road infrastructure and other developments. Some of these encroach directly onto the river course and flood plain and present significant constraints on the passage of peak and regular flood flows. Once it enters the city, the river course is in part canalized into a series of tunnels and Armtec corrugated steel culverts of varying length separated by reaches of open channel that convey the river water through the city into the larger Kura River (Figure 5). The most upstream and oldest tunnel, 230 m in length, was built by the Russians in 1958 and lengthened as part of more recent infrastructure related developments⁴¹.

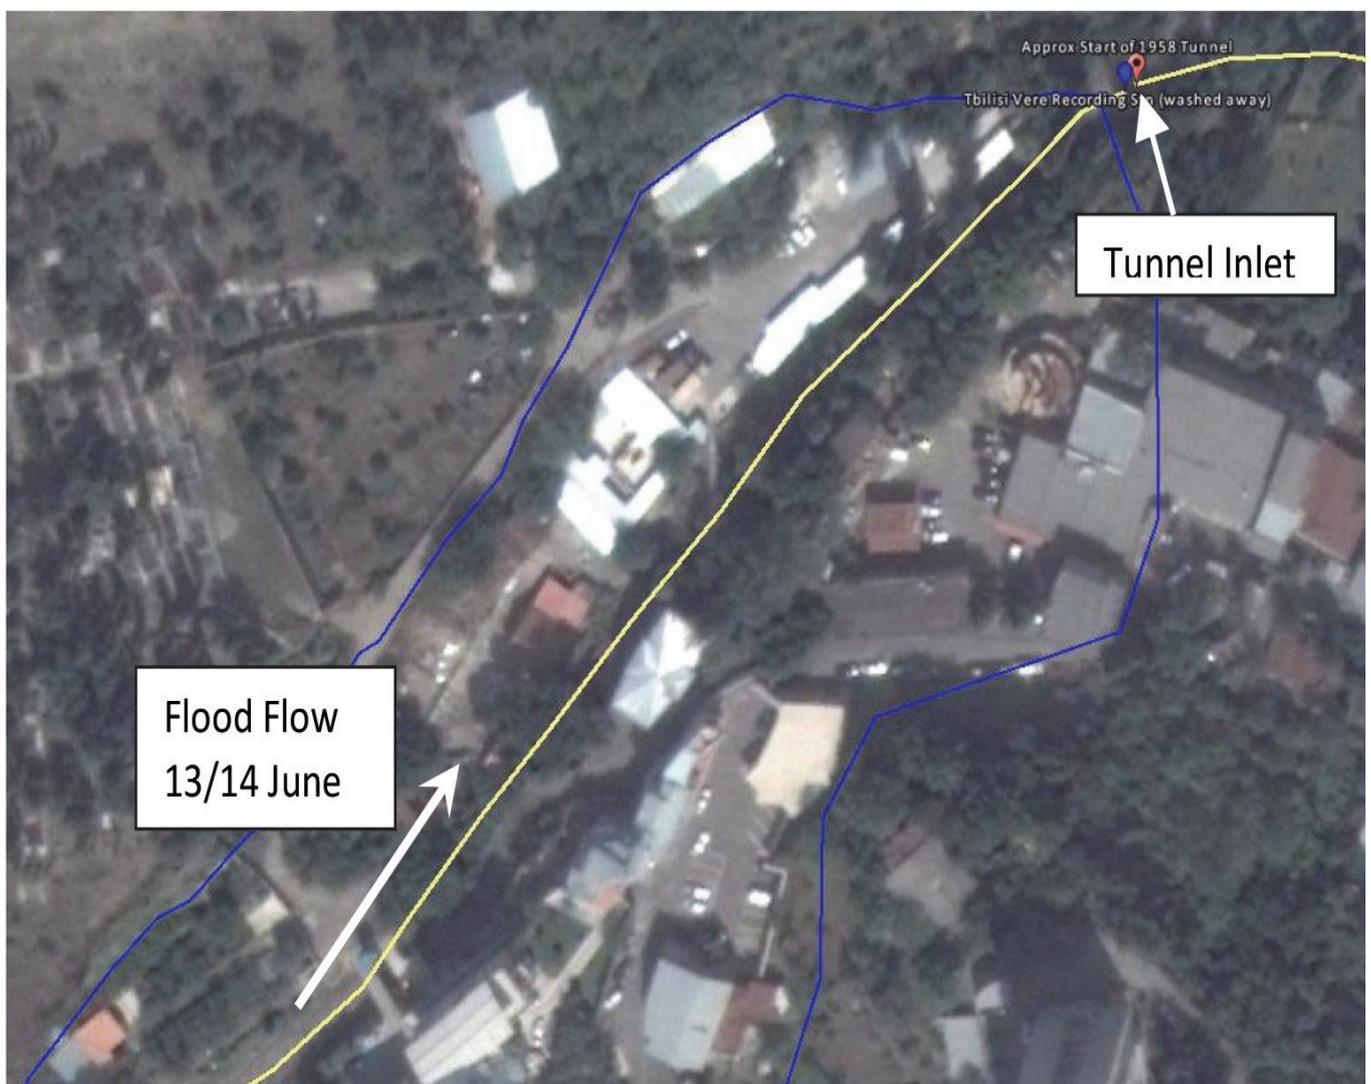
Figure 6. Development Restricting the Vere River course Upstream from the 1958 Tunnel.

As the first flood peak passed down the River, the severity of the flood flow volume was increased by the narrowing of the river course 225 m upstream from the tunnel inlet due to incursion into the river course by the unapproved extension of buildings (Dog Home; Sausage Factory; low bridges) – Figure 6 and Photos 3.1 & 3.2. Not only did this restrict the carrying capacity of the river, more importantly it caused it to adopt a new course over the left bank thereby transporting a parked lorry into the mouth of the first tunnel (now designated Tunnel 6 + extension). This blocked the tunnel entrance and facilitated the build up of trees and other debris that together completely dammed the tunnel entrance.

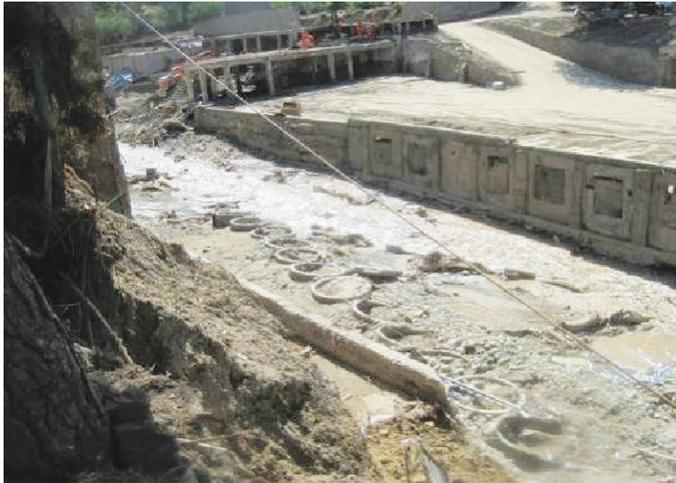
Photo 3.1 Unapproved Bridges Upstream from the 1958 Tunnel

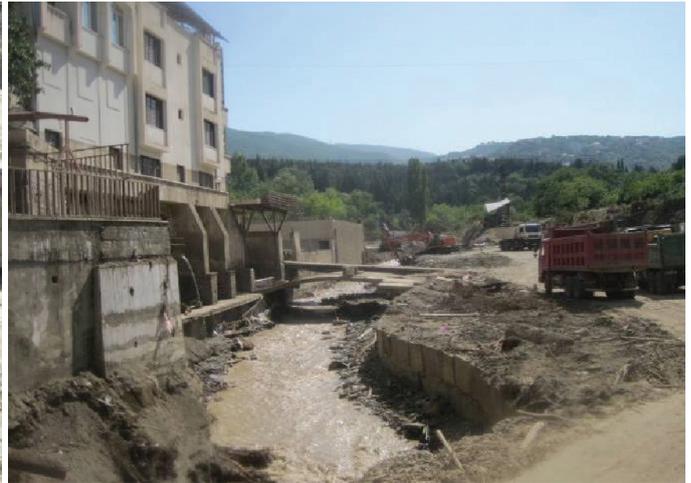
Photo 3.2 River Encroachment u/s from 1958 Tunnel

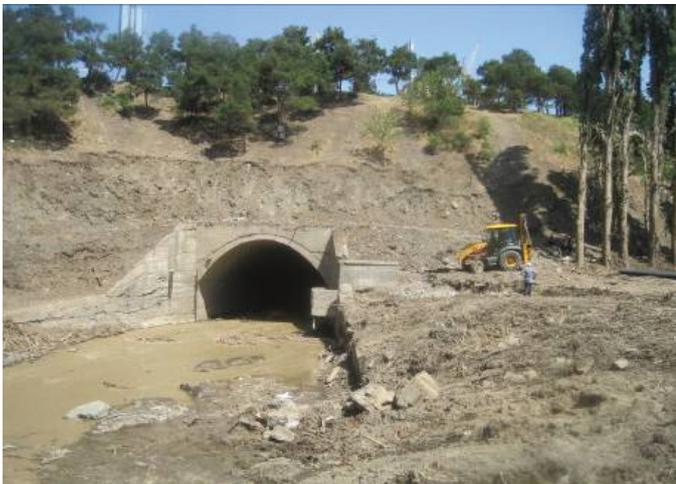
Photo 3.3 Inlet to 1958 Tunnel Cleared After Flood

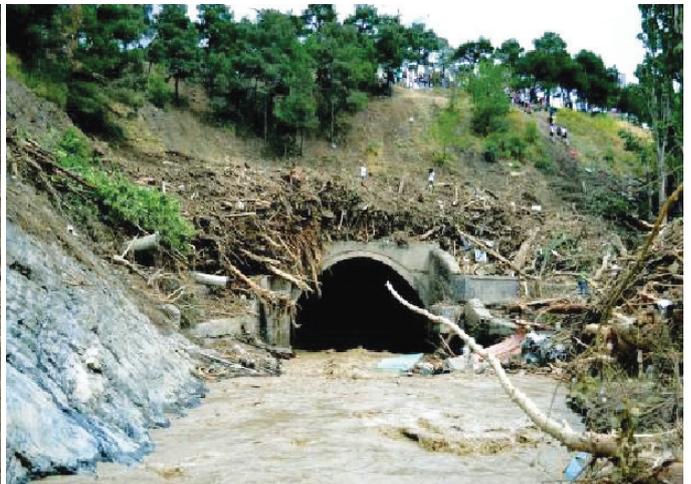
It was then impossible for debris laden flood waters to pass unhindered through the tunnel and this caused the water level upstream from the tunnel to rise between 5 and 10 metres (Photos 3.3 & 3.4) and caused flooding of Svanidze Street and neighbouring buildings.

Photo 3.4 Inlet to 1958 Tunnel after Flood

Tunnel Protection. Although the measures proposed above should be adequate, it is recommended that additional steel piles are located in the Vere River course immediately upstream of tunnel #6 to prevent any large objects such as vehicles from being washed into and blocking the tunnel system. This would be regarded as a backup measure should the others proposed be ineffectively maintained or damaged or broken or not be implemented in time should another severe flood occurred.

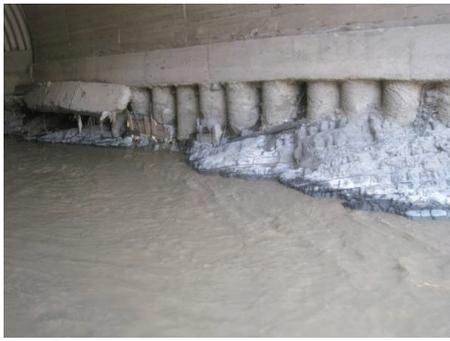
Eventually, the high head of water (10m = 1 atmosphere) was sufficient to create an hydraulic explosion that cleared the blockage. Unfortunately this created a surge flow down the entire tunnel system that had such a high velocity (>5m/sec.) that not only brought much of the deposited sediment back into suspension, but also caused considerable damage to other tunnels, downstream river banks undermining buildings and anything in the flood flow path.

Photo 3.5 Outlet from Tunnel 6 showing extent of Scouring of Bed

B. River Bank Stability. Some of the open river sections between the existing tunnels and culverts in Tbilisi City were badly damaged during the floods and especially those at the upper end of the system near the outlet from Tunnel 6 and the inlet to Tunnel 5 as described in Section 3.3.1. (See Annex E - photos 6 & 7). Although some works are on-going in this area, the right river bank is very unstable due to the number and size of the upslope buildings (see Annex E - photos 13 & 14). It is therefore imperative that without delay, the following studies and investigations are initiated:

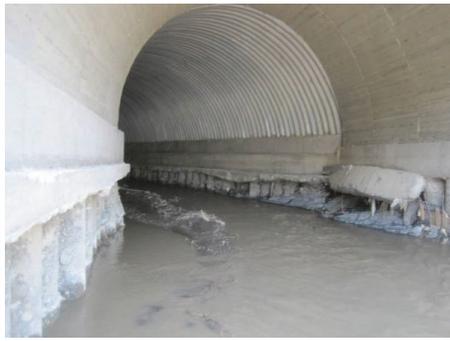
Photo 3.6 Exposed Pile caps & piles at Outlet from Tunnel 6

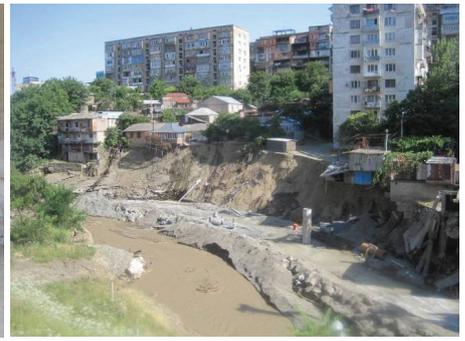
Photo 3.7 Flood Scoured RB of Vere River d/s from Tunnel 6 showing undermining of Buildings

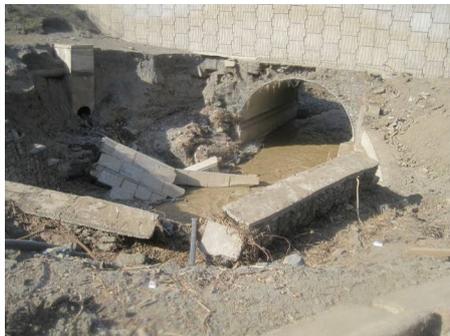
Photo 3.9 Flood Damage to 2nd Part of Tunnel 5

All of the river tunnels and culverts within the Tbilisi municipality will need to be cleaned, structurally examined in detail and repaired. It has been assumed that these aspects and associated costs have been taken into consideration when the damage assessments had been made for the road infrastructure as almost all are directly related to the reinstatement of good transport communications within the city.

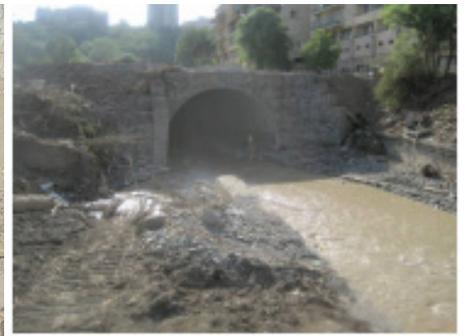
Photo 3.10 Flood Damaged Exit to Tunnel 4

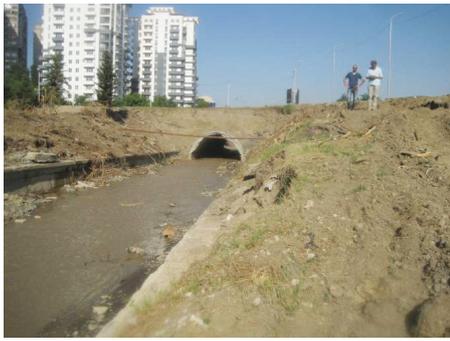
The whole process was repeated down the tunnel system. This is evidenced by the considerable material distortion at the entrance and outlets of subsequent tunnels and downstream damage (Photos 3.5 to 3.13). At the exit to Tunnel 2, the excessive velocities washed away the last 10 to 15 metres of the culvert, undermined the two carriageway highway that crossed over it and caused deep flooding and sedimentation in the Mziuri Park on the right bank.

Photo 3.11 Open Vere River Channel Section after Tunnel 4

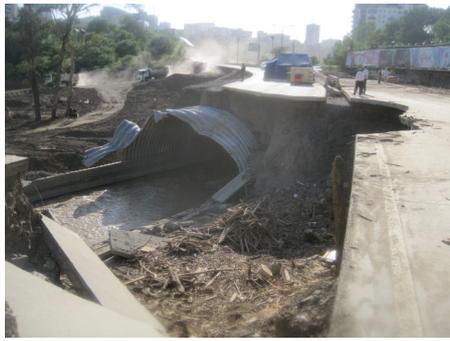
Photo 3.12 Flood Damaged Exit to Tunnel 2

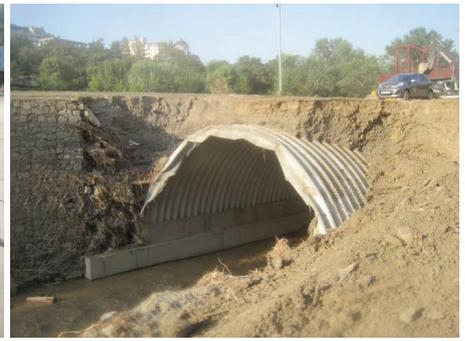
Photo 3.13 Flood Damaged Entrance to Tunnel 1

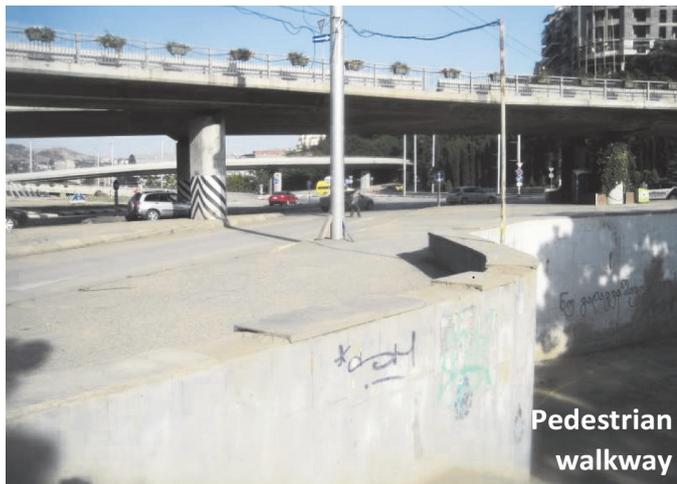
Once again, as the deep and fast flood proceeded downstream, it again crossed over the two carriageway highway as by then too much water had accumulated to pass easily through the next entrance to the final Tunnel I. Unfortunately the Tbilisi Zoo was located on the other side of this highway (Photo 3-15) and at a lower elevation from which the only exit was the small underground pedestrian walkways (Photo 3-14) and the lower road sections of the roundabout at Heroes Square⁴³.

Photo: 3-14 looking downstream towards Heroes' square

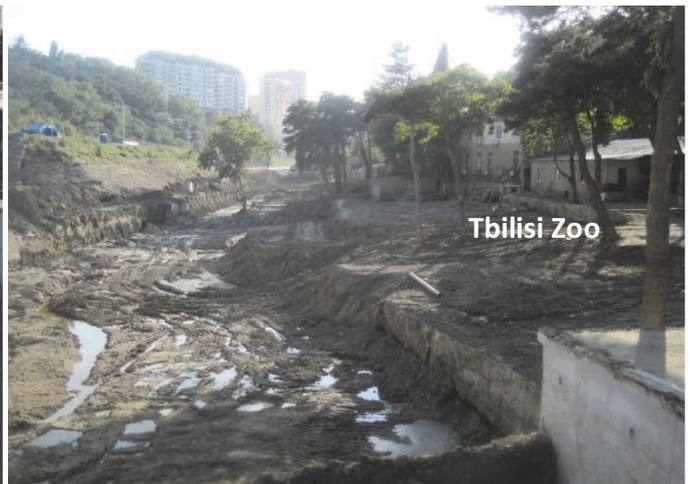
Photo: 3-15 looking upstream at same location as Photo 3-14 from the Tbilisi Zoo
