Adapting to Climate Change:

A Story of Communities that have Overcome their Vulnerability to Disasters on the Honduran Coast

© UNDP, Honduras, June 2013

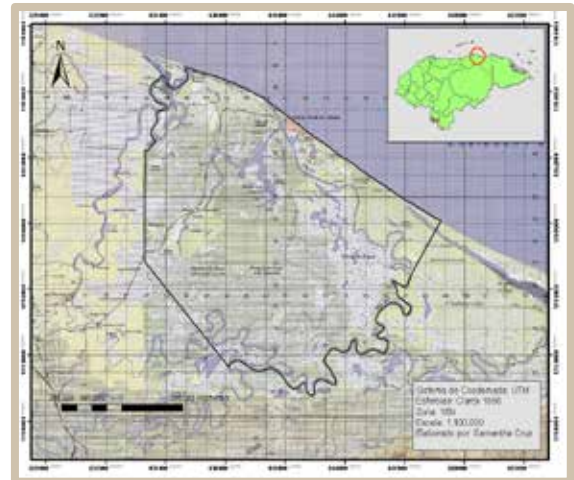
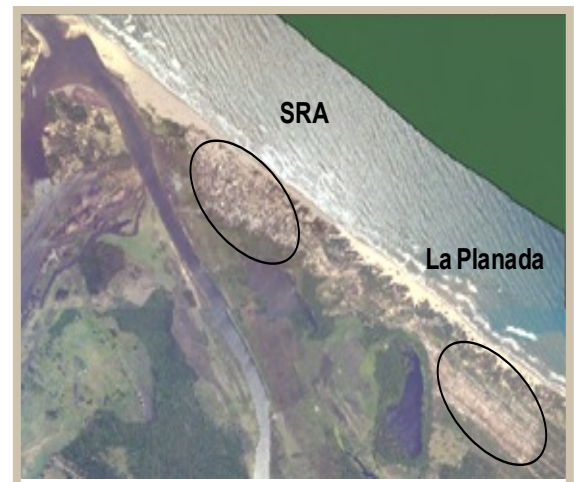
Imagen (A) La hoja cartográfica muestra la delimitación del municipio de Santa Rosa de Aguán; (B) imagen de color señalando la comunidad, elipse negra izquierda Santa Rosa de Aguán, elipse derecha La Planada, coordenadas: UTM, SRA (0641299,176335), La Planada (0642899, 1762810).

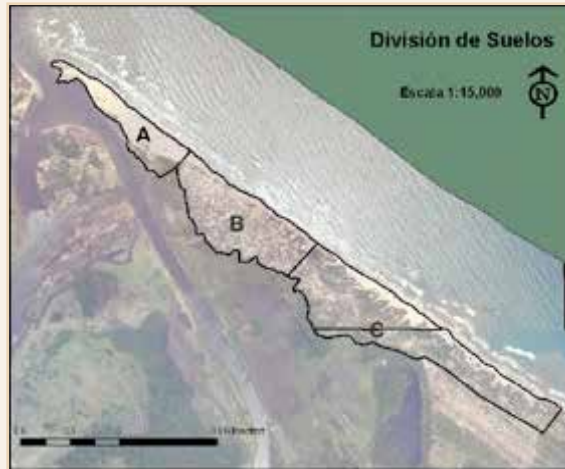
“To determine the loss or increase of dune ridge areas, aerial photographs between 1992 and 2008 and a topographic survey from 2010, at a scale of 1:15,000, were analyzed.”

Calculation of land increases and losses. A: Sand bars with dunes close to the mouth of the river; B: Community; C: Larger dunes between the cemetery and La Planada

“The greatest losses of land occurred between 1992-2001 with -21.52 ha. Homes and coastal dunes were lost due to coastal erosion that may have been caused by the effects of Hurricane Mitch in 1998.

In the period between 2001 and 2008, area A showed greater sediment accumulation, with decreases in sediments in areas B and C. This is a product of coastal erosion influenced by tropical storms. Between 2008 and 2010, an increase in sediments was found to have been concentrated in area A.

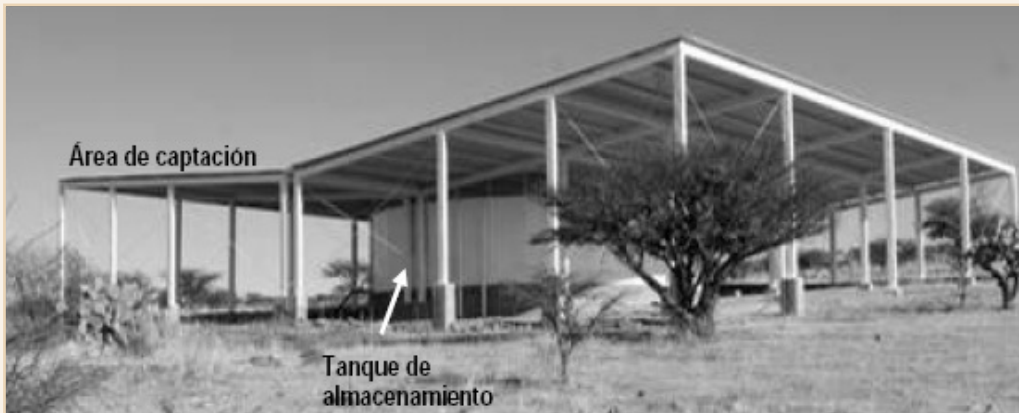
Rainwater capture by roof catchment (Anaya and Martínez, 2007)

In accordance with the area’s characteristics, rainwater harvesting systems with roofs, ponds lined with polyethylene or black plastic, or trenches lined with black plastic were proposed.”

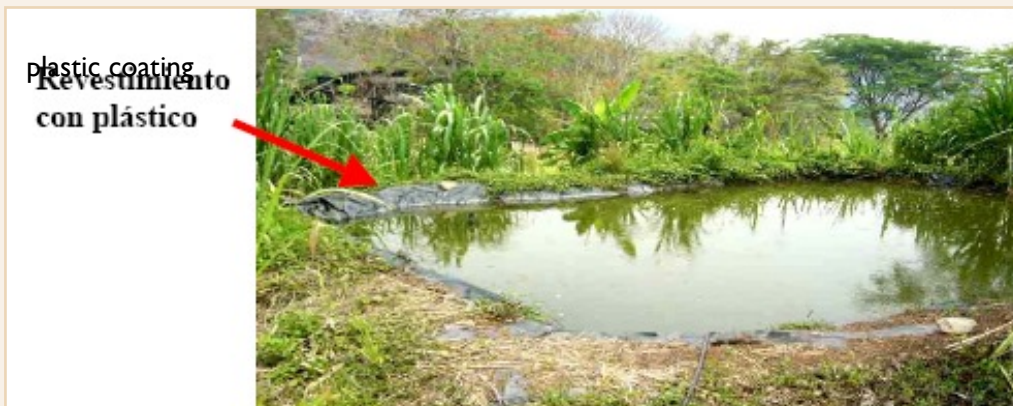
Example of a pond lined with black plastic (CATIE, 2006)

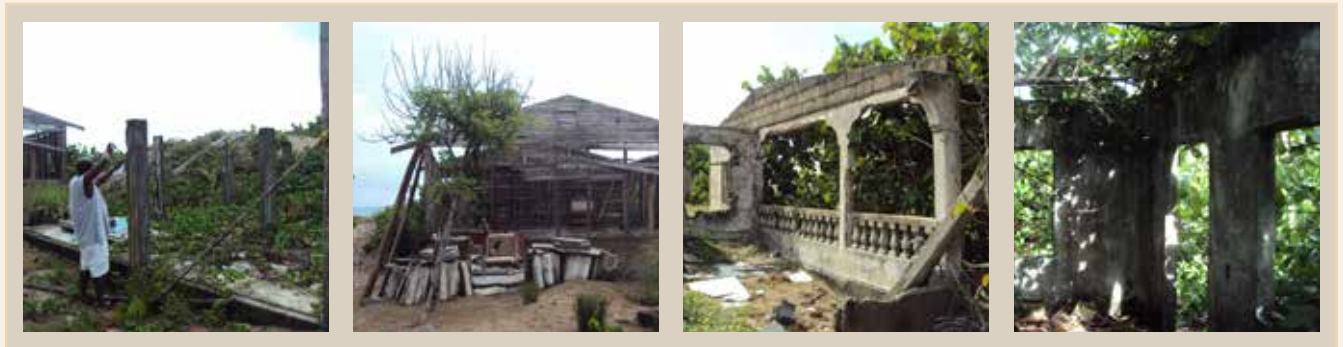
Photos of some demolitions
to be done

According to *El Primer y Segundo Informe de Supervisión de Obras*, by UNDP Honduras. Cruz, S., “As part of the intervention measures to rehabilitate the frontal coastal dunes, it has been suggested to demolish the concrete structures, which are remains of homes destroyed by Hurricane Mitch and which restrict dune formation as they prevent the spread of native vegetation and impede the geomorphological formation of the dune, thus affecting the dune ecosystem.”

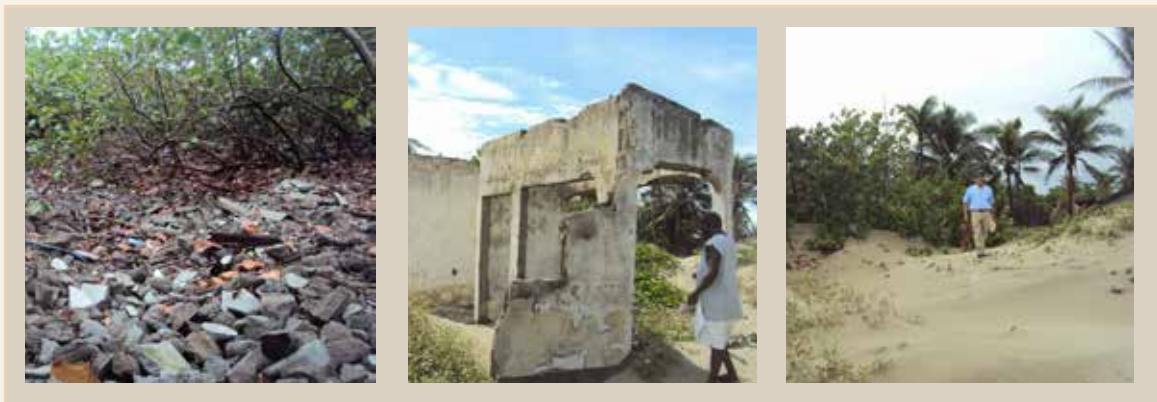
Accumulation of home demolition debris, impeding the dune dynamic.

Part of a destroyed home.

The hauling of debris left by the demolition of the remains of homes destroyed by Hurricane Mitch was completed in two phases. Care was taken to not leave any remains as they could leave a negative impact through visual pollution and remains and could affect the natural regeneration of dune vegetation species.
