# APPROPRIATE TECHNOLOGIES SUSTAINABLE LIVELIHOODS

**LESSONS FOR DISASTER RESILIENT  
CONSTRUCTION IN ODISHA**

The assessment team visited and documented the condition of 20 TDUs (of the 63 constructed under the project) across 20 villages in Balasore, Kendrapara, Jagatsingpur and Puri districts. Table 5 provides a summarized overview of the TDUs visited. Detailed assessments of the 12 TDUs visited are provided in Annexure C.

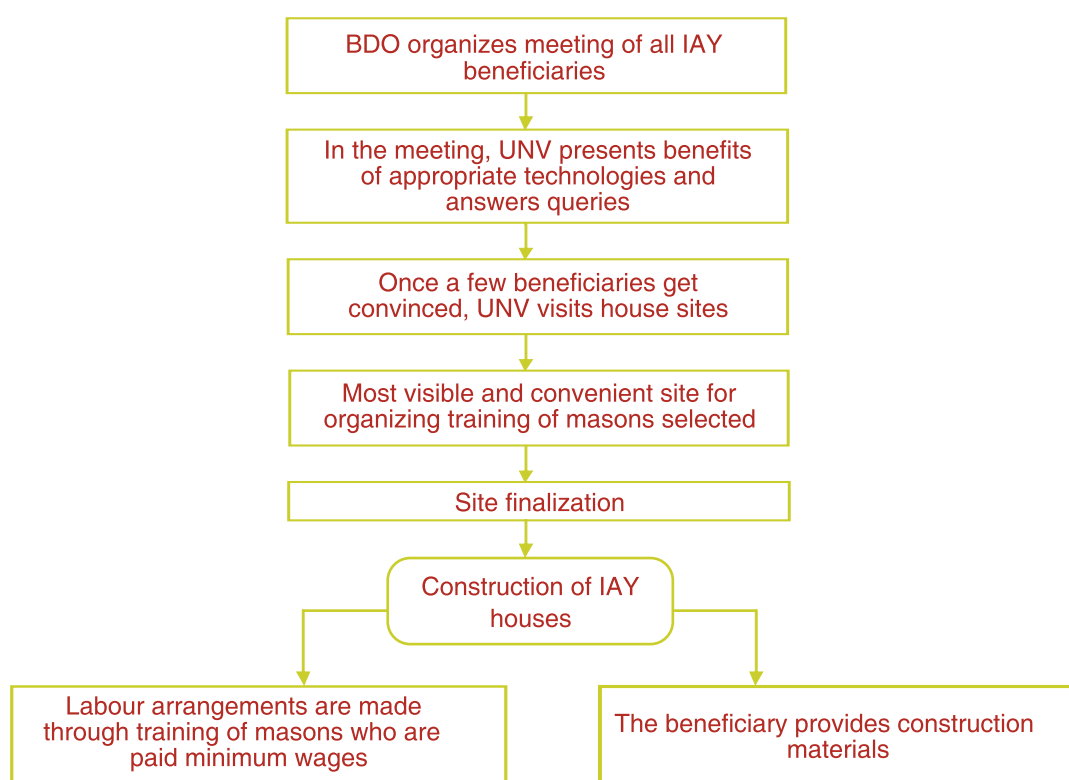
Figure 5: Protocol followed for IAY house construction under masons' training programme

Since the Shelter Project ultimately aimed at facilitating IAY, a few trainings focused on constructing IAY houses. This required much planning and coordination, including convincing the Block Development Officer (BDO) about the efficacy of the appropriate technologies<sup>7</sup>. The protocol followed to commence the training on construction of an IAY house is described in the following chart (see Figure 5).

- (i) Before building material procurement, UNVs assisted beneficiaries to calculate house sizes that could be completed within allocated IAY funds.
- (ii) Before commencing the training of masons, the house's foundation and plinth were constructed under UNV's supervision.
- (iii) Masons were nominated by the community and were briefed about the training background, the technologies being used and their benefits.
- (iv) The masons underwent hands-on training that addressed all aspects of IAY house construction including all jointing, reinforcement and tiling details.

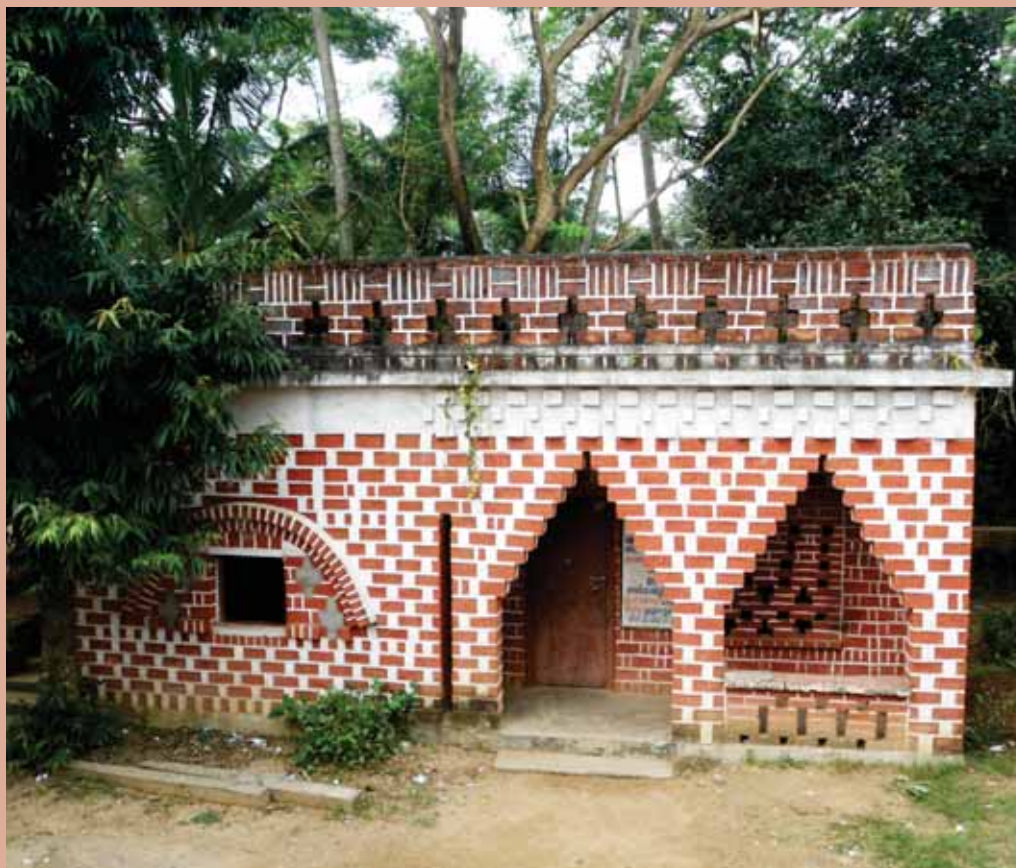
Condition of TDU in 2013

The TDU at Kusunpur is part of the school premises where AWC classes are regularly held. It has been maintained well. The masons from this village, trained under the UNDP Shelter Project, also explained the technologies and showed a number of houses they had built themselves using these technologies.

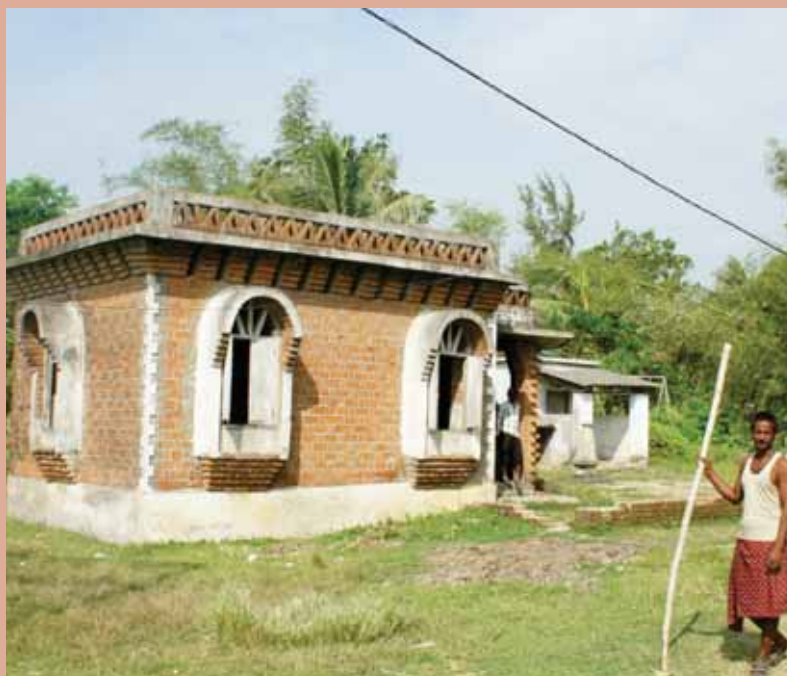
**Box 2: TDU at Kantaimundali village, Astarang block, Puri district**

The TDU at Kantaimundali, with an area of 528 sq. ft, has been maintained well and is used as an AWC. Its foundation comprises of stepped footing in brick and cement mortar with 25mm thick DPC; the walls are made of 250mm thick brickwork in rat-trap bond in 1:6 mortar; the roof is made of 100mm thick filler slab in 1:6 cement mortar using Mangalore tiles as filler material.

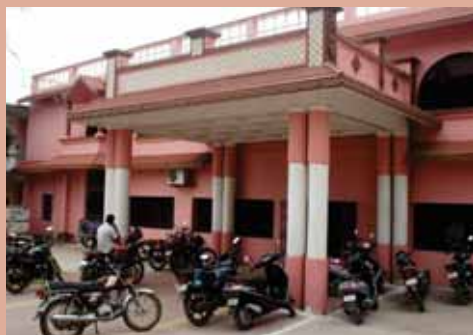
Non-IAY building with filler slab, Kujang, Jagatsinghpur

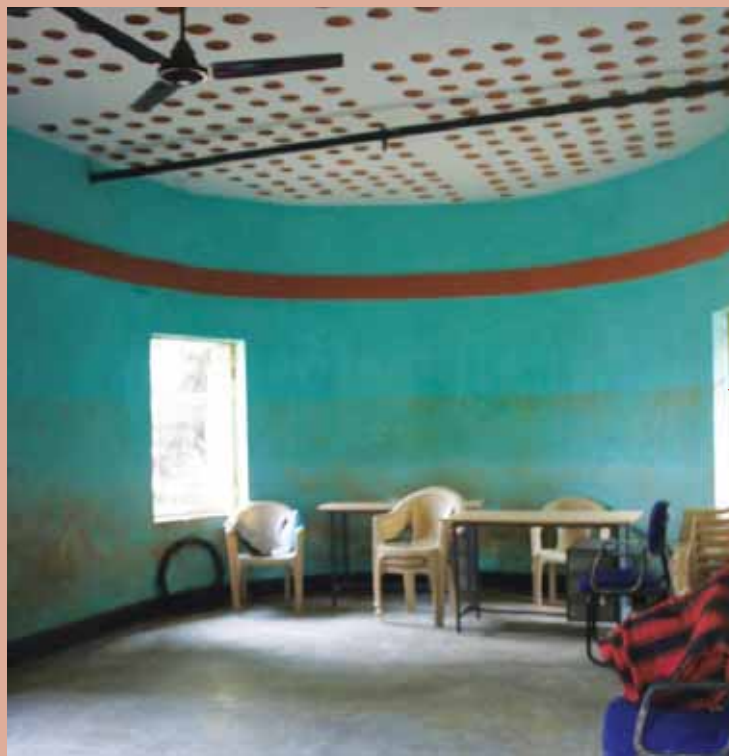
### **Box 7: Disaster resilient TDU, Fulwar Kasba, Balasore Sadar block, Balasore district**

Following Cyclone Phailin, Balasore district faced one of the worst floods in over 40 years. The TDU at Fulwar Kasba in Sadar block was inundated with over 10 feet of water for three days. Despite its 3'6" high plinth, the water level crossed the lintel level. The women's SHG, using the TDU as their office, remarked that the TDU only required thorough cleaning after the flood waters receded. The community expressed their confidence in these building technologies, which had multiplied several fold post Cyclone Phailin.

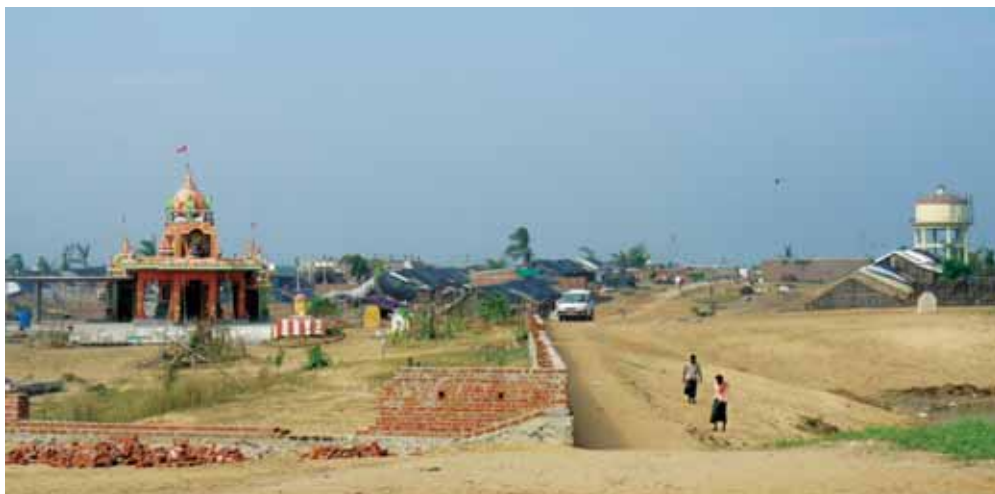
Figure 7: Village temple undamaged by Cyclone Phailin

Markandi, located at the mouth of the River Rishikulya close to the Odisha - Andhra Pradesh border, is a fishermen’s village with about 1300 households. The settlement, organized in a grid-iron plan, has east-west main *kutch*a roads with perpendicular arterial lanes. The settlement has only one *pucca* house with two floors constructed in brick and concrete. Cyclone Phailin and its storm surge damaged and flooded dwellings located in the low-lying and riverine portions, while dwellings on higher elevations were spared. Many roofs were blown away and some walls collapsed. The *pucca* house and the village temple did not suffer damages (see Figure7).

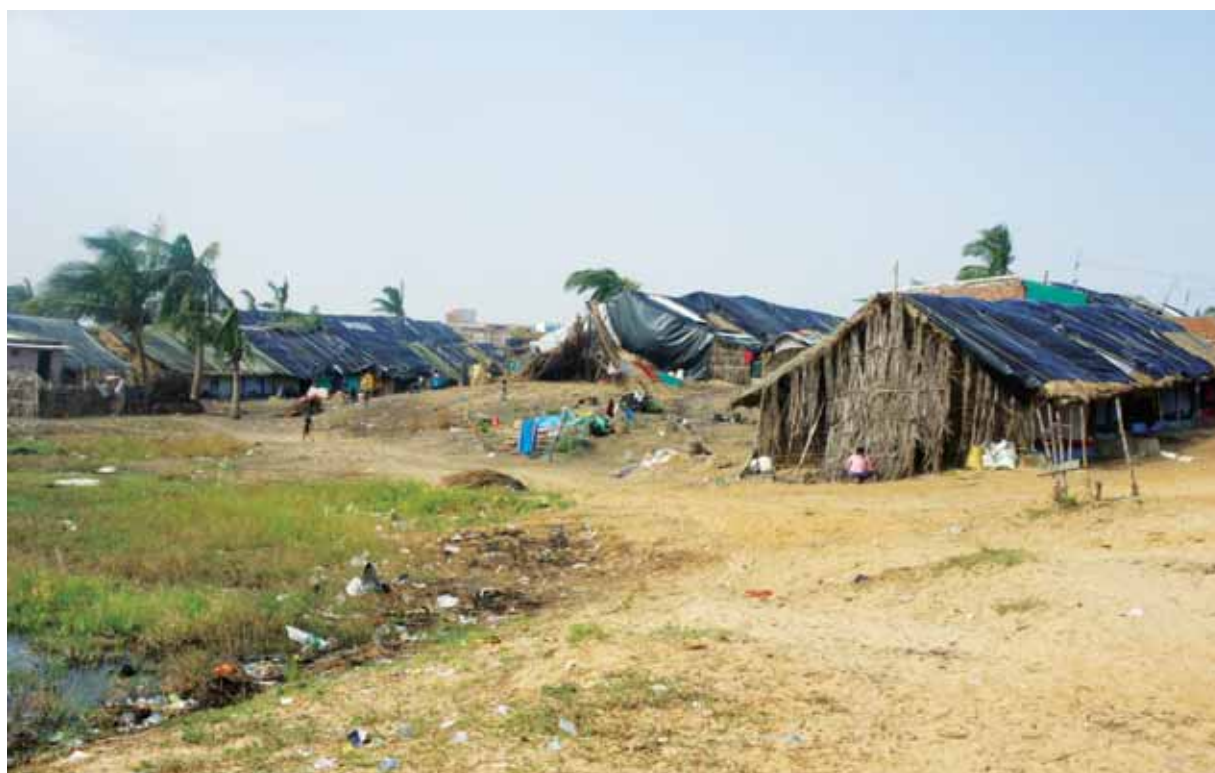
Figure 8: Damaged dwellings in Markandi village, Ganjam district

The building materials used are primarily mud, bamboo and thatch. Most dwellings do not have foundations or plinths. The walls are constructed with mud, reinforced with bamboo. The roof structure, supported by vertical bamboo posts, comprises of a simple bamboo truss. Thatch and straw are common roofing materials, which are often secured onto the truss by fishing nets. Post-Phailin, many residents covered damaged roofs with the tarpaulin sheets supplied as relief material.

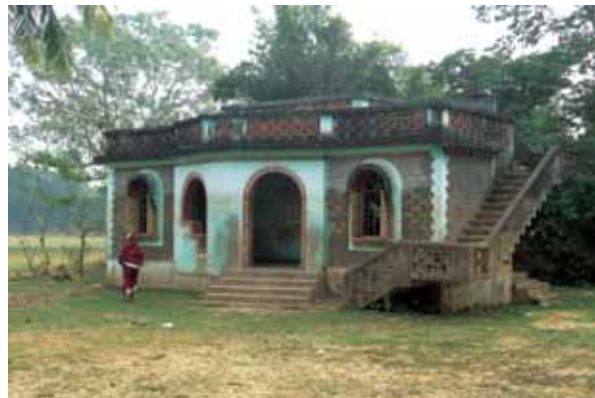
##### Ashraya TDU, Fulwar Kasba, Nagaram GP, Balasore Sadar Block

Funded By	Care Today
Year of Construction	2004-2005
Constructed By	Fulwar Kasba Nirmaan Samiti
Technical Guidance	Anandamayee ASHG and DTF

Ashraya TDU is situated within the Fulwar Kasba UP school campus. It has been subjected to floods twice in nine years. In 2006, the TDU was flooded for three days; the flood waters had reached above plinth level. In the recent post-Phailin floods, flood waters from the River Budhabalanga reached up to a height of 8 feet from ground level. About 10 families took shelter in the Multi-Purpose Cyclone Shelter (MPCS) built near the school campus after the TDU had been constructed. The TDU is presently being used by a women's SHG federation office for meetings and the local youth club.

Components	Status as on November 2013	Technical Observations
Foundation	In good condition. No cracks or settlement in the foundation.	Pile foundation has been chosen according to the site's black-cotton soil.
Wall	No damage found.	No building maintenance.
Roof	No water leaks. Roof surface not cleaned properly. Shrubs have taken root at the parapet bases.	Needs to be cleaned periodically.
Openings	No damage found.	
Doors & Windows	In good condition.	Painting required.
Parapet	In good condition.	Cleaning required.

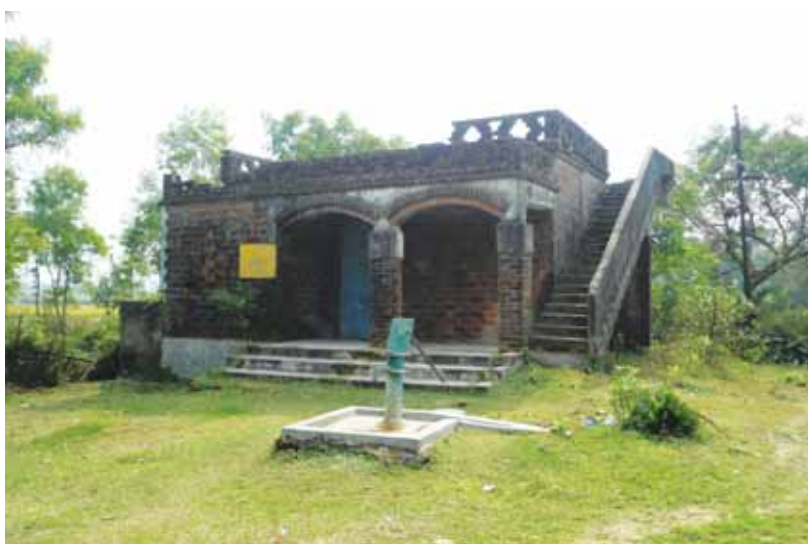
### Bhakti TDU, Arala, Kalyani GP, Bahanaga Block

Building Element	Construction Details
Foundation	Pile foundation of 250mm diameter with an under ream of 625mm at varying depths; 250mm x 200mm grade beam with anchorage bar to tie the three components – roof, wall and foundation
Wall	250mm brickwork in rat-trap bond in 1:6 cement mortar
Roof	110mm thick filler slab in M15 (1:2:4) grade cement concrete using Raniganj tiles as filler material in upper roof; PP joists and RC planks using M15 grade concrete in lower roof
Openings	Reinforced brick lintel and arches
Doors & Windows	Ferro cement doors and windows without wooden frames
Parapet	Brick <i>jali</i> work

Components	Status as on November 2013	Technical Observations
Foundation	Most parts have cracks, but negligible settlement.	Pile foundation has been chosen according to the site's black-cotton soil.
Wall	Exterior brick surfaces, near brick <i>jalis</i> , were broken.	There has been no maintenance of the walls.
Roof	No visible water leaks.	
Openings	No cracks present.	
Doors & Windows	In fair condition.	Need repairs.
Parapet	Some portions of the lower roof parapet and upper roof portion were broken.	There has been no maintenance of the building and there has been some pilferage of bricks broken from the parapet.

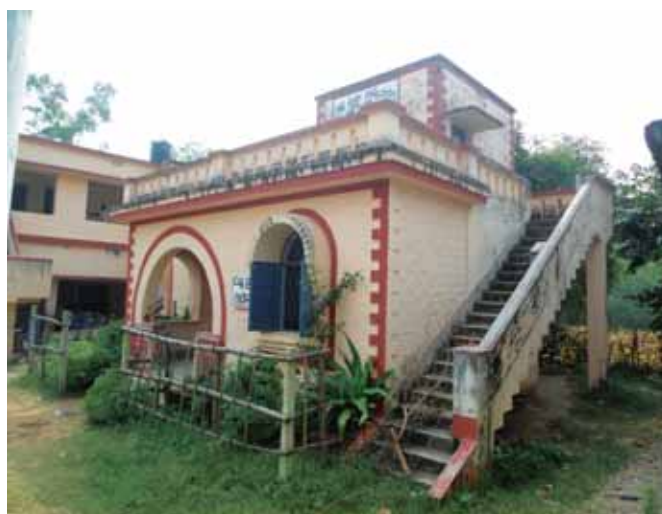
Pratimbha TDU is located within Sundari Primary School campus. Thus, school authorities have taken care of its maintenance through the school maintenance grant and have carried out exterior plastering and painting of walls, doors and windows.

Components	Status as on November 2013	Technical Observations
Foundation	No visible cracks or settlement. In stable condition.	Pile foundation has been chosen according to the site's black-cotton soil.
Wall	In excellent condition.	Exterior plastering and painting has been done.
Roof	No roof water leaks and is cleaned and maintained periodically.	An additional storage room has been constructed on the roof.
Openings	No damage found.	
Doors & Windows	In good condition.	Doors and windows have been painted.
Parapet	In good condition.

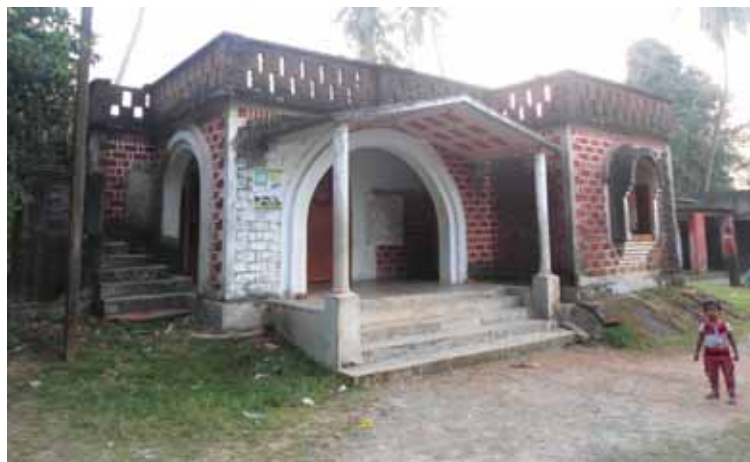
#### Ananya TDU, Kasoti, Jamadhara GP, Kendrapara Block

Building Element	Construction Details
Foundation	Well ring foundation with 'I' section grade beam (250mm x 400mm) with anchorage bar to tie the three components – roof, wall and foundation
Wall	250mm brickwork in rat-trap bond in 1:6 cement mortar with vertical anchorage bars and window sill level clips in 'L' and 'T' junctions
Roof	110mm thick filler slab in M15 (1:2:4) grade cement concrete using Raniganj tiles and brick as filler material in roofs
Openings	Corbelled brick arches
Doors & Windows	Iron frames with local wood panel shutters for doors windows.
Parapet	Brick <i>jali</i> work
Stair	Folded slab cantilevered from wall

Components	Status as on November 2013	Technical Observations
Foundation	No cracks and no settlement observed in the foundation. In good condition.	Well ring foundation has been used in accordance with the site's black-cotton soil.
Wall	No damage. Visible dampness on the walls inside the hall.	Requires painting.
Roof	No water leakages. Roof surface is unclean with shrubs sprouting from parapet base.	Roof drainage spouts are broken and need replacement to check dampness and storm water flow along the walls to minimize discoloration.
Openings	No damage found.	Requires painting.
Doors & Windows	In good condition.	
Parapet	In good condition.	Requires painting.

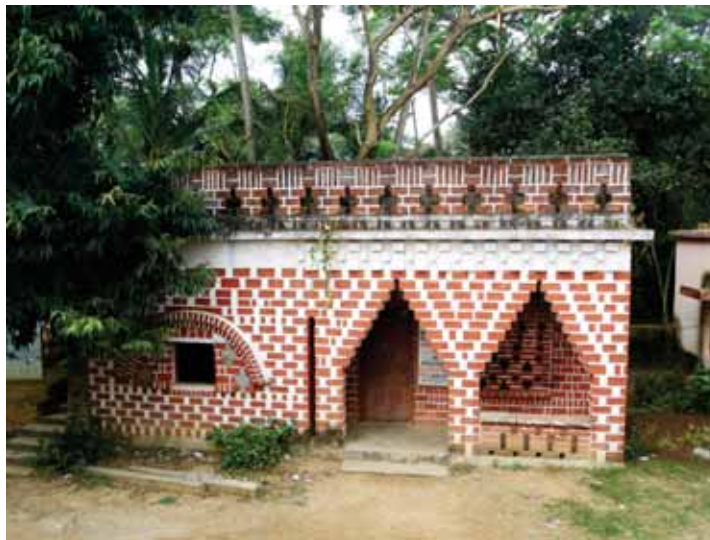
### Gitanjali TDU, Kusunpur, Dumuga GP, Marshaghai Block

Building Element	Construction Details
Foundation	Stepped footing in brick and cement mortar with 25mm thick Damp Proof Course (DPC)
Wall	250mm brickwork in rat-trap bond in 1:6 cement mortar
Roof	110mm thick filler slab in M15 (1:2:4) grade cement concrete using Raniganj tiles as filler material
Openings	Brick corbel, brick lintel and brick arches
Doors & Windows	Wooden doors and windows with wooden shutters.
Parapet	Brick <i>jali</i> work
Stair	Waist slab with brick steps

Components	Status as on November 2013	Technical Observations
Foundation	No cracks or settlements in foundation. In good condition.	Pile foundation has been used to suit the site's black-cotton soil.
Wall	In good condition.	No maintenance carried out so far.
Roof	No water leaks in the roof.	Maintenance is required, particularly in waterspouts to avoid roof and wall damage.
Openings	No cracks.	
Doors & Windows	In good condition.	
Parapet	Some portions of the lower roof parapet and upper roof were broken.	No maintenance of the TDU building.

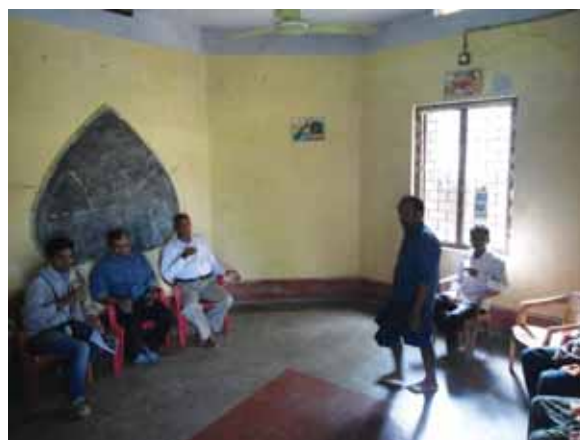
Kalinga Bhavan TDU is located within the Dalit community hamlet inside the premises of Bata Mandir. It is used as an AWC and for meetings or religious purposes. In 2006, the TDU was used as an emergency shelter since surrounding areas had been inundated in the floods. In 2008, since the building was itself nearly flooded, its rooftop was used with makeshift tents for shelter for 15 days even after the water receded. It has also been designated as the community relief distribution centre during emergencies.

Components	Status as on November 2013	Technical Observations
Foundation	No cracks, damage or settlement found in the foundation. In good condition.	Suited to the site's black-cotton soil, a well ring foundation has been used.
Wall	No damage found.	No maintenance of the building.
Roof	No water leaks from the roof.	
Openings	No damage found.	
Doors & Windows	In good condition.	Requires painting.
Parapet	In good condition.	
Dampness	Visible dampness on the walls in the hall.	Broken spouts have caused this damage and need to be replaced.

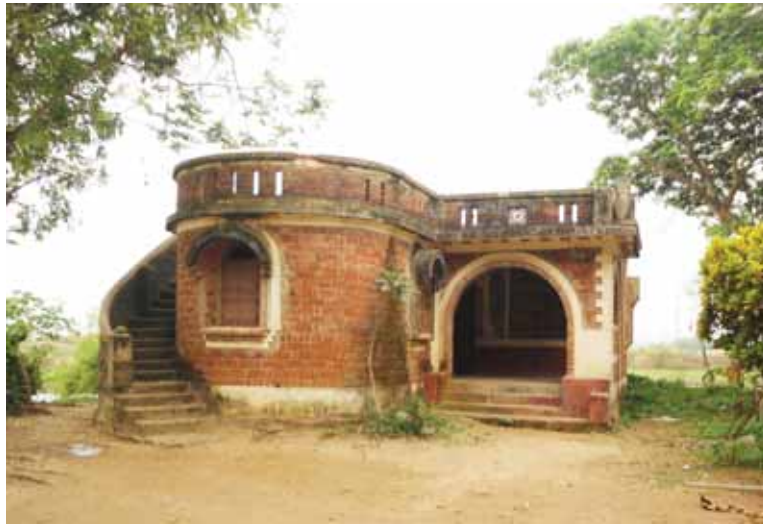
### Ananda TDU, Bhuanahi, Japa GP, Ersama Block

Building Element	Construction Details
Foundation	Well ring foundation with 'I' section grade beam (250mm x 400mm) with anchorage bar to tie the three components – roof, wall and foundation
Wall	250mm brickwork in rat-trap bond in 1:6 cement mortar with vertical anchorage bars and window sill level clips in 'L' and 'T' junctions
Roof	100mm thick filler slab in M15 (1:2:4) grade cement concrete using Raniganj tiles and brick as filler material in roofs
Openings	Corbelled brick arches in semicircular, segmented and flat shapes.
Doors & Windows	Wooden frames with local wood panel shutters for doors windows.
Parapet	Brick <i>jali</i> work
Stair	Waist slab using Raniganj tiles as filler material

Components	Status as on November 2013	Technical Observations
Foundation	No cracks or settlements in the foundation. In good condition.	Well ring foundation has been provided suited to the site's black-cotton soil.
Wall	No damage found.	No large-scale maintenance of the building is evident.
Roof	No water leaks from the roof. Shrubs sprouting up from the parapet bases.	Users need to clean the roof and the spouts periodically.
Openings	No damage found.	
Doors & Windows	In good condition.	Requires painting.
Parapet	In good condition.	Required cleaning.
Dampness	Visible dampness on the walls in the hall.	Some spouts on the roof are broken and need to be replaced.
