# ASBESTOS HEALTH AND SAFETY REQUIREMENTS

Minimum Standards for Working with Debris Waste in Beirut

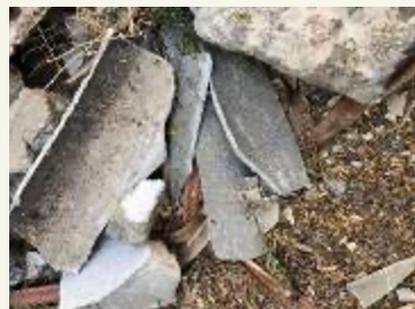
Figure 1: asbestos containing materials within general debris

Debris from damaged and demolished buildings can be found throughout affected areas of Beirut. As well as debris spread around buildings and on public roads, temporary waste piles containing construction and demolition (C&D) waste have been created in some locations in the city, with rubble from various clearance operations having been moved to these locations. Visual inspection of general debris and these waste piles indicates the presence of asbestos, generally in the form of asbestos cement containing chrysotile and crocidolite. Due to the highly degraded nature of some of the debris and the uncontrolled segregation of asbestos waste, it is likely these waste piles are widely contaminated with asbestos.

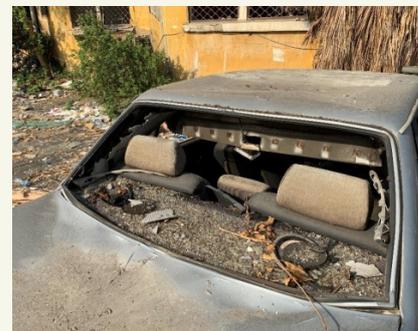
Figure 2: private vehicle damage

A number of vehicles parked under shelter or on the street in affected areas of the city were damaged to a higher or lesser degree by falling masonry and other building materials. Those vehicles have been rendered inoperable as a result of damage caused by the explosion remain stranded in the city. ACM debris from the explosion is present in the surrounding area and on these vehicles. Asbestos is also known to have been used in vehicle manufacture, particularly in the engines (in the form of gaskets or textile wraps to exhausts) and in friction products such as brake linings, in older vehicles.

A number of materials may be able to be salvaged and reused. In particular it is recommended that the scrap vehicles could relatively easily be decontaminated and sent for onward processing. Decontamination can be achieved by careful removal of all visible ACM debris, then cleaning of dust from exposed surfaces. Cleaning of metals and glass materials is also a relatively simple process and these can be segregated easily.

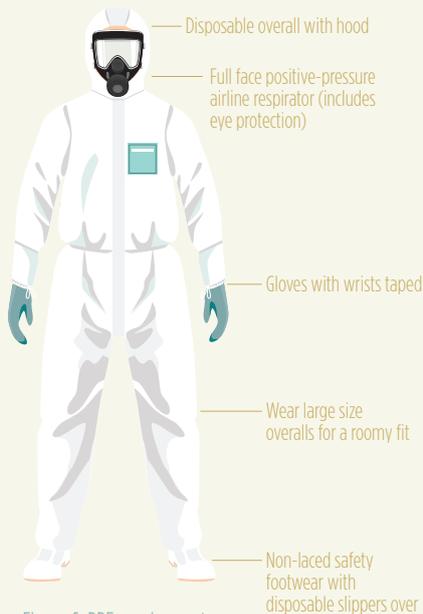
Figure 6: PPE requirements when working with asbestos

Figure 6 shows the necessary full PPE required when working to clear ACMs. This is the level of PPE necessary for trained people spending significant amounts of time working to separate and dispose of ACMs who will therefore have a high level of exposure to asbestos over a sustained period. Disposable overalls should be Type 5/6 (relevant standard BS EN ISO 13982+A1). Gloves should be Type 5/6 single use and be appropriately disposed of at the end of each day. Footwear should be solid sole, ankle high wherever possible. Wellington boots (see Figure 5) or non-laced pull-on footwear is preferable as these are easier to clean. Disposable overshoes should be used if non-laced footwear is not available. Disposable overalls, gloves and overshoes should be treated as hazardous and disposed of with other asbestos waste.
