EXPERIMENT-BASED EARTHQUAKE RESISTANT PROTOTYPE DESIGN OF RESIDENTIAL BUILDINGS IN NEPAL

Keywords: building reconstruction, shock table, stone masonry, containment, earthquake safety

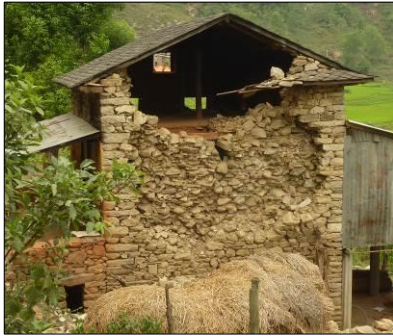
(a) Delamination and bulging of wall wythe, 2015 Gorkha earthquake, Nepal

Figure 2. Typical failure modes of stone masonry building with weak mortar

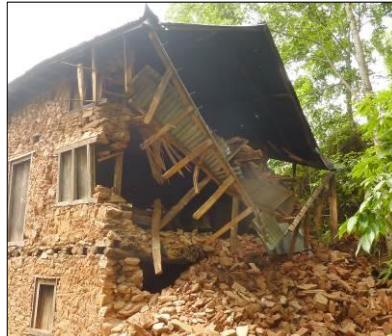
(b) Out-of-plane collapse of wall led to collapse of roof and floor, 2015 Gorkha earthquake, Nepal

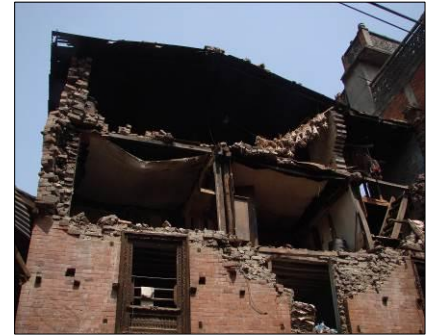
(c) Out-of-plane collapse of walls, destruction of top storey, 2015 Gorkha earthquake, Nepal

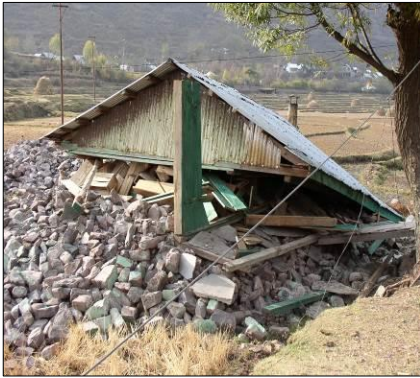
(d) Destruction of a house, 2005 Kashmir earthquake, Pakistan

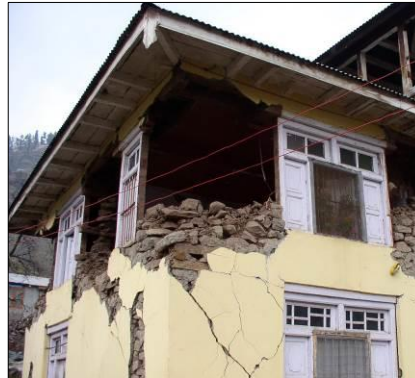
(e) In-plane wall and corner damage, 2005 Kashmir earthquake, Pakistan

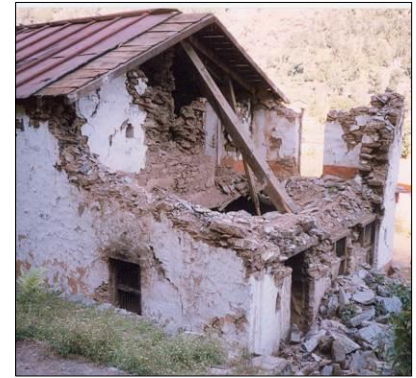
(f) Roof collapse due to absence of wall-roof connections, 1999 Chamoli earthquake, India

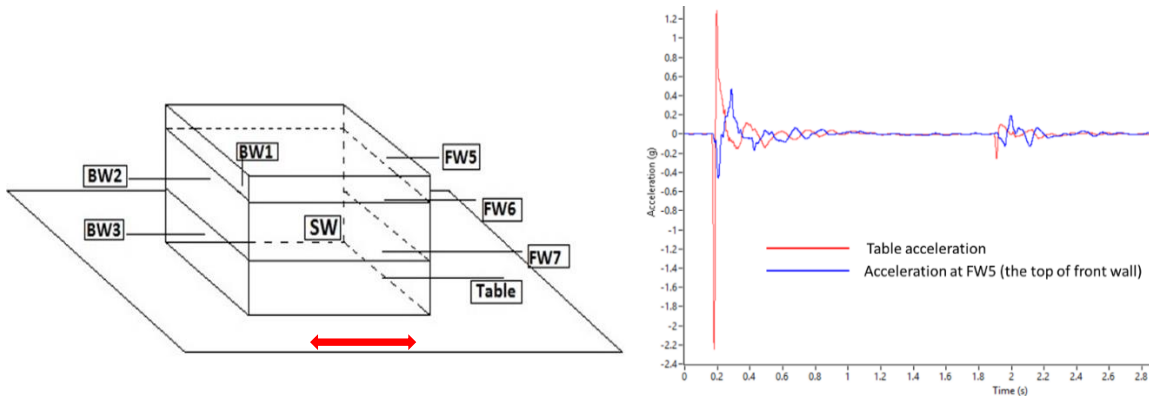
Figure 4: Instrumentation and typical recorded time history for a two storey building

(a) Location of accelerometers for two storey building (BW: back wall, FW: front wall, SW: side wall)

(b) Acceleration time history for Shock # 14 for two storey building when using a pendulum angle of 70°.

All the tested model buildings were shaken in the transverse direction considering the high vulnerability of the long walls (refer Figure 4) when subjected to face loading. The model buildings were constructed on top of the table platform and were subjected to a gradually increasing intensity of base shocks by increasing the angle of release of the pendulum, which caused progressive damage to the model. Figure 5 presents the damage history of both one and two-storey model buildings.

Eight accelerometers were mounted, one on the shock table and seven at different levels of model walls (Figure 4 (a)). During each shock test, the acceleration response was obtained by using high-speed data acquisition system. Prior to the base shock test, free-vibration tests were conducted to obtain the dynamic properties and damping in the models. Figure 4 (b) presents recorded peak accelerations on the shock table and at the top of front wall. Every test run was documented on video by two strategically placed video cameras and photo cameras. After every test run, the models were inspected for possible damage which was recorded/documentated in the form of visual observations, still photographs and continuous recording through video cameras.

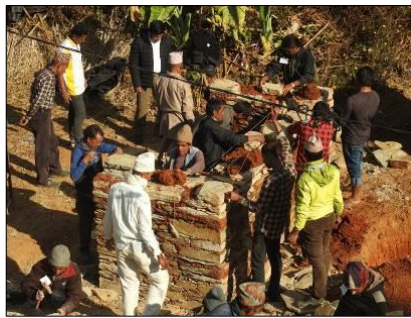
(b) Participants installing cross-links

hands-on training. In the initial stages and prior to starting the building reconstruction, training was delivered on building mock-ups, which involved the construction of walls of short length and approximately 2 m height. All-important building features such as fabrication and installing of cross-links, cutting and installing welded wire mesh on walls in the form of bands, installing the timber wall plate at the wall top, and installing the vertical containment wires were practiced by the trainees. Once the reconstruction efforts commenced, the training was delivered at the actual residential building's construction sites.

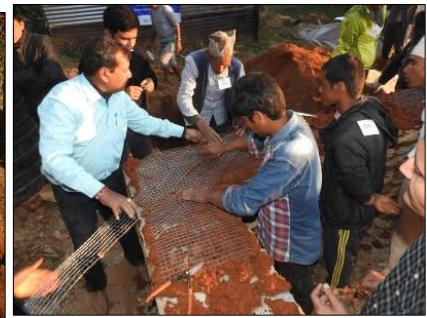
(c) Participants installing WWM bands

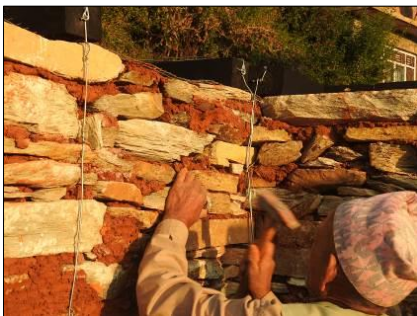
(d) Participant installing vertical wires

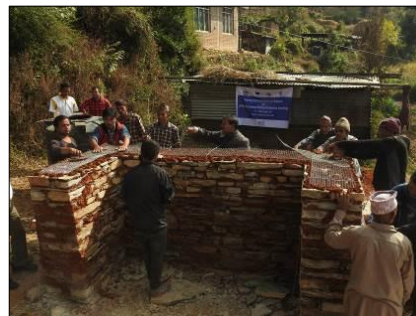
(e) Another example of participants installing WWM bands

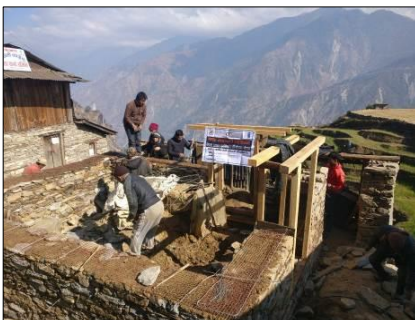
(a) Installation of WWM band

Following the approval of the design by the authorities in Nepal [14] and the training of local engineers, site foreman and artisans, the technology was rolled out for reconstruction of residential houses in the earthquake-affected areas (Figure 8). Considering no change from the prevailing construction practices in the area other than a few additional elements, the technology was considered simple and easy to implement.

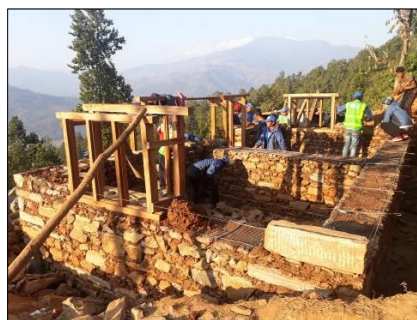
(b) Installation of window frames

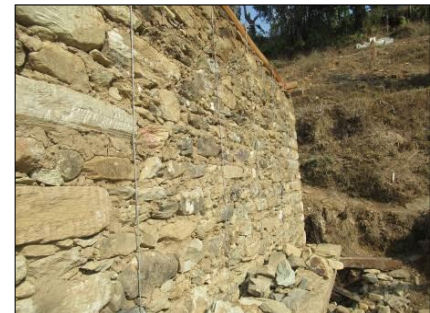
(c) Close up view of vertical wires
