Assessment Report of the Biophysical, Ecological and Socio-Economic Conditions of Mangroves Ecosystem of Timor Leste

The report is contracted by UNDP and MAF and prepared by Mr. Muhammad ILMAN, 2017. The Copyright of the report is the property of UNDP and National Directorate of Forestry, Coffee and Industrial Plants, MAF, Timor Leste, 2017

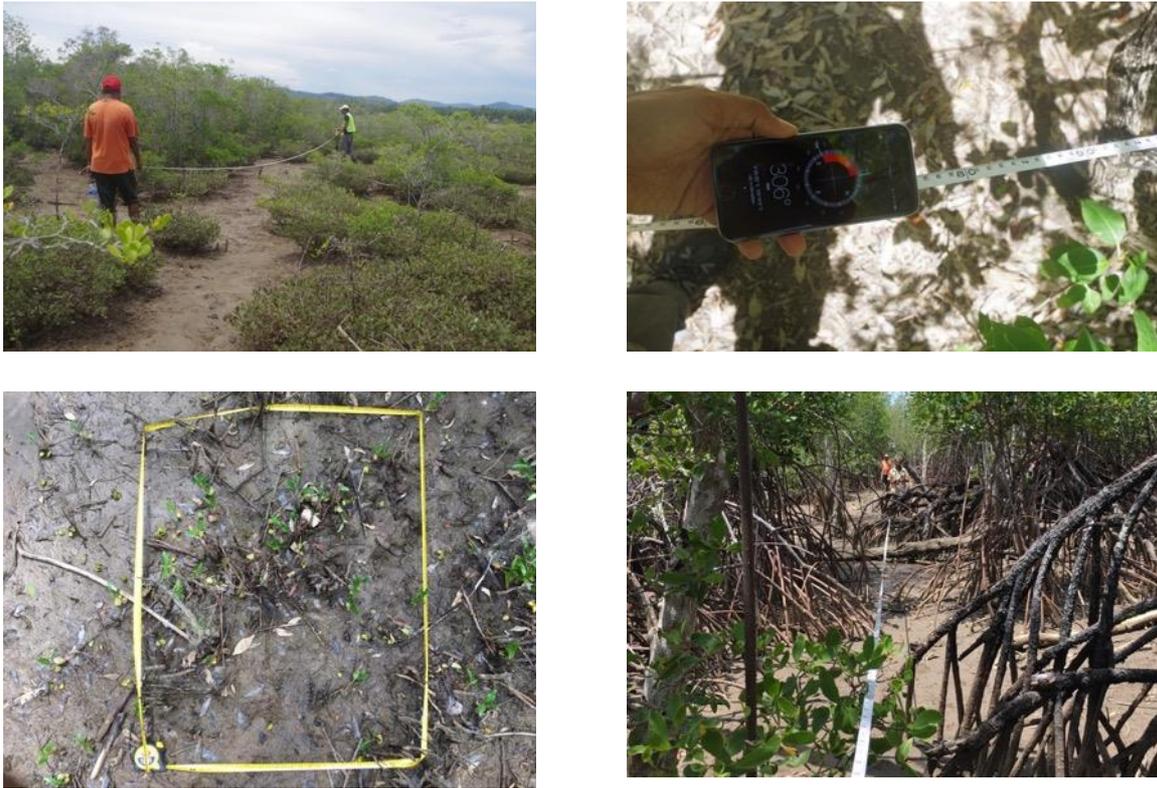
Figure 2. Mangroves inventory activities

Main purpose of the transect survey is to estimate the number of species, size of trees, species dominance, abundance, and distribution. There were two types of transects, firstly the square transects: 1x1 m or 2x2 m for small trees with height less than 2m; and 10x10 or 20x20 for larger trees.

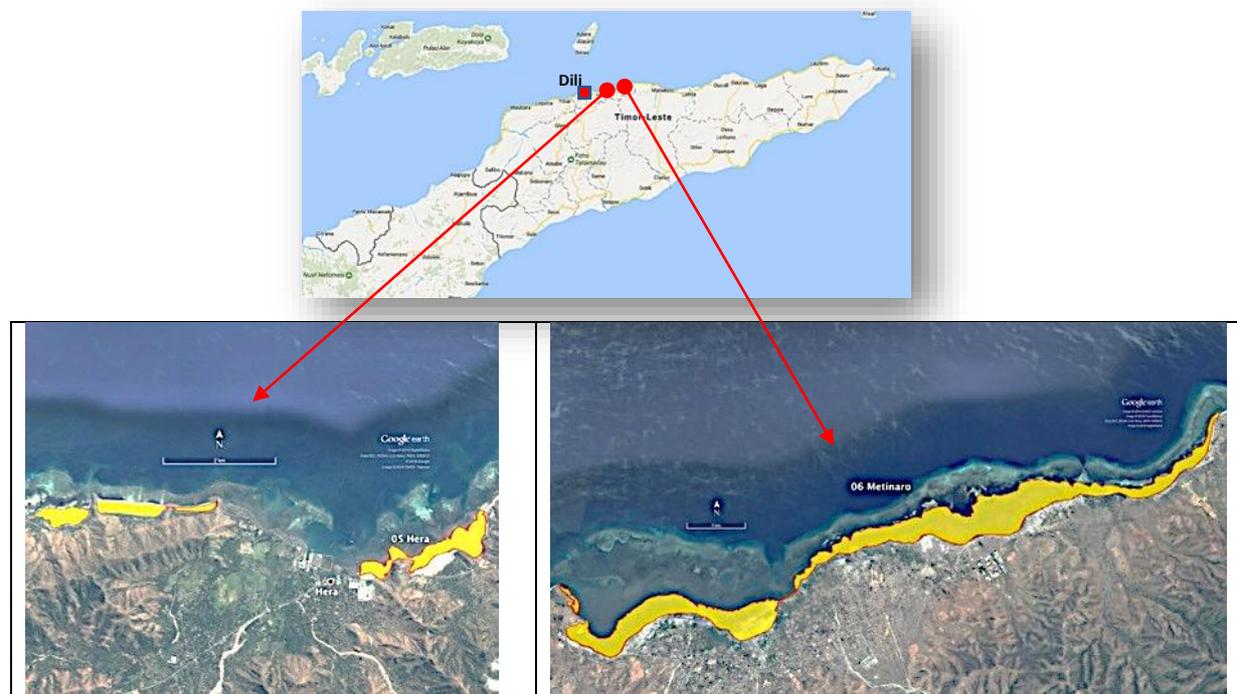
Figure 3. Mangroves in Hera (photo left) and in Metinaro (photo right)

The mangroves in these locations developed a unique formation where the landward zone dominated by either stunted dense *Ceriops tagal* (15,000 - 35,000 trees/ha), *Avicennia*, or mix

Ceriops and Avicennia. The width of the zone is varying between 10 – 200 m. In the next zone (middle zone) toward the sea, vegetation is comprising a mixed of Rhizophora, Lumnitzera, and Bruguiera, with around 3,000-4,000 trees/ha and the width of the zone between 50m to 250 m. At the sea edge, the mangrove community is dominated by pure Sonneratia, particularly in the sandy substrate; and mixed with Rhizophora in the muddy substrate with around 1,000-2,000 trees/ha. The width of the Sonneratia-Rhizophora zone is between 10 – 50 m.

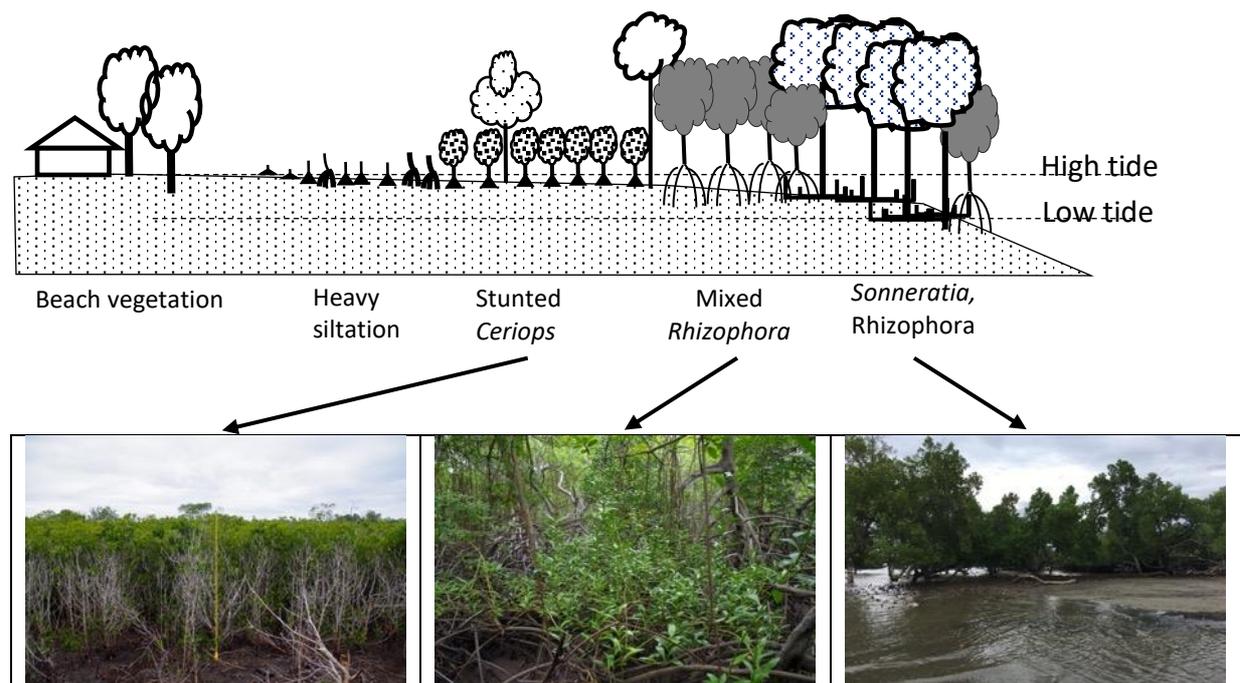
The zonation of mangroves in the north coast is a common pattern zones in mangroves, except for the unique formation of the stunted mangroves that dominating the landward side.

Figure 4. Typical mangrove zonation in Hera and Metinaro. The landward is dominated by stunted Ceriops (photo left), the middle zone is occupied by mixed species like Rhizophora, Avicennia, Lumnitzera, Bruguiera, and Acanthus (photo middle); and at the sea edge dominated either by pure Sonneratia or mixed sonneratia and Rhizophora.

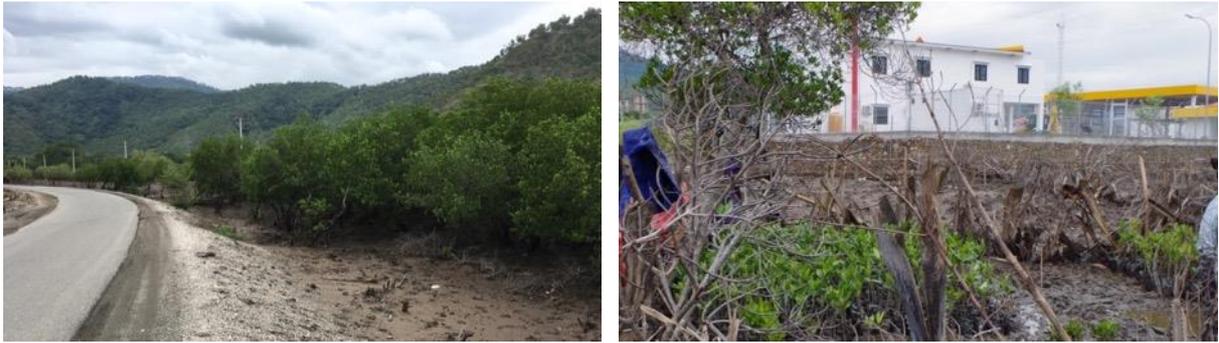
Road and building along Hera and Metinaro changed the wetlands ecosystem permanently. However, the actual scale of the impact to the mangrove is not clear as the roads have been built for a long time. The roads, perhaps, could have helped reducing the sands' spill over to the mangroves area. The newly-built building complex along the road have obvious direct consequences to the mangroves as they are reducing the wetlands area.

Figure 5. Road and building construction inside the mangroves along the Hera and Metinaro

The road was built across the mangroves in Metinaro, creating a semi-isolated wetland behind the road (photo left); a building complex was built in a coastal wetland in Hera.

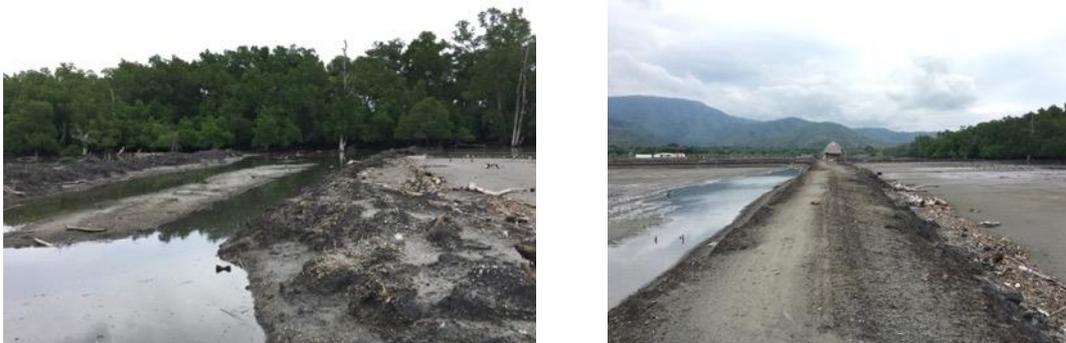
Currently there is some continuing efforts to build shrimp/fishpond along the Hera and Metinaro. The ponds, although built on the degraded mangroves have direct negative consequence to the environment as they drastically change the type of ecosystems and reducing potential area for wetland restoration. There is also possibility that the pond dikes reflect the incoming waves and create unfavourable condition for mangroves to grow and regenerate.

Figure 6 Construction of water channel and embankments for fishpond

Some of the ponds were likely developed with the help from government related projects. While the project had good intention, it is very important to avoid any physical development in the coastal wetlands area along the coast of Hera and Metinaro.

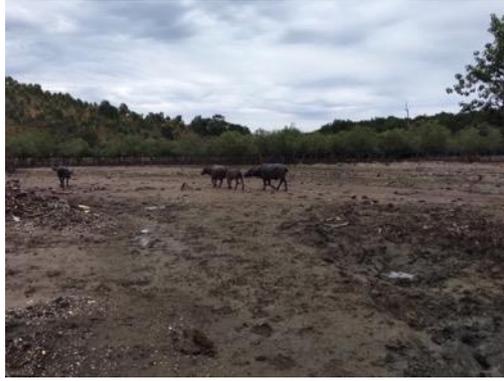
This is the major current problems faced by mangrove along the Hera and Metinaro. Animals like water buffalos, pigs, cows, goat are freely wandering the mangroves, grazing on young leaves and shoots, and trampling on the newly grow seedlings. The situation creates a condition were young seedlings almost impossible to thrive in the environment because of feedings and trampling.

Figure 7. Water buffalo roaming the supposed to be natural recolonization sites in Metinaro.

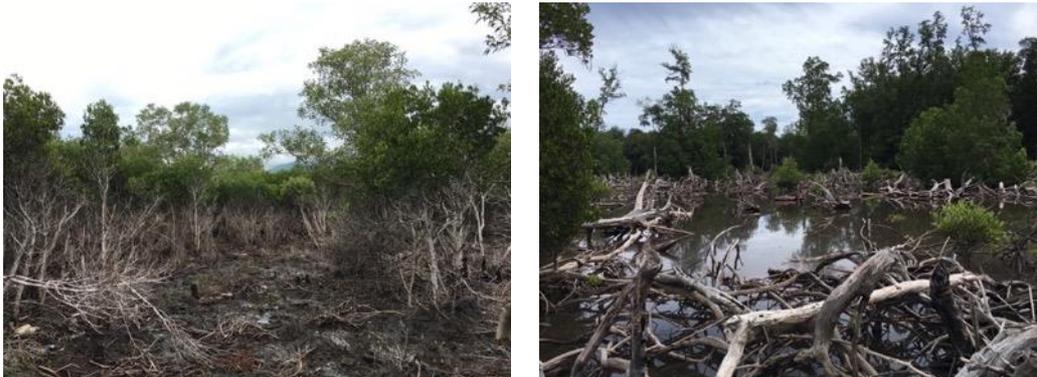
Mangrove cutting is one of the most devastating activities to the existing mangroves. Despite the obvious shrinking area of mangroves along the Hera and Metinaro, the cutting is continuing until now. The coverage of cutting areas are relatively low, we found three spots with area 100 – 200 m². However, there is strong evidence that the cutting is not followed by natural regeneration. Even the area of massive mangroves logging occurred between 2007 – 2009 in the Metinaro, has not recovered until now.

Figure 8 Freshly cut mangroves, 2017 (left) and old cut mangroves, 2008 (right).

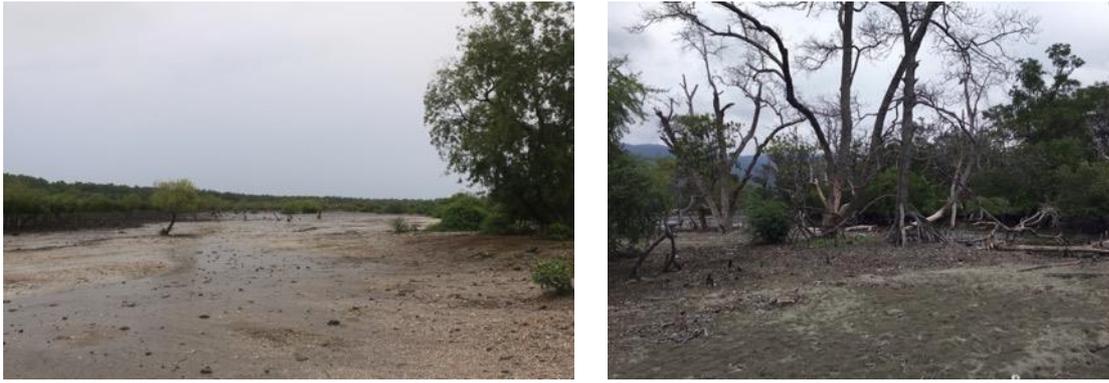
Along the north coast of Timor-Leste, including Hera and Metinaro, the coastal areas are suffering from sands piling from the hills that covering large area along the coast. The situation is particularly worst on mangroves as the sands bury mangroves pneumatophore roots. The hot and dry sand eventually kill the mangroves and change the wetland ecosystem into sand flats.

Figure 9. Heavy siltation on mangroves areas

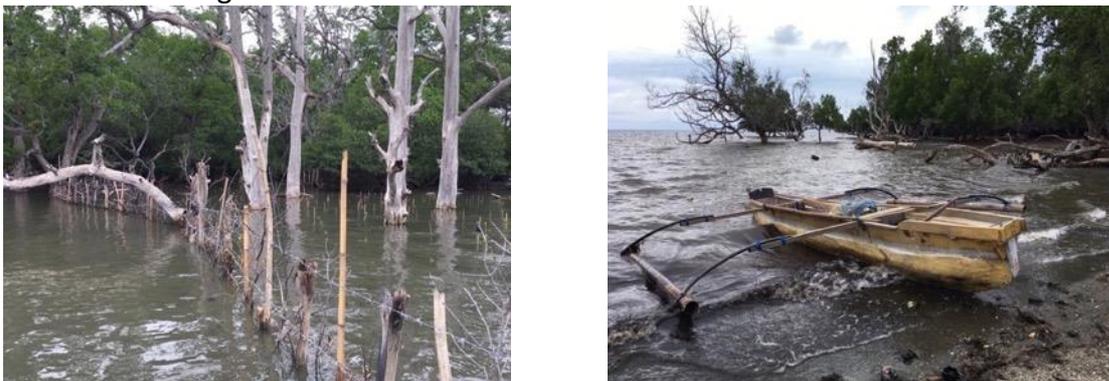
In the last two decades, the sea level has raised over 22 mm in Timor-Leste (Barnett et al., 2007), but there is no record about the actual increase of the sea level in Hera and Metinaro. Observation of the dead mangrove trees in the area strongly indicated that most of them were *Sonneratia* with aerial roots submerged for a long time during high tide. Other species like *Rhizophora*, or even *Sonneratia* with higher aerial roots (exposed to the air during high tide), were still surviving.

Figure 10. Mangroves (*Sonneratia*) that dying due to the increase of sea level, beyond the height of their pneumatophores.

In other places, mangrove may adapt by gradually shift to higher grounds or accumulating organic materials that uplift the soil-surface elevation (Lovelock et al., 2015). There is no easy way to deal with the situation, especially for the fringing mangrove in the north coast of Timor-Leste. The space to move inland is blocked by sands and built-up area, especially road. At the same time, accumulation of organic materials from mangroves in North Coast is very small to help elevate the soil surface to match the sea level rise.

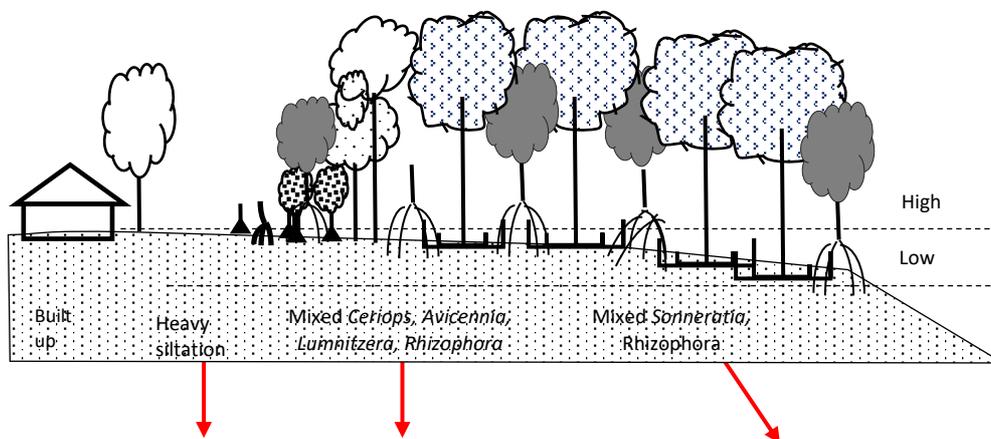
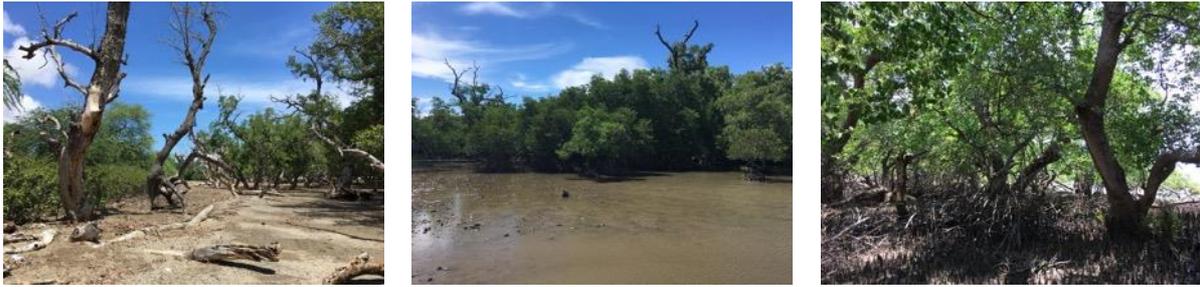
The width of mangrove green belt in Tibar, Ulmera, and Biacou is relatively thin, make the mangrove zonation is not clear. In all sites, the landward side occupied by mixed of *Sonneratia*, *Rhizophora apiculata*, *Lumnitzera*, and *Ceriops tagal*. While the sea side dominated by pure *Sonneratia* or mixed with *Rhizophora*.

Figure 11. Mangrove zonation commonly found in Tibar, Ulmera, and Beacou

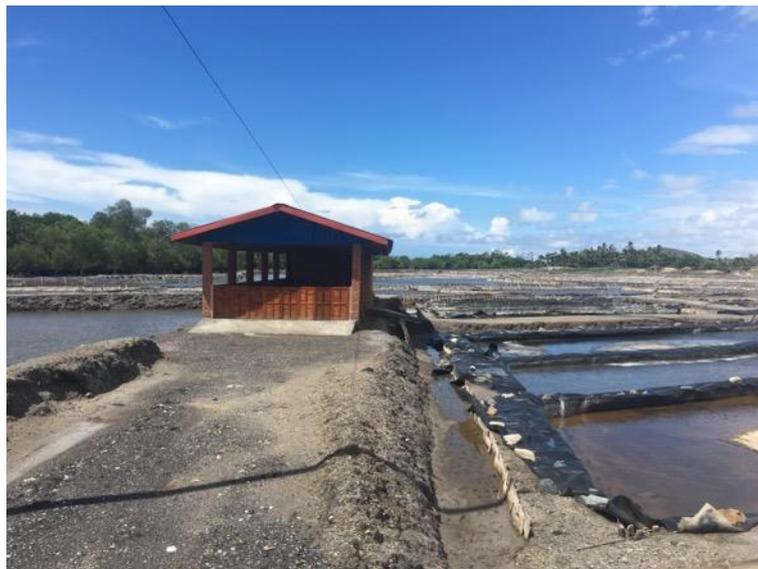
The mangroves areas of Tibar and Ulmera are heavily utilise as aquaculture pond and salt pans. In the ponds, the community cultivate mud crabs, milkfish, and wild shrimp that enter the ponds freely during the high tide. Nearly 50% (15 ha) of the mangrove loss in the three locations were now built as aquaculture and salt pans.

Figure 12. Salt pan in Ulmera

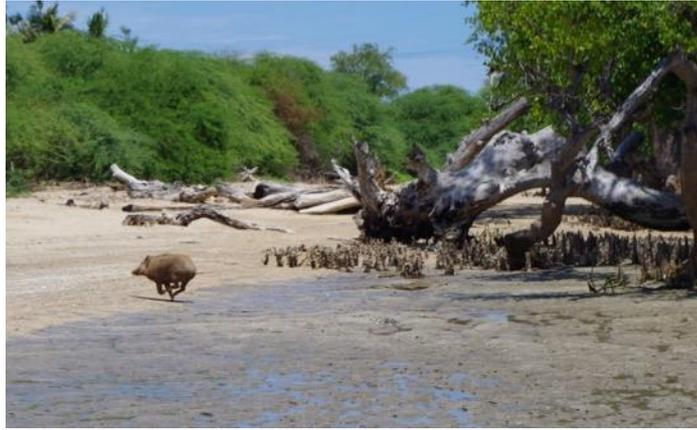
One of the most challenging thing to the allow a natural regeneration of mangroves in these areas is disturbance from cattle (buffalo, goats, pigs, and cows), that regularly enter the mangroves. The buffalo, goat, and cow trampling and foraging young shoots, and pig rooting the mangroves. The activities were so massive that make young seedling nearly impossible to establish naturally.

Figure 13. A pig running away from mangroves during the study in Tibar

Community should be encouraged to better managed their livestock and at the same time mangroves in these areas should be protected with fencing. Utilising social capital approach such as *tara bandu* may also effective to increase the chance of mangrove seedling to survive from cattle.

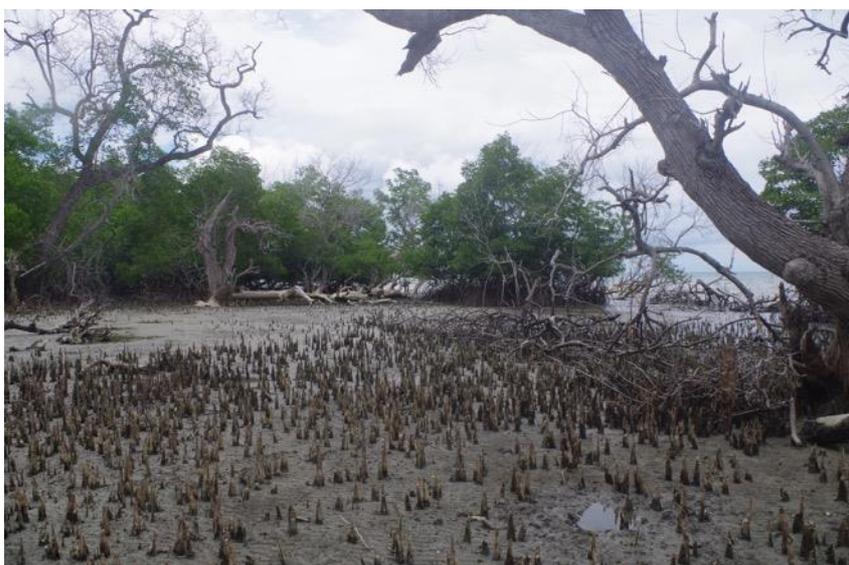
The low fertility of sediment in wetlands in the north coast of Timor-Leste may have caused the very slow pace of adaptation of *Sonneratia* with sea level rise. Therefore, although the increase of sea level is relatively slow, estimated to be only 4 mm per year, the situation creates deadly condition for old *Sonneratia* in sea ward along the coast of Tibar, Ulmera, and Beacou. It seems, the old trees' pneumatophores can no longer grow higher and leaves them suffocated during the high tides. Species like *Rhizophoracea* are likely to survive as they have higher pneumatophore roots to cope with the higher tidal level. Therefore, the coastal wetlands along the north coast that once dominated by *Sonneratia*, are likely to evolve into *Rhizophora* dominated wetlands.

Figure 14. Mangroves, *Sonneratia* are dying due to continuing higher sea level, while *Rhizophoracea* in the background is striving to survive.

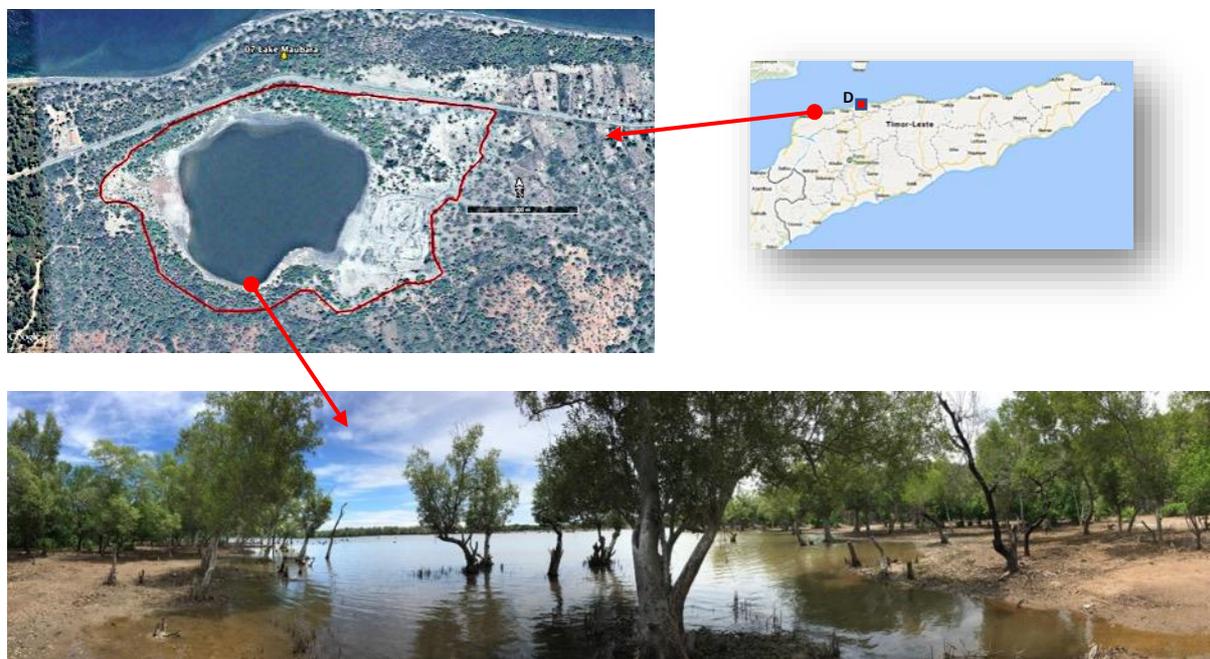
Total area of the Maubara Lake inundated during the heavy rain could reach 47 ha, while during the normal year the water surface is only around 18 ha.

Figure 15. Maubara lake, location on the map of Timor-Leste, aerial photo, and panoramic photo

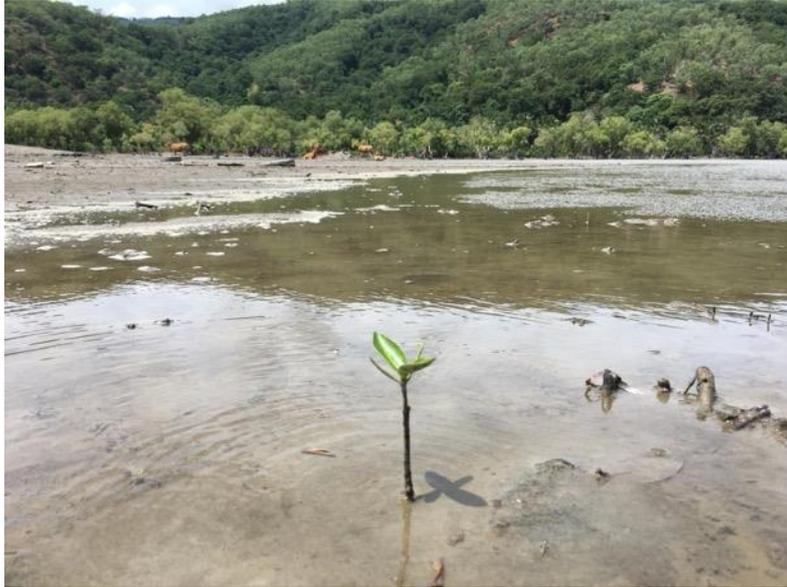
Figure 16. Young seedlings strive to survive.

The mangroves in the Lake are heavily degraded due to logging, particularly in the east side of the lake. However, there are many signs showing that natural seedlings could survive if the areas are protected from animal trampling and grazing. In addition, creating canals to the degraded areas would enable the distribution of seedlings and restore back the wetlands forest surrounding the lakes.

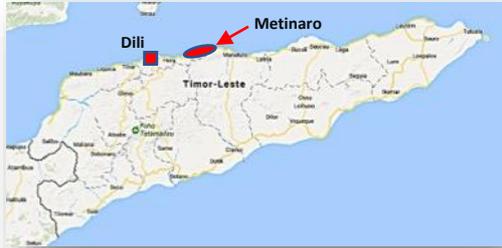
1. Metinaro

Location	Dili Municipality
Proposed status	<p>National Importance</p> <p>The site is the largest continues mangroves areas in Timor-Leste</p> <p>The site is source of livelihoods for local communities</p> <p>The site provide protection for community from strong winds, waves, and coastal erosion.</p> <p>International importance.</p> <p>Ramsar Criterion 2: The site supports vulnerable, endangered, or critically endangered species or threatened ecological communities. Migratory, frequent water bird - <i>Numenius madagascariensis</i>, EN</p> <p>Ramsar Criterion 8: it is an important source of food for fishes, spawning ground, nursery and/or migration path on which fish stocks, either within the wetland or elsewhere, depend.</p>
Mangrove biodiversity	There are 19 species of true mangroves found in the location, which one species <u>could possibly</u> <i>Bruguiera hainesii</i> a species listed in IUCN Red List as Critically Endangered species. A further species identification is needed.

Mangrove Areas	Original area: 497 ha
Current areas	375 ha
Potential restoration area	60 ha
Beach revegetation area	100 ha
Major threats	Mangrove cutting, aquaculture development, animal grazing, sediment spill.
Immediate intervention required	<p>Protection</p> <ul style="list-style-type: none"> - Establishment of <i>tara bandu</i> to protect the mangroves from livestock and cutting - Fencing to block livestock entering the natural regeneration sites. <p>Restoration</p> <ul style="list-style-type: none"> - Creation of canals and bunds to traps natural seedlings - Limited re-planting activities, particularly species <i>Ceriops</i>, <i>Lumnitzera</i>, and <i>Rhizophora</i> (100-200 seedlings/ha). - Planting ground dwelling plants and multi-purpose trees in the heavy siltation areas.

Long term management	<ul style="list-style-type: none"> - Establish national regulation for the strict conservation and restoration of the entire mangrove area. - Develop large scale sediment retention - Develop low impact tourism activities: mangrove walks - Establish research and education sites - Regulate a limited harvest of fish, crabs, mussel in certain areas; priority for local community. - Proposing the location as a Ramsar Site, directly under Montreaux Record
----------------------	--

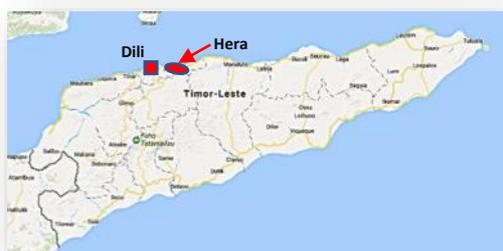
2. Hera

Location	Dili Municipality
Proposed status	<p>National Importance</p> <p>The site is source of livelihoods for local communities The site provide protection for community from strong winds, waves, and coastal erosion.</p> <p>International Importance</p> <p>Ramsar Criterion 2: The site supports vulnerable, endangered, or critically endangered species or threatened ecological communities. Migratory, frequent water bird - <i>Numenius madagascariensis</i>, EN Ramsar Criterion 8: it is an important source of food for fishes, spawning ground, nursery and/or migration path on which fish stocks, either within the wetland or elsewhere, depend.</p>
Biodiversity	The site harbour 18 species of true mangroves
Mangrove Areas	Original area: 131 ha
Current areas	115 ha
Potential restoration area	6 ha
Beach revegetation area	16 ha
Major threats	Building construction, industrial wastes, aquaculture, mangrove cutting, animal grazing, sediment spill.

Immediate intervention required	<p>Protection</p> <ul style="list-style-type: none"> - Monitoring, controlling of the impact of industries and building construction to wetlands. - Establishment of <i>tara bandu</i> to protect the mangroves from livestock and cutting - Erecting fence to block livestock entering the natural regeneration sites. <p>Restoration</p> <ul style="list-style-type: none"> - Creating canals and bunds to traps natural seedlings - Limited re-planting activities, particularly species <i>Cerriops</i>, <i>Lumnitzera</i>, and <i>Rhizophora</i> (100-200 seedlings/ha).

<ul style="list-style-type: none"> - Planting ground dwelling plants and multi-purpose trees in the heavy siltation areas.
Long term management	<ul style="list-style-type: none"> - Designating the mangrove area as nationally protected wetlands. - Regulating the flow of sediment to avoid mangroves. - Developing community based, low-impact tourism activities. - Regulating a limited harvest of fish, crabs, mussel in certain areas; priority for local community.

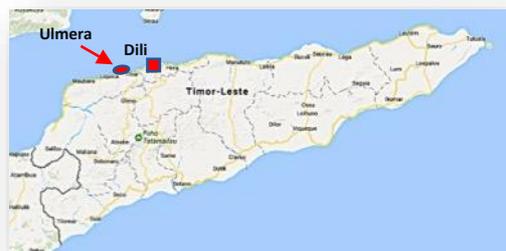
4. Ulmera

Location	Liquica Municipality
Status	<p>National Importance</p> <p>The site is source of livelihoods for local communities</p> <p>The site provide protection for community from strong winds, waves, and coastal erosion.</p>
Mangrove Areas	Original area: 62 ha
Current areas	45 ha
Potential restoration area	25 ha
Beach revegetation area	17 ha
Major threats	Domestic wastes, pond expansion, bark extraction, mangrove cutting, animal grazing, bait worm collection in mangroves, sediment spill from the land.
Immediate intervention required	<p>Protection</p> <ul style="list-style-type: none"> - Reducing domestic waste to wetlands. - Establishment of <i>tara bandu</i> to protect the mangroves from livestock, cutting, and bait worm collection. - Erecting fence to block livestock entering the natural regeneration sites. <p>Restoration</p> <ul style="list-style-type: none"> - Creating canals and bunds to traps natural seedlings - Limited re-planting activities, particularly species <i>Cerriops</i>, <i>Lumnitzera</i>, and <i>Rhizophora</i> (100-200 seedlings/ha). - Planting grass and multi-purposes trees in the built-up area zone, hills, riverside, to reduce soil erosion and provide community with livestock's' feed, fire woods, fruits, medicine, and shades.

Long term management	<ul style="list-style-type: none"> - Designating the mangrove areas as nationally protected wetlands. - Regulating the flow of sediment to avoid mangroves. - Developing community based, low-impact tourism activities. - Regulating a limited harvest of fish, crabs, mussel in certain areas; priority for local community.

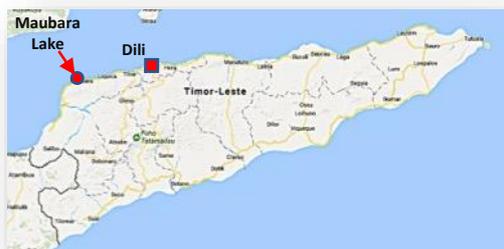
5. Maubara Lake

Location	Liquica Municipality
Status	<p>National Importance</p> <p>The site has beautiful scenery for tourism.</p> <p>The site is regularly visited by at least 18 water bird species.</p>
Mangrove Areas	Original area: 47 ha (water body and buffer zone)
Current areas	47 ha
Potential restoration area	15 ha
Beach revegetation area	15 ha
Major threats	Domestic wastes from visitors, mangrove cutting, animal grazing, siltation from the land, exotic fish species introduction.
Immediate intervention required	<p>Protection</p> <ul style="list-style-type: none"> - Reducing domestic waste from visitors. - Establishment of <i>tara bandu</i> to protect the mangroves from livestock and cutting. - Erecting fence to block livestock entering the natural regeneration sites. - Evaluating the status of exotic fish in the lake and develop planning for their eradication. <p>Restoration</p> <ul style="list-style-type: none"> - Creating canals to encourage natural seedlings dispersal and grow. - Limited re-planting activities, particularly species <i>Avicennia</i>, and <i>Lumnitzera</i> (100-200 seedlings/ha). - Planting grass and multi-purposes trees in the built-up area zone, hills, riverside, to reduce soil erosion and provide community with livestock's' feed, fire woods, fruits, medicine, and shades.

Long term management	<ul style="list-style-type: none"> - Regulating the flow of sediment to avoid mangroves. - Development of commercial, low-impact tourism activities, assisted by experienced tourism professionals.

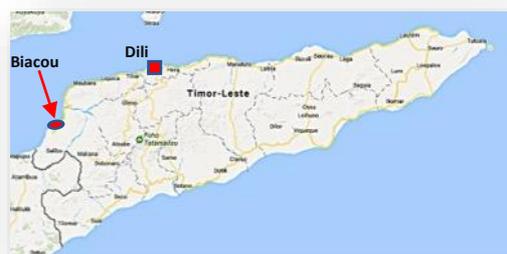
6. Biacou

Location	
Status	<p>National Importance</p> <p>The site is source of livelihoods for local communities</p> <p>The site provide protection for community from strong winds, waves, and coastal erosion.</p>
Mangrove Areas	Original area: 131 ha
Current areas	11 ha
Potential restoration area	1 ha
Beach revegetation area	4 ha
Major threats	Domestic wastes, pond expansion, mangrove cutting, animal grazing, bark extraction in mangroves, sediment spill from the land.
Immediate intervention required	<p>Protection</p> <ul style="list-style-type: none"> - Reducing domestic waste to wetlands. - Establishment of <i>tara bandu</i> to protect the mangroves from livestock, cutting, and bait worm collection. - Erecting fence to block livestock entering the natural regeneration sites. <p>Restoration</p> <ul style="list-style-type: none"> - Creating canals and bunds to traps natural seedlings - Limited re-planting activities, particularly species <i>Ceriops</i>, <i>Lumnitzera</i>, and <i>Rhizophora</i> (100-200 seedlings/ha). - Planting grass and multi-purposes trees in the built-up area zone, hills, riverside, to reduce soil erosion and provide community with livestock's' feed, fire woods, fruits, medicine, and shades.

Long term management	<ul style="list-style-type: none"> - Designating the mangrove areas as nationally protected wetlands. - Regulating the flow of sediment to avoid mangroves. - Developing community based, low-impact tourism activities. - Regulating a limited harvest of fish, crabs, mussel in certain areas; priority for local community.

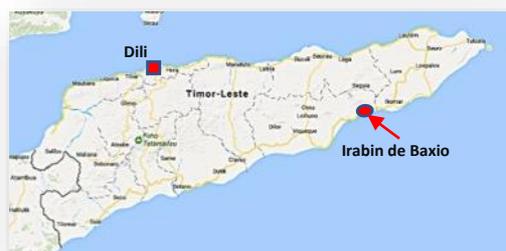
7. Irabin de Baxio

Location	Viqueque
Status	<p>National Importance</p> <p>The site is source of livelihoods for local communities.</p> <p>The site provide protection for community from strong winds, waves, and coastal erosion.</p> <p>International Importance</p> <p>Ramsar Criterion 8: it is an important source of food for fishes, spawning ground, nursery and/or migration path on which fish stocks, either within the wetland or elsewhere, depend.</p>
Mangrove Areas	Original area: 187 ha
Current areas	77 ha
Potential restoration area	50 ha
Beach revegetation area	100 ha
Major threats	Mangrove cutting, animal grazing, agriculture expansion
Immediate intervention required	<p>Protection</p> <ul style="list-style-type: none"> - Establishment of <i>tara bandu</i> to protect the mangroves from livestock, cutting. - Erecting fence to block livestock entering the natural regeneration sites. <p>Restoration</p> <ul style="list-style-type: none"> - Creating canals and bunds to traps natural seedlings - Limited re-planting activities, particularly species <i>Rhizophora</i>, <i>Ceriops</i>, and <i>Avicennia</i> (100-200 seedlings/ha). - Planting multi-purposes trees in the built-up area zone and hills to provide community with alternatives for livestock's' feed, fire woods, fruits, medicine, and shades.

Long term management	<ul style="list-style-type: none"> - Designating the mangrove areas as nationally protected wetlands. - Developing community based, low-impact tourism activities. - Regulating a limited harvest of fish, crabs, mussel in certain areas; priority for local community. - Environmentally friendly agriculture

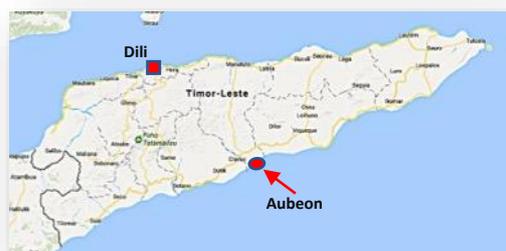
8. Aubeon

Location	Manatuto Municipality
Status	<p>National Importance</p> <p>The site is source of livelihoods for local communities.</p> <p>The site is home to water birds, crocodiles, and fish important for communities.</p> <p>The site provide protection for community from strong winds, waves, and coastal erosion.</p> <p>International Importance</p> <p>Ramsar Criterion 8: it is an important source of food for fishes, spawning ground, nursery and/or migration path on which fish stocks, either within the wetland or elsewhere, depend.</p>
Mangrove Areas	Original area
Current areas	260
Potential restoration area	-
Beach revegetation area	20 ha
Major threats	Mangrove cutting, animal (crocodile) hunting
Immediate intervention required	<p>Protection</p> <ul style="list-style-type: none"> - Establishment of <i>tara bandu</i> to protect the mangroves from livestock, cutting. - Discouraging community from wild hunting animal activities, particularly crocodile. - Increase awareness about the important of <p>Restoration</p> <ul style="list-style-type: none"> - The site is relatively in good condition, no need for mangroves restoration. - Planting multi-purposes trees in the built-up area zone to provide community with alternatives for livestock's' feed, fire woods, fruits, medicine, and shades.

Long term management	<ul style="list-style-type: none"> - Designating the mangrove areas as nationally protected wetlands. - Developing community based, low-impact tourism activities. - Monitoring and regulating a limited harvest of shrimp, fish and crabs in the lagoon; priority for local community. - Developing environmentally friendly agriculture and aquaculture as source of livelihoods to reduce threat to mangroves in the Lake.

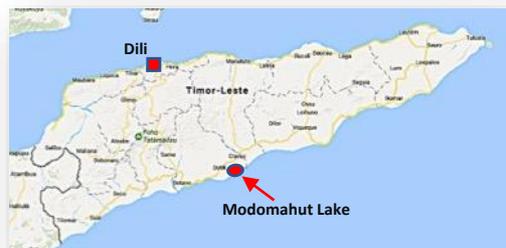
9. Modomahut Lake

Location	Same Municipality
Status	<p>National Importance</p> <p>The site is source of livelihoods for local communities</p> <p>The site provide protection for community from strong winds, waves, and coastal erosion.</p> <p>International Importance</p> <p>Ramsar Criterion 1: A wetland should be considered internationally important if it contains a representative, rare, or unique example of a natural or near-natural wetland type found within the appropriate biogeographic region.</p> <p>Ramsar Criterion 8: it is an important source of food for fishes, spawning ground, nursery and/or migration path on which fish stocks, either within the wetland or elsewhere, depend.</p>
Mangrove Areas	Original area
Current areas	240 ha
Potential restoration area	-
Beach revegetation area	20 ha
Major threats	Mangrove cutting, animal hunting (crocodile)
Immediate intervention required	<p>Protection</p> <ul style="list-style-type: none"> - Establishment of <i>tara bandu</i> to protect the mangroves from cutting and hunting. - Increase awareness of community to protect wildlife of the lagoon. <p>Restoration</p> <ul style="list-style-type: none"> - There is no significant degradation of wetlands on the lagoon, therefore, no specific restoration activities are needed. - Planting multi-purposes trees in the built-up area zone and farms to provide community with alternatives for livestock's' feed, fire woods, fruits, medicine, and shades.

Long term management	<ul style="list-style-type: none"> - Designating the mangrove areas as nationally protected wetlands. - Proposing the areas as Ramsar Site for its unique examples as natural mangrove lagoon harbouring the giant <i>Sonnerata</i> roots in the bioregion. - Developing community based, low-impact tourism activities. - Regulating a limited harvest of fish, crabs, mussel in certain areas; priority for local community. - Environmentally friendly agriculture and aquaculture in the lake

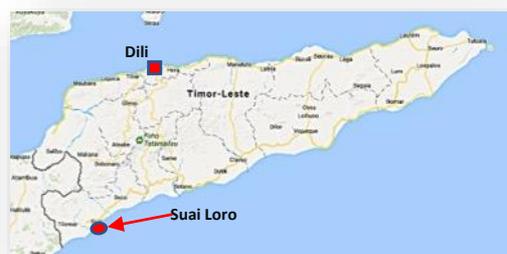
10. Suai Loro

Location	Cova Lima Municipality
Status	<p>National Importance</p> <p>The site is source of livelihoods for local communities.</p> <p>The site representing the richest mangrove biodiversity in the South Coast.</p> <p>If needed, could be the source of mangrove seedlings (seed bank) for restoration in the South Coast.</p> <p>The site provide protection for community from strong winds, waves, and coastal erosion.</p> <p>International Importance</p> <p>Ramsar Criterion 8: it is an important source of food for fishes, spawning ground, nursery and/or migration path on which fish stocks, either within the wetland or elsewhere, depend.</p>
Mangrove Areas	Original area: 40 ha
Current areas	40 ha
Potential restoration area	35 ha
Beach revegetation area	20 ha
Major threats	Domestic pollution, mangrove cutting, animal grazing.
Immediate intervention required	<p>Protection</p> <ul style="list-style-type: none"> - Establishment of <i>tara bandu</i> to protect the mangroves from livestock, cutting. - Erecting fence to block livestock entering the natural regeneration sites. - Reduce the domestic waste dumped into the wetlands. <p>Restoration</p> <ul style="list-style-type: none"> - Creating canals and bunds to traps natural seedlings - Limited re-planting activities, particularly species <i>Lumnitzera</i>, <i>Sonneratia</i>, <i>Avicennia</i>, and <i>Rhizophora</i> (100-200 seedlings/ha). - Planting multi-purposes trees in the built-up area zone to provide community with alternatives for livestock's' feed, fire woods, fruits, medicine, and shades. - Planting beach vegetation such as Tamarind, <i>Azadirachta indica</i>, Mangos, Coconut, and Raintree.

Long term management	<ul style="list-style-type: none"> - Designating the mangrove areas as nationally protected wetlands. - Developing community based, low-impact tourism activities. - Regulating a limited harvest of fish, crabs, mussel in certain areas; priority for local community. - Environmentally friendly agriculture

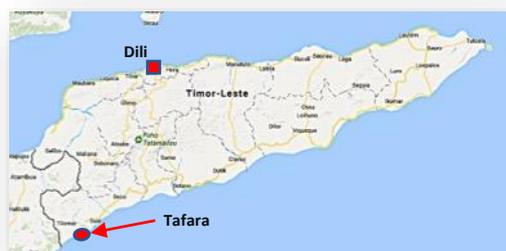
11. Tafara

Location	Suai Lima
Status	National importance The sites are important habitat for crocodile.
Mangrove Areas	Original area
Current areas	
Potential restoration area	
Beach revegetation area	
Major threats	Coastal erosion, beach vegetation cutting
Immediate intervention required	<p>Protection</p> <ul style="list-style-type: none"> - Awareness campaign to avoid beach vegetation cutting and dangerous encounter with animal. <p>Restoration</p> <ul style="list-style-type: none"> - Planting multi-purposes trees in the surrounding areas to provide community with alternatives for livestock's' feed, fire woods, fruits, medicine, and shades.
Long term management	<ul style="list-style-type: none"> - Developing community based, low-impact tourism activities. - Regulating a limited harvest of fish, crabs, mussel in certain areas; priority for local community. - Planting beach vegetation such as Tamarind, <i>Azadirachta indica</i>, Mangos, Coconut, and Raintree - Environmentally friendly agriculture
