**NOVEMBER 2013**

# STUDY OF THE FLOODING IN RWENZORI MOUNTAIN FOR EFFECTIVE DISASTER RISK MANAGEMENT

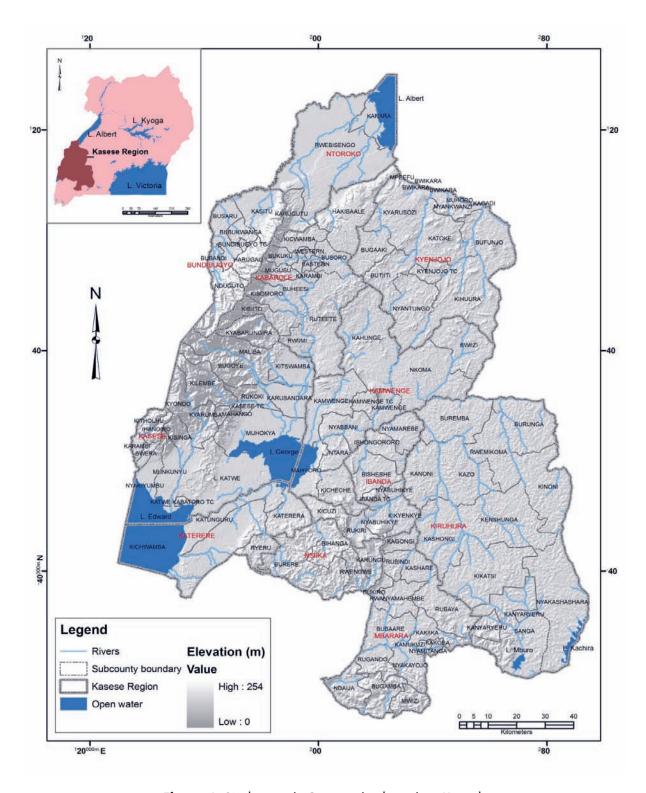
Figure 1: Study area in Rwenzori sub-region, Uganda

The area of study covers Mt Rwenzori, which hitherto will be referred to as Rwenzori sub-region (Figure 1). The region includes the districts of Kasese, Kabarole and Ntoroko. The region is drained by many rivers and streams which empty in lakes George and Edward. The rainfall received is moderately high but increases with altitude. Broadly the area is seismically active or located in an earthquake zone thus also prone to slope failures. It has a number of protected areas – national parks and game reserves. Outside the conservation areas are dense settlements; the population growth is high. The study delineated and characterised prominent catchments in the region for detailed flood assessment.

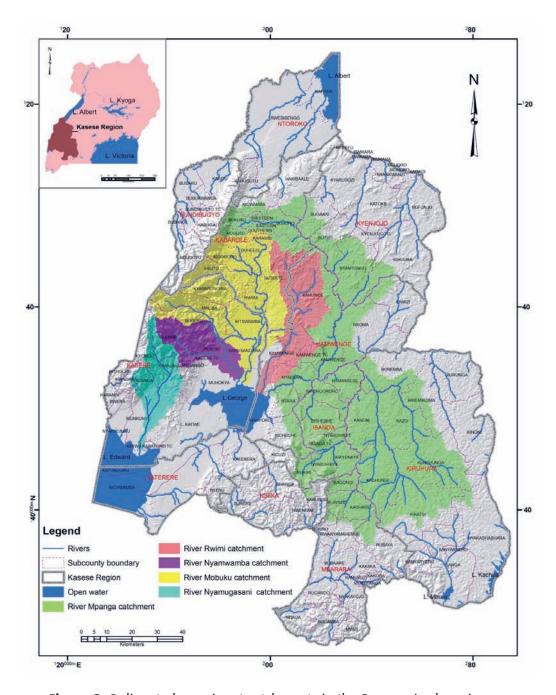
Figure 2: Delineated prominent catchments in the Rwenzori sub-region

Figures 2 and Table 1 summarise the main catchment characteristics identified and delineated in the region.

Many of the rivers that flooded had a high percentage of bare cover ranging from 6-11% bare rock in the upper part of the catchment. Rivers Mobuku, Nyamugasani and Nyamwamba flow from a high elevation (3000 to 4500m above sea level) in the alpine zone which receive high rainfall and have dominantly steeper channels thus vulnerable to flash floods. River Mpanga had greater length followed by Mobuku and Rwimi.

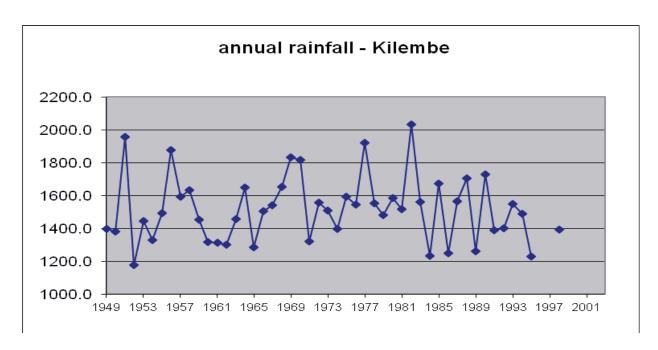
Figure 3: Annual rainfall at Kilembe mines weather station in mid R. Nyamwamba catchment

The region receives varied annual rainfall depending on altitude and aspect with respect to the mountain. The low lying parts gets lower amounts but this increases with altitude until about 3300m asl. According to Osmaston, (1996) from the base of the Rwenzori mountain around 1250 mamsl, precipitation was observed to increase with rising elevation from 1150 mm a\_1 to a maximum annual precipitation of 2600 mm a\_1 recorded at 3290 mamsl in the Heath-moss forest zone. Above this, precipitation decreased to 2000 mm a\_1 at Lake Bujuku in the Afroalpine zone (3990 mamsl) within the Central Rwenzori Massif Overtime the rainfall has also varied (Figure 3). High rainfall amount were received in 1951 and 1982, whereas the lowest ever received was in 1954. The amount and frequency of rainfal are closely linked to runoff.

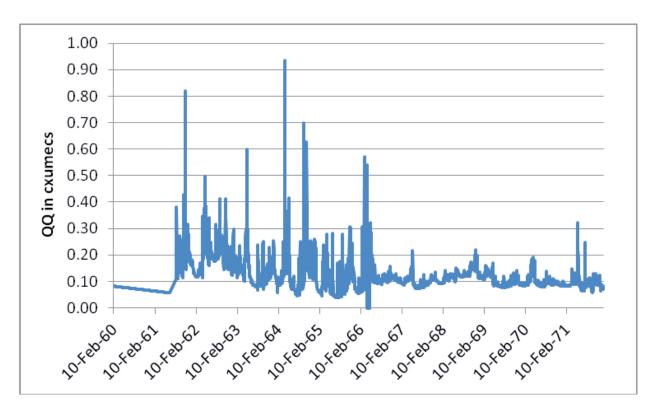
Figure 4: Hydrograph for R. Mobuku, 1951-1971

Significant flow peaks in 1961 and 1964 averaging >70 cm<sup>3</sup>/s confirm the flooding incidence reported by the responents during interviews and dicussions. The flow on R. Nyamwamba was over 80 m<sup>3</sup>/s

around 6 May 2013 and R. Rukoki a lower tributary recorded 58 m<sup>3</sup>/s

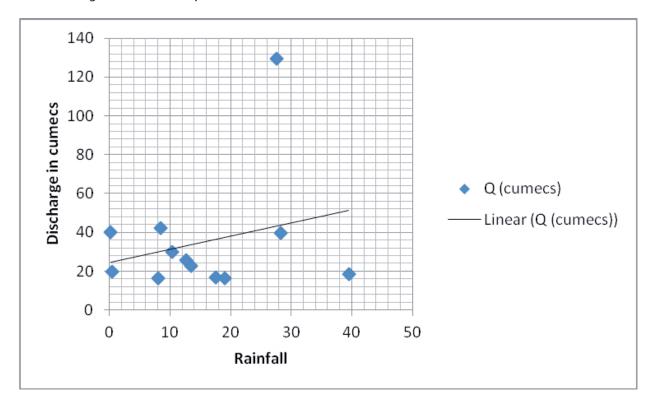
Figure 5: Rainfall and discharge relation

A weak correlation between rainfall and discharge (Figure 5) was recorded based on the data at a low elevation weather station at Kasese Airfield. This provides an indication that runoff due to reported intensive and prolonged rains from higher elevation of the catchment could have been a key factor in flooding. Prolonged rainfall contributed to high antecedent mositure. Therefore more rains on 1st May eqsily genrated large surface and stream runoff. However, rainfall records from high elevation weather stations were not accessible. Also the discharge records/measurements at high elevation were lacking for further analysis.

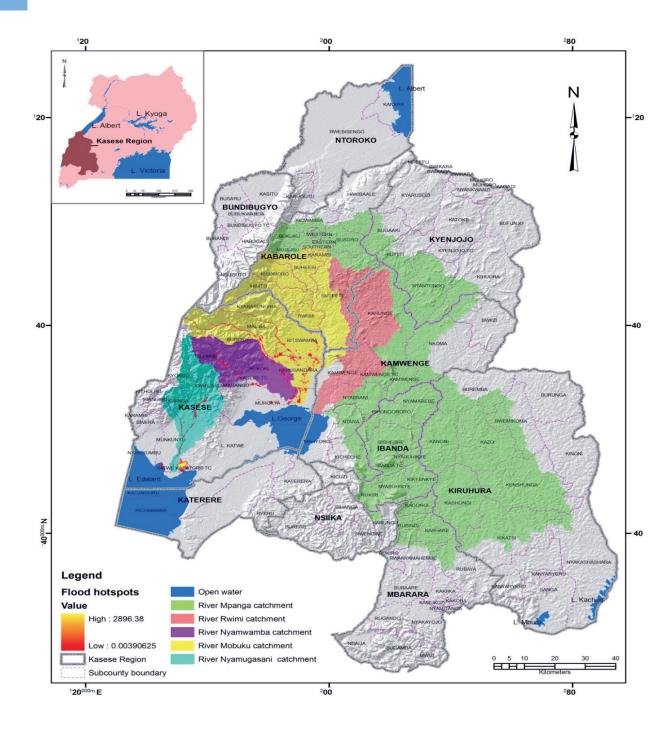
Figure 6: Flood hot spots in Rwenzori sub-region

The distribution of flood hotspots are shown in Figure 6. In total 13 sub counties were affected by the flooding (Table 4); however, the most affected were the sub counties of Kilembe, Bulembia, central division of Nymwamba, Rukooki, and Kusandara, within the Nyamwamba catchment. These were followed by the subcounties of Maliba, and Kichamba; and Kyarumba within the Nyamugasani catchment.

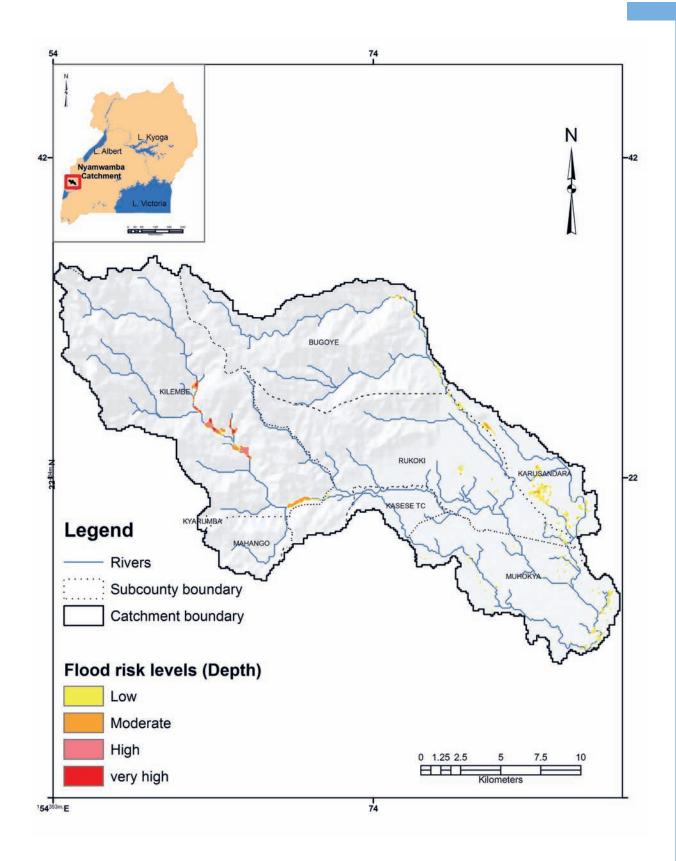
Figure 7: Flood risk areas and elements in along Nyamwamba in Kilembe

At a larger scale areas at risk (high, moderate and low) within the flood hotspot areas are illustrated in Figure 7 a and b. Most of the high flood risk areas occur very close to the river edge and in depressions. The low risk areas lie further away (>50 m) from the immediate river banks and on higher elevation sites. These observations have serious implication on flood risk management as presented later.

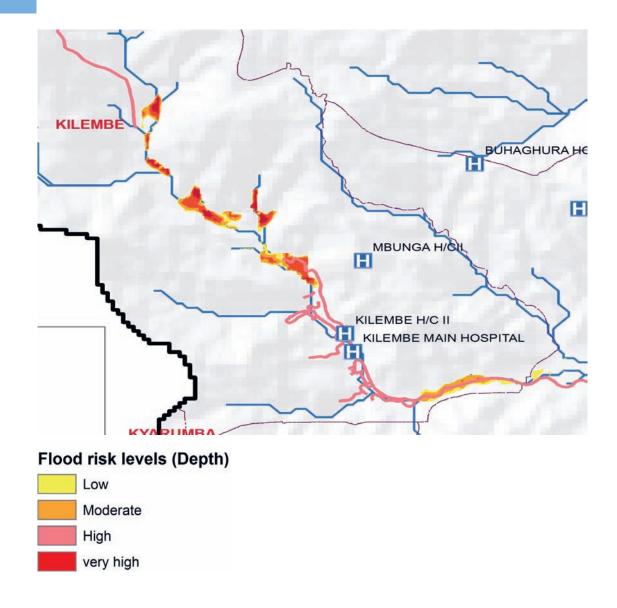
**Figure 8:** Areas and elements at flood risk in Kilembe town; roads, schools and health centres are particularly at great risk

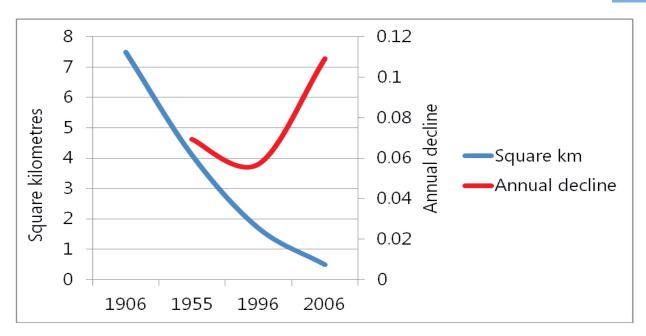
Figure 9: Glacial retreat and rates of annual decline on Mt Rwenzori (Source: Osmaston, 1996; Taylor, et al., 2006)

Figure 9 shows a dramatic decline in glaciers on the mountains and over the last 11 years there has been a decline at a rate of 0.11 square kilometres per year. However, no reports of serious floods have been reported in the mountains over the same period in the region. We can therefore say with the highest level of confidence that, glacial melting contributed little (if any) to the floods in Rwenzori sub-region. Further, the only major river in the region that is connected to glacial melting is R. Mubuku through Lake Bujuku and therefore, glacial melting could not in any way, have contributed to the extensive flooding witnessed in May 2013.

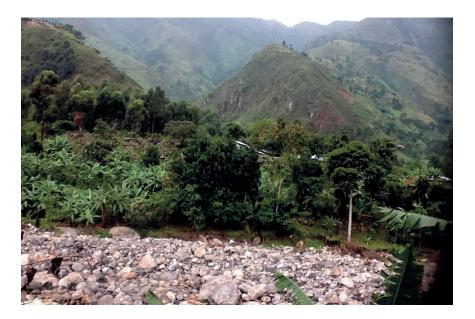
Figure 11: Land use in the upper Nyamwamba catchment; steep slopes are cultivated up to the park boundary while others are almost bare with exposed rocks. In the fore front is the deposit of boulders in R. Nyamwamba, evidence of bank-full and fast flowing stream.

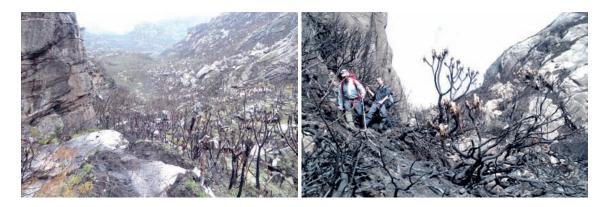
Fire burning (Figure 11) occurred in the upper part of the forest-alpine zone in February 2012 affecting mainly the catchments of Nyamwamba and Nyamugsani. The cause of the fire remains a mystery; it could be linked to human errors or natural cause. Burning was quite extensive covering over 15 km<sup>2</sup> and exposed the underlying rock and boulders, and most likely had negative effects on vegetation retention capacity, thus increasing runoff and erosion. It also reduced the organic matter hence the water retention capacity.

Figure 12: Fire burning occurred in the upper part of the forest-alpine zone in Feb 2012; note the bare rocks, reduced vegetation cover hence the high potential for downstream surface run off and flooding

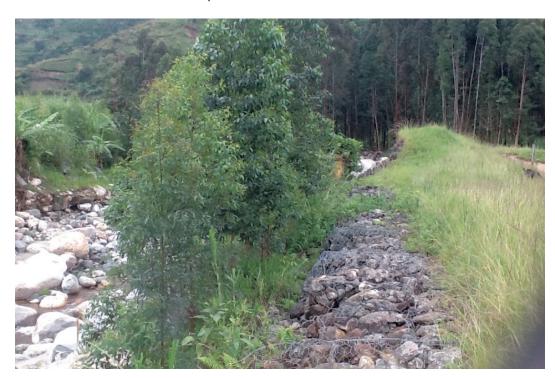
**Figure 13:** Embankment enhanced by tree planting on R. Nyamwamba, upper Kilembe Town,

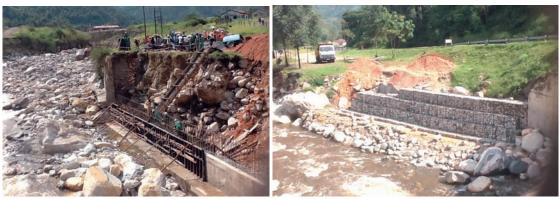
Figure 14: Re-construction of wall at the bridge near Nyamwamba sub-county and roll stone protecting

- **Redesigned flood proof bridges [high and strong]** for example. two bridges in Kilembe town should be considered for this as a matter of urgency.
- **Rock rolls (gabions) and retaining walls** were routinely applied in the higher reaches of River Nyamwamba especially where flow velocities are too high and in the sections where the river was in direct contact with infrastructure and housing. This report still argues that such structure; flexible 'sausages' of crushed rock contained with nylon netting that are placed at river banks to prevent undercutting and fluvial scour; are still important to protect the most vulnerable sections of River Nyamwamba. Rock rolls are typically 300 to 400mm in diameter and come in 2 m or up to 5 m lengths.

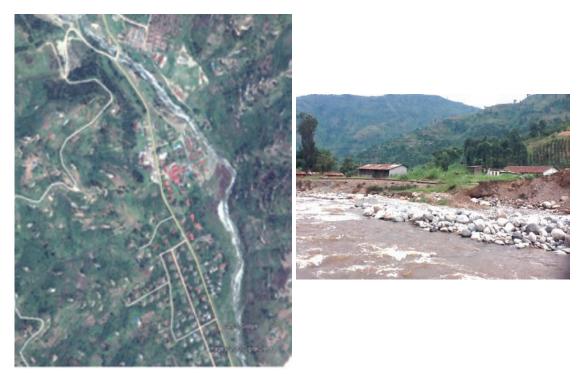
Figure 15: Section on R. Nyamwamba being proposed for constructing a flood wall [re-embankment] close to the Kilembe Hospital shown by white dotted line)

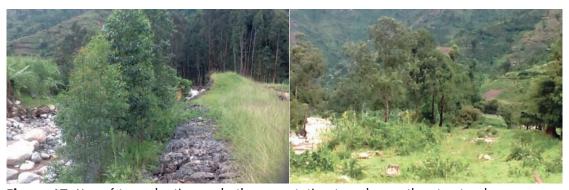
Figure 17: Use of tree planting and other vegetation to enhance the structural measure

b) Bio-engineering and river bank stabilization - To manage river bank instability and erosion and protect communities against flash flood intrusion, there is a need for the application of robust river bank erosion control and shoreline/bank stabilisation measures (Figure 13). This assessment recommends the application of VETIVER grass. There are opportunities to utilise Vetiver grass technology as an alternative to structural engineering measures. Vetiver grass has been used extensively in several other regions of the world for shoreline stability and it is expected that there would be a natural reluctance by responsible agencies to promote the use of Vetiver grass or for communities to adopt it but what is required is the demonstration trials to verify the suitability of the grass. The main advantages of Vetiver grass over concrete are the considerable saving in construction costs and the lower maintenance requirements in the longer term. It is thus possible to construct significantly longer sections of bank protection for the same cost resulting in a significant increase in the area benefited for a given works budget. In addition, the inevitable involvement of local communities in the propagation, planting and maintenance of the grass following the adoption of Vetiver grass technology may in the future require less demands for major inputs from governmental agencies as the communities adopt a self-help approach using their skills and knowledge of vetiver to carry out their own protection projects.
