Damage & Capacity Assessment

PORTS OF HODEIDAH, SALIF AND RAS ISSA

Henk Engelberts and Marc Wormmeester

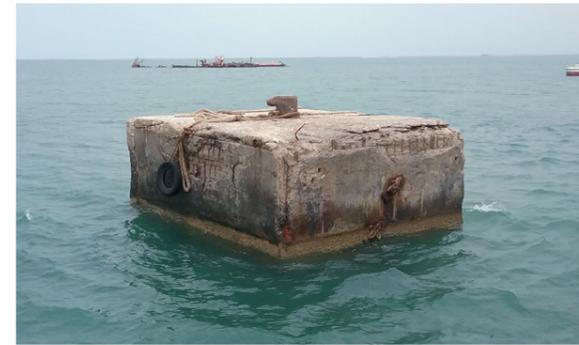
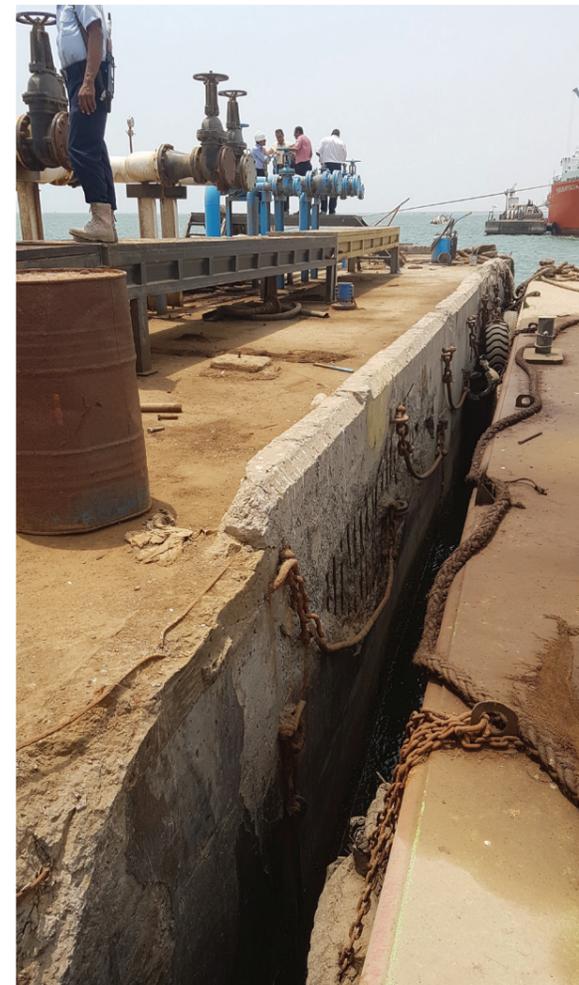
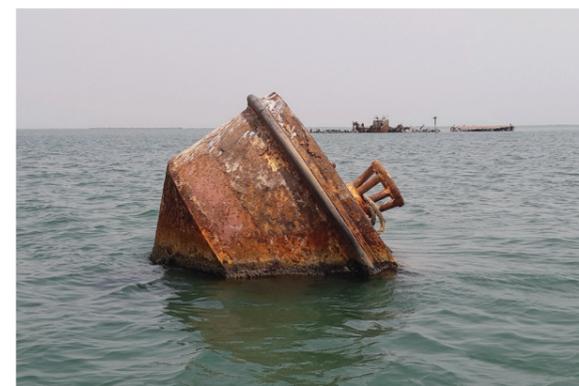
Above and left, all images: Hodeidah Oil Berth 1

Concrete structure The concrete structure of both the platform and the dolphin is disintegrating to a large extent. The reinforcement of the concrete structure is corroding and due to the lack or poor execution of maintenance the concrete is broken over the entire structure.

Sheet piles The concrete structure is placed on Larssen V sheet piles¹ and has not been treated with cathodic protection.² According to YRSPC, the sheet piles have not been inspected as they were informed that corrosion of submerged steel structures was not possible.

Bollards Bollards and anchors are corroded.

Fender system Fenders are degraded to a large extent and/or are no longer present. Provisional fenders have been installed to keep the berth functional.

Buoy The buoy is in a bad state of maintenance. It is corroded and leaks.

Pipelines The casing pipes through which the oil pipes pass are filled with concrete. The outside is considerably corroded.

Personal safety Loose materials on the platforms create a tripping hazard. There is no railing on the platform and the risk of falling into the water is great. Should this happen, it is not possible to ascend to the platform or dolphin as no ladders have been installed.

Fenders are degraded to a large extent and/or are no longer present.

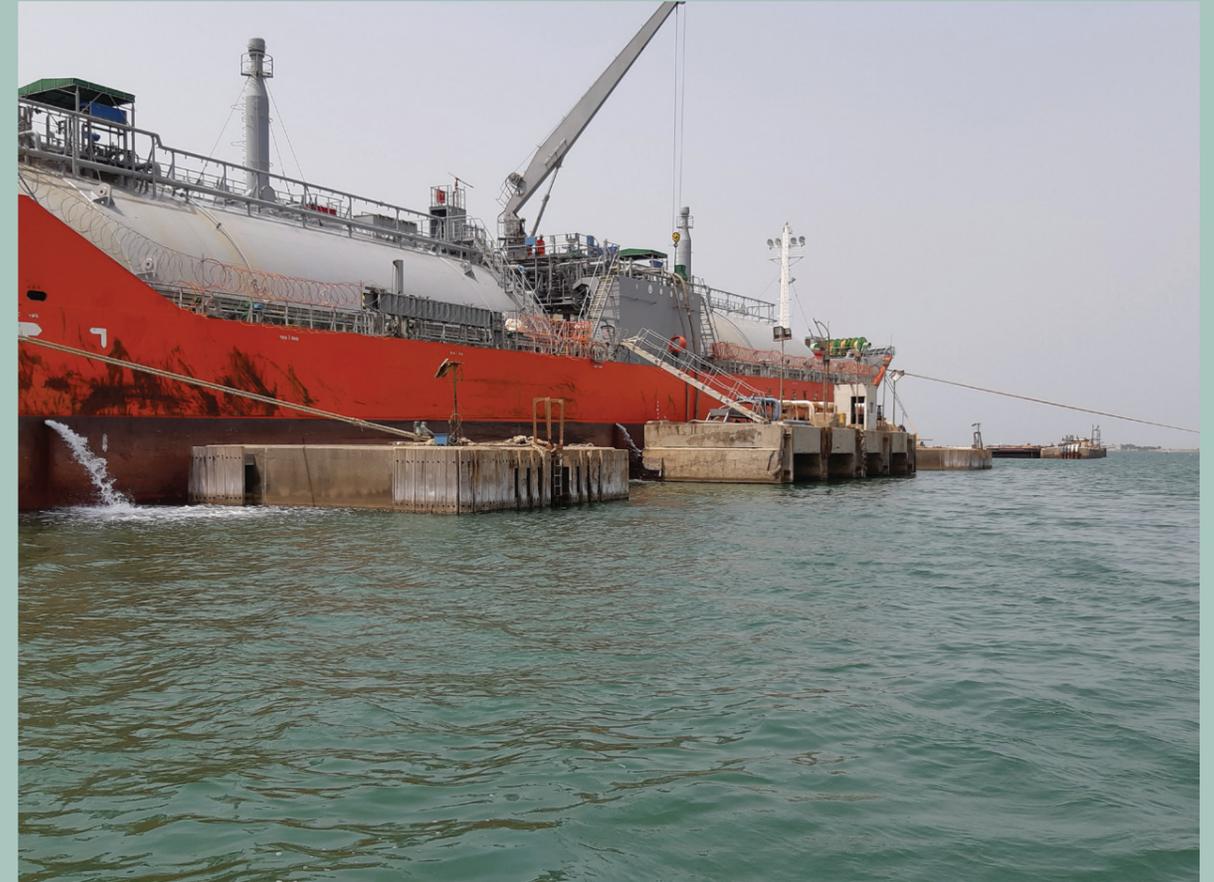
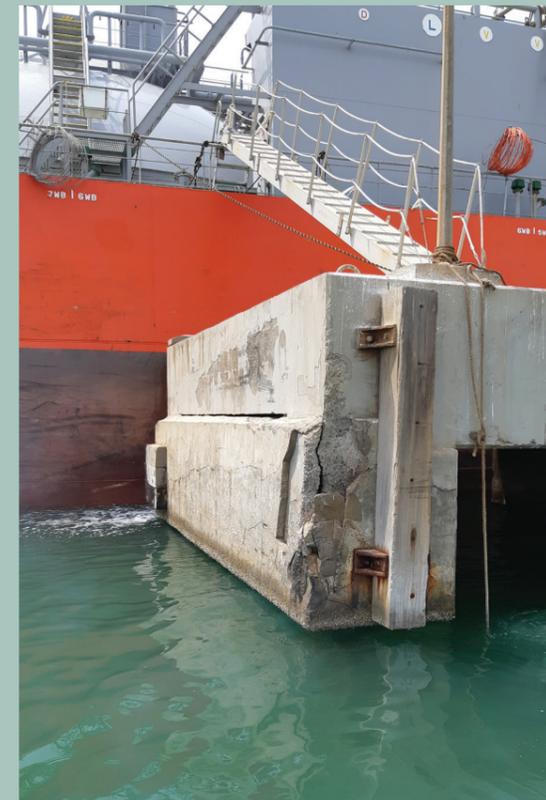
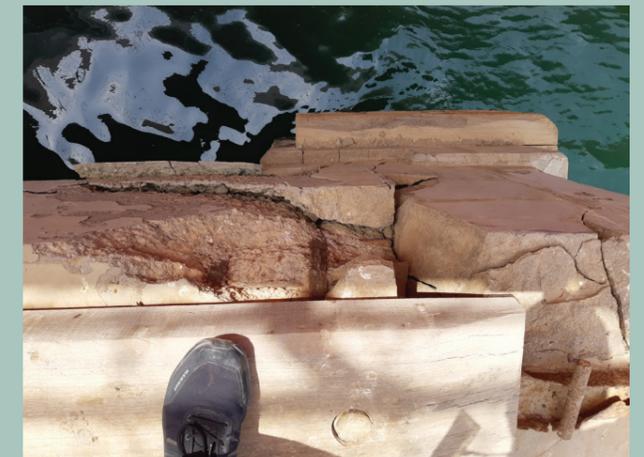
Above and below: Hodeidah Oil Berth 2

Concrete structure The concrete structure of both the platform has largely been degraded. The reinforcement of the concrete structure is corroding and due to the lack or poor execution of maintenance the concrete is broken over the entire structure. Additionally, the platform suffered severe structural damage in 2016 due to a ship's collision. To date, the damage has not been repaired.

Sheet and foundation piles The concrete structure of the dolphins is placed on Larssen V sheet piles and are not provided with cathodic protection. The current state of the steel foundation piles under the platform is unknown.

Bollards The bollards and anchors are corroded but appear to be in a reasonable condition.

Fender system The dolphin's fender systems are in a reasonable condition.

Buoys The buoys appear to be in reasonable condition with minor defects. The current state of the buoys' steel chains and anchors are unknown.

Personal safety There is loose material on the platform and the walkway around the platform is small with no handrails. There is a provisional ladder installed to ascend to the platform. The ladders installed on the dolphins are in poor condition.

The casing pipes through which the oil pipes pass are filled with concrete and the outside is considerably corroded.

There is loose material on the platform and the walkway around the platform is small with no handrails.

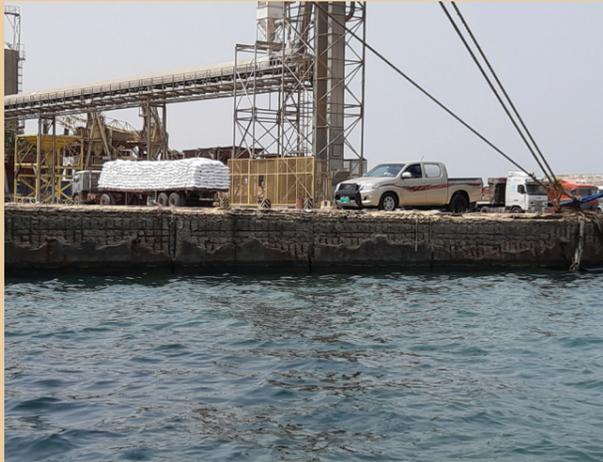
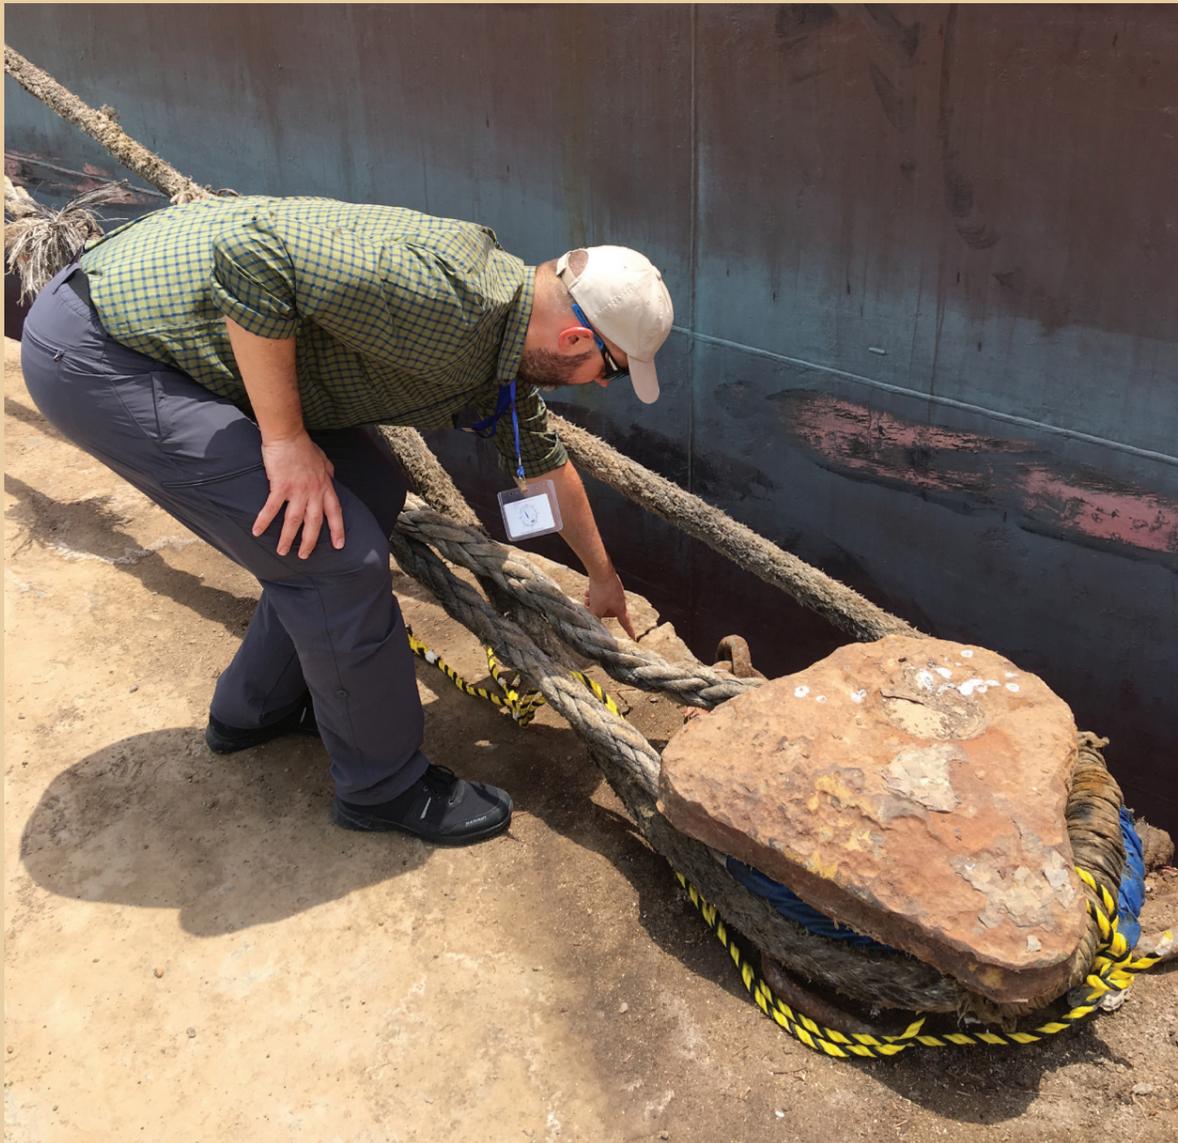
Above and below: Hodeidah quay wall, Berths 1–5

The quay's concrete has largely degraded. Due to poor maintenance—or lack thereof—corrosion of the reinforcement is spreading.

Concrete structure The quay's concrete has largely degraded. Due to poor maintenance—or lack thereof—corrosion of the reinforcement is spreading, and parts of the concrete structure have broken.

Sheet piles The Larssen V sheet piles have not been treated with cathodic protection. The current state of the sheet piles is unknown. According to YRSPC, the sheet piles have not been inspected as they were informed that corrosion of submerged steel structures was not possible. Their integrity is unknown.

Part of the sheet pile wall was damaged as a result of a collision on Berth 4. The sheet pile is torn and soil seeps out; the damaged part has not been repaired.

Fender system The rubber fenders are in a reasonable condition; however, the anchors, booms and chains are heavily corroded. Some fenders have been removed to replace the damaged fenders on Berths 6 and 7.

Bollards The quay has steel bollards filled with concrete. The bollards and its anchors are corroded, and some bollard's concrete foundations are cracked. During the site visit, up to four mooring lines were placed on the bollards.

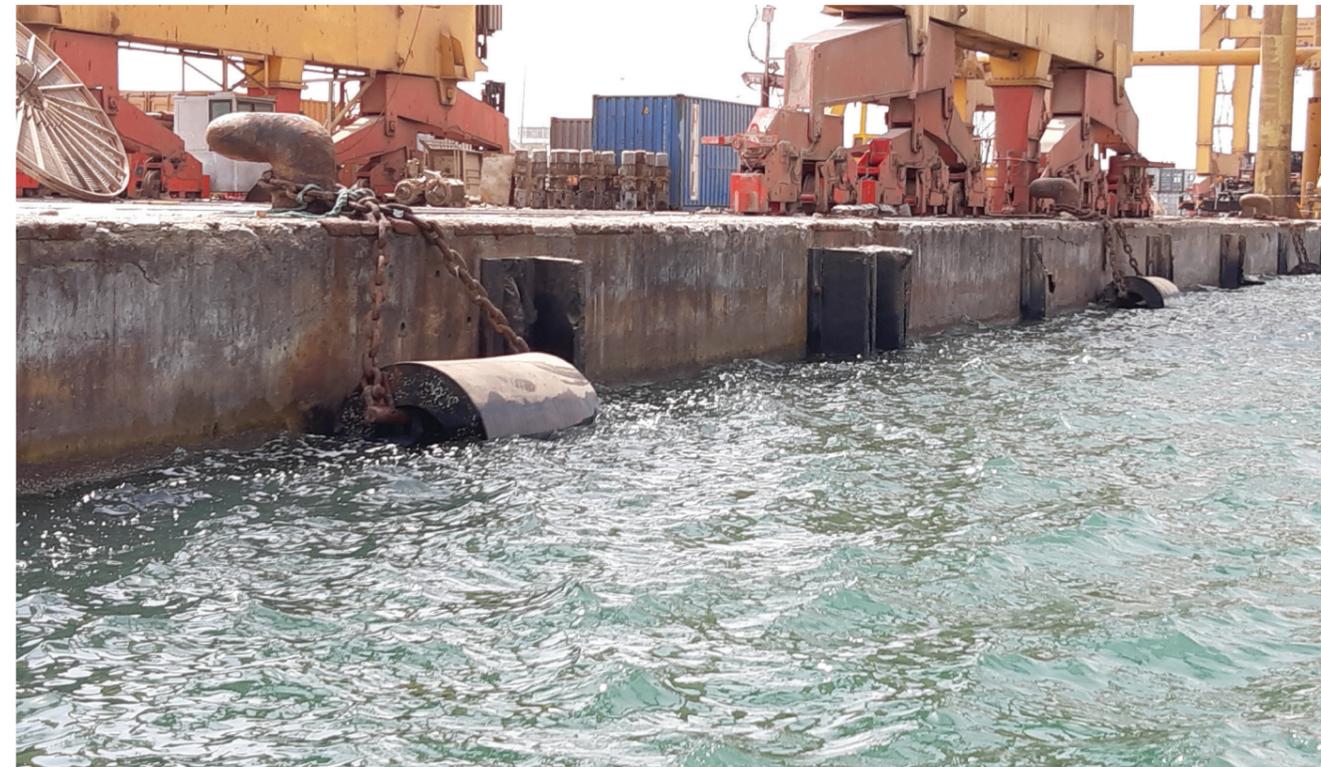
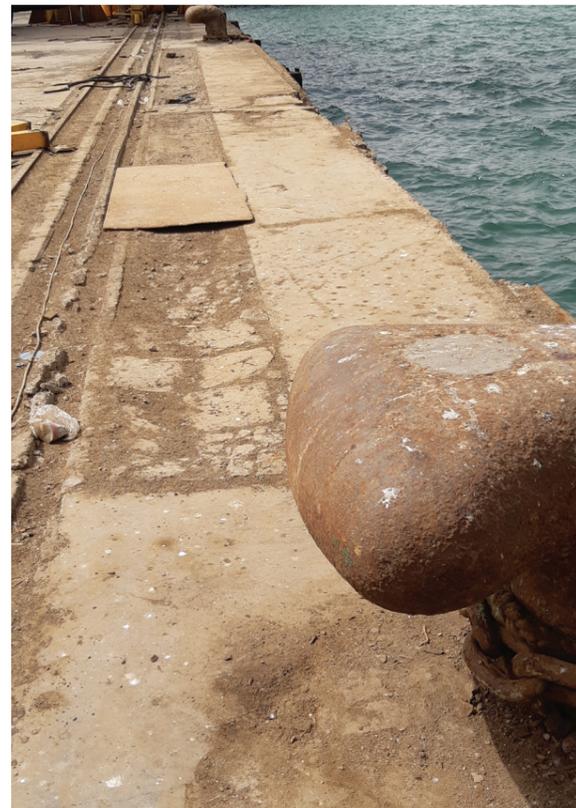
Hodeidah quay wall, Berths 6-7

Concrete structure The quay's concrete shows damage due to corrosion of the reinforcement and because of irregular maintenance, the concrete structure has broken.

Cylindrical cells and sheet piles The cylindrical cells of Berth 6 and the Larssen V sheet piles of Berth 7 and 8 do not have cathodic protection; their current state is unknown. According to YRSPC, the sheet piles have not been inspected as they were informed that corrosion of submerged steel structures was not possible.

Fender system The quay's fenders have deteriorated to a great extent and are unusable. Cylindrical fenders from Berths 1–4 have been used to replace damaged fenders.

Bollards The quay has steel bollards filled with concrete; however, the bollards and its anchors are corroded, and some bollards have cracks in the concrete foundation.

Service trenches The waterside service trenches alongside the crane rails are filled with sand, water and dirt. Nearly all the concrete trench covers are broken or missing.

The bollards and its anchors are corroded, and some bollards have cracks in the concrete foundation.

Bollards and mooring lines In the ports of Hodeidah, with the MBL of mooring lines of 50-ton mooring lines and the SWL of the 75-ton bollards, a maximum of two mooring lines on each bollard should be allowed.

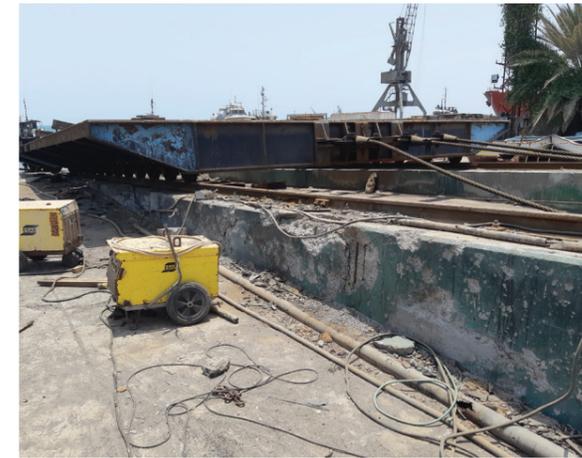
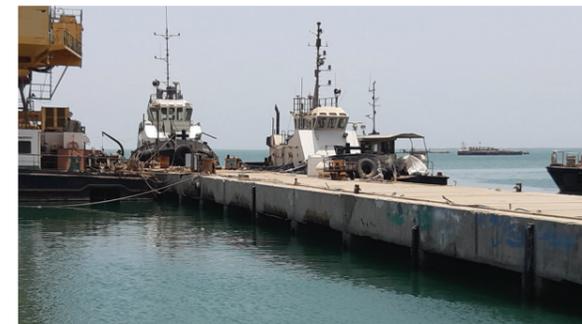
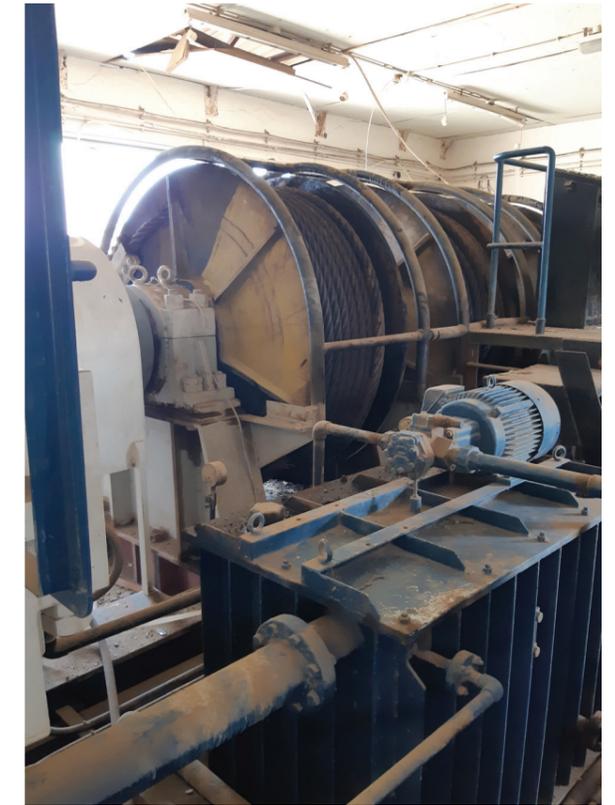
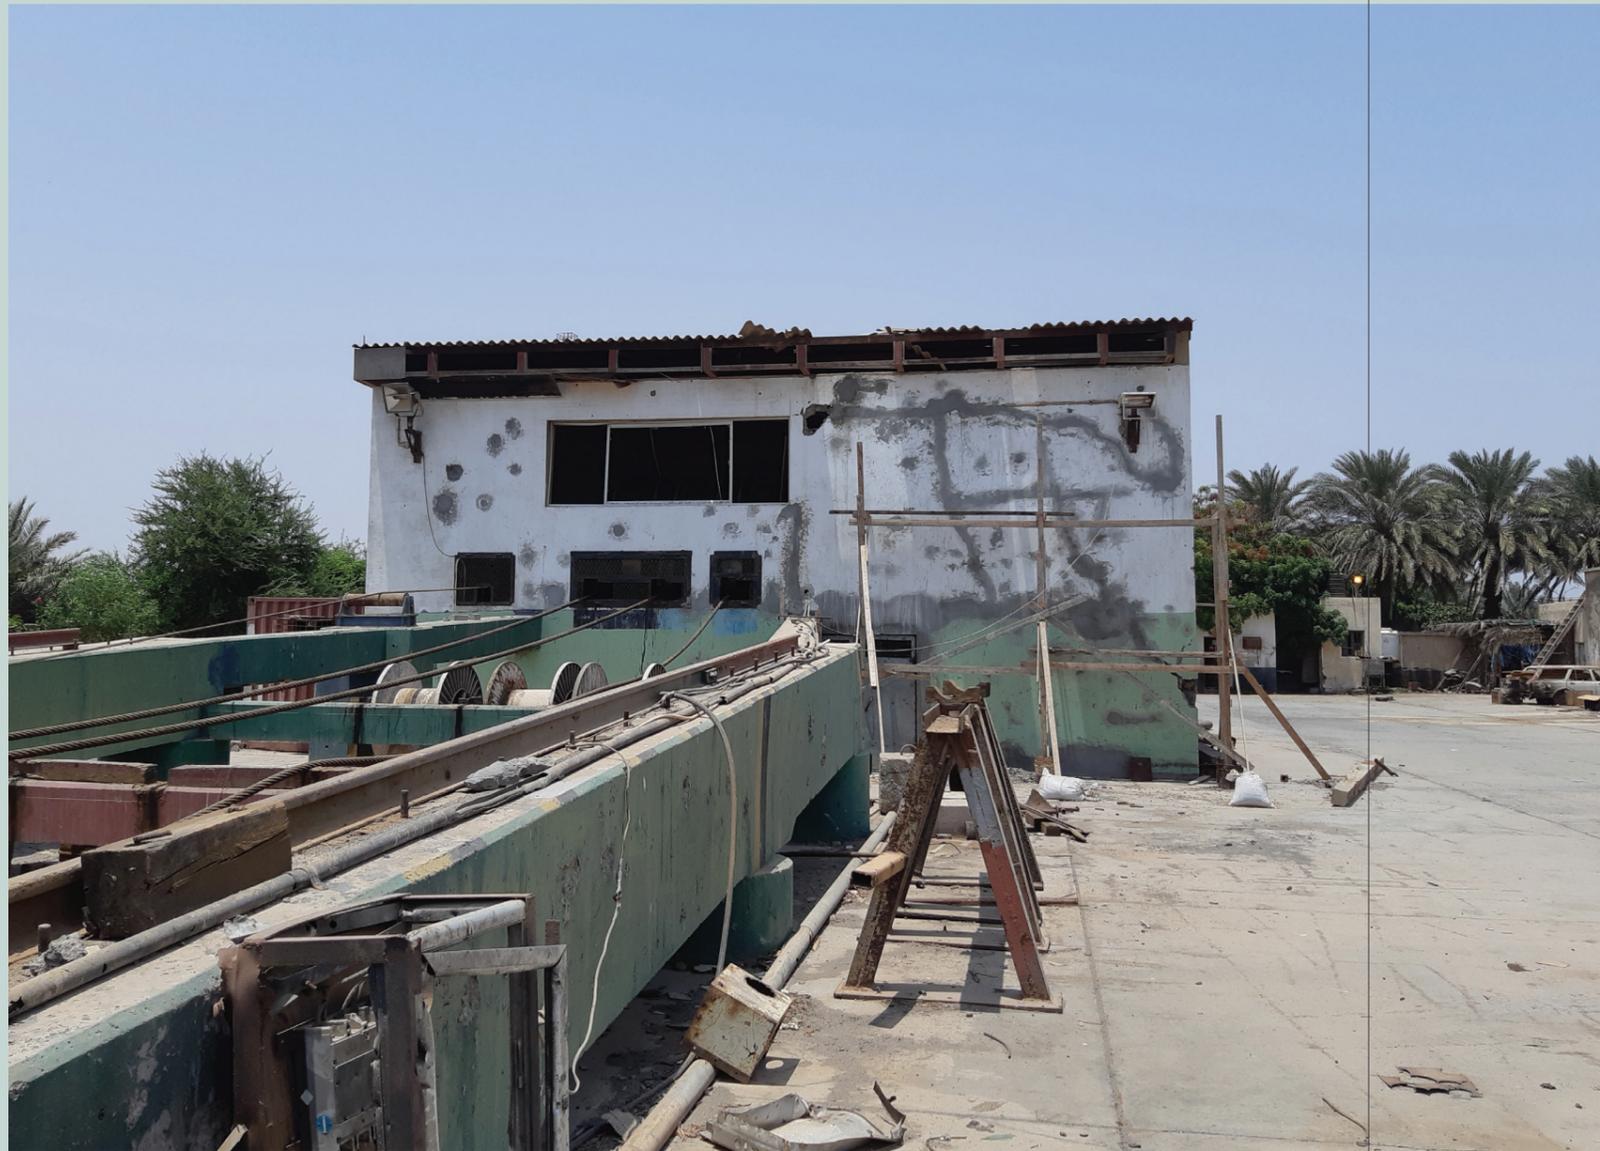
Above, all images: Slipway

Slipway building The slipway building and concrete beams were damaged in the conflict. Provisional repairs were made to the building wall; however, the building is also in need of repair. The ceiling sustained damage, and the assessment found the cable drum drip trays to contain oil and fat and the facility to be dusty. The electric motor is in good condition, but the electrical installation is in need of repair. The steel pulling cables are damaged, but provisional repairs have been made.

Slipway yard The yard next to the slipway can be better maintained, discarding scrap, old equipment and waste to help enable a safer, cleaner and more functional environment.

The yard next to the slipway can be better maintained to help enable a safer, cleaner and more functional environment.

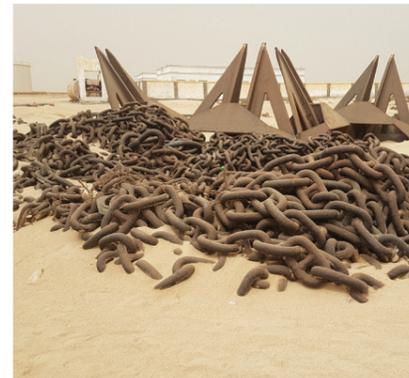
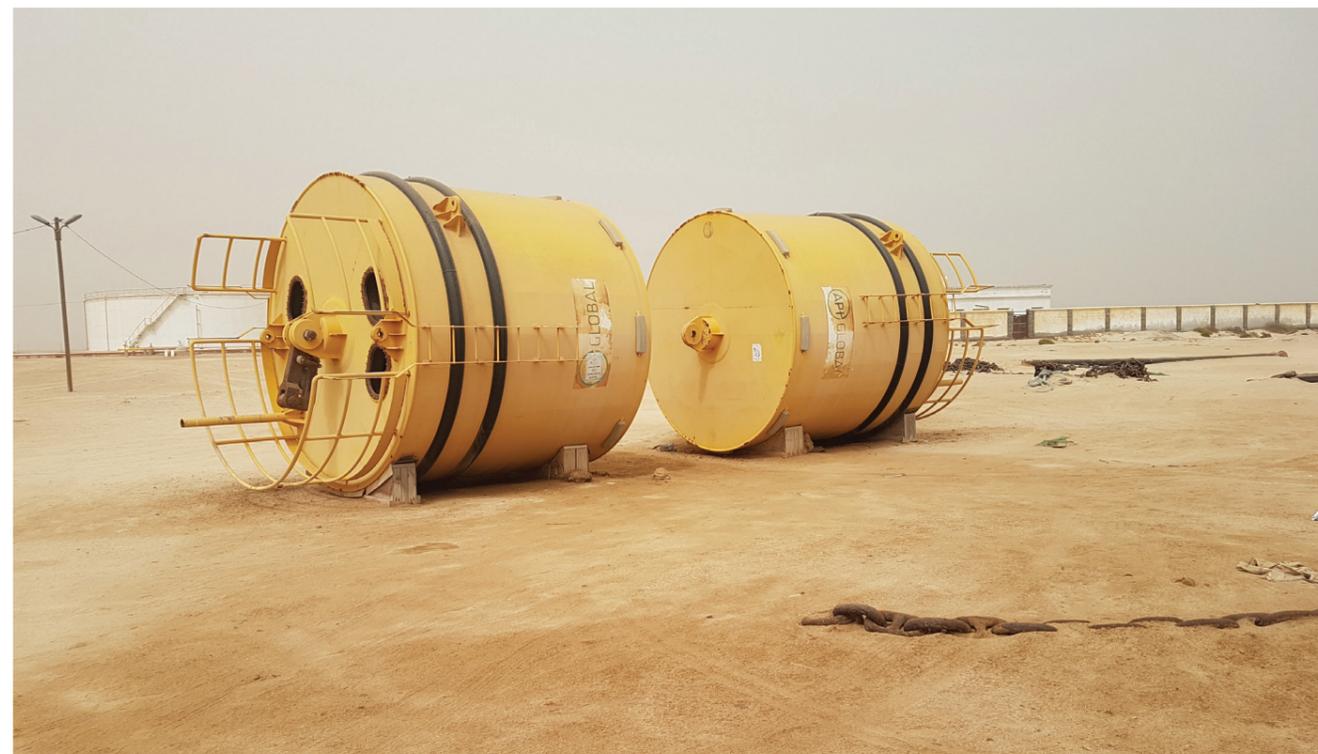
Above, both images: Ras Issa port buoys

The port of Ras Issa has very deep water (greater than 50 meters/ 164 feet). Because of this, there is no restriction on the draft and the largest tankers can visit the port. The port of Ras Issa is used to unload diesel fuel via a pipeline system to existing storage tanks. Tankers moor in a buoy system and unload the diesel fuel to storage tanks via a floating pipeline.

The new buoy system is owned and operated by the YRSPC. Placing the buoys in the water will make the location fully operational; however, an operational timeline is unknown, and the port is currently not functioning due to the conflict.

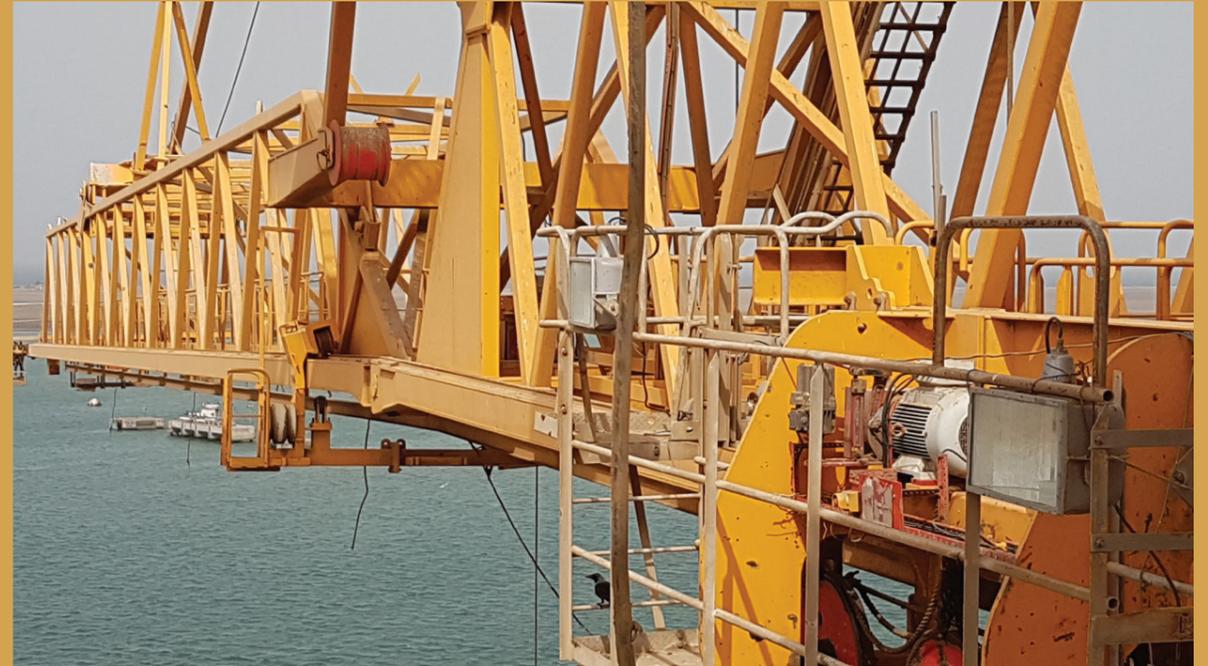
Damage to machine and electricity house

The two other cranes were built by Liebherr, Germany in 2011 and have a container lifting capacity of 41-tons. Both cranes have sustained damaged from the conflict in the machine house on top of the gantry, behind the rear legs. The machine houses will need to be replaced including the hoisting engines (spreader and boom) and central electronics of the crane.

Both cranes sustained collateral damage when the machine houses were destroyed. Other minor damage is due to contact with shrapnel; both cranes have minor secondary damage to all parts of the crane.

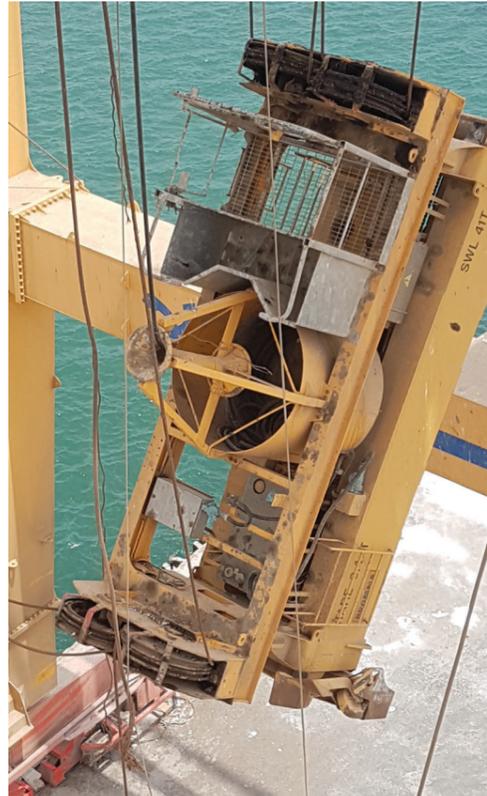
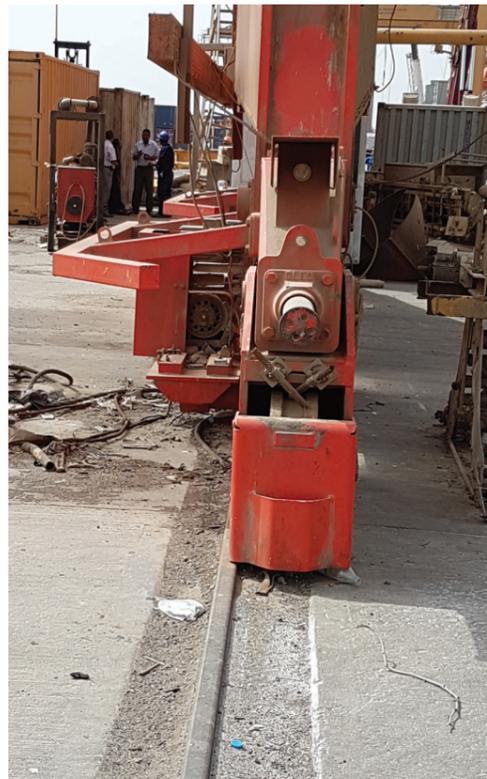
- Crane IR 1801** Crane IR 1801 has secondary damage to the stairs, the festoon cable, the upper rear support beam, the forestage and to the bogies of the rear legs that are positioned next to the rails. The hoisting cables for the boom and the spreader will need to be replaced to ensure operational ability. It is likely that lifting the rear leg of the crane will cause the bogies to be repositioned over the rails (the bogies are all aligned) allowing for immediate operation.

The headblock and spreader are salvageable but need urgent action to move them to a safe location. The most critical is the damage to the crane boom as it currently hangs at an angle of 1 to 2 degrees. This is likely a result of when the engine house sustained damage and the hoist cables broke, causing the forestage to stretch as the boom fell; the forestage must be replaced. The structural damage to the boom's hinge could also be the reason for the hanging of the boom. If this is the case, significant repairs to the crane will be required. *Note:* The structural damage to the hinge was not determined but must be part of a detailed assessment of the crane's structure.

Top: Spreader of crane IR1801; bottom: bogies of rear leg of crane IR1801 next to rail

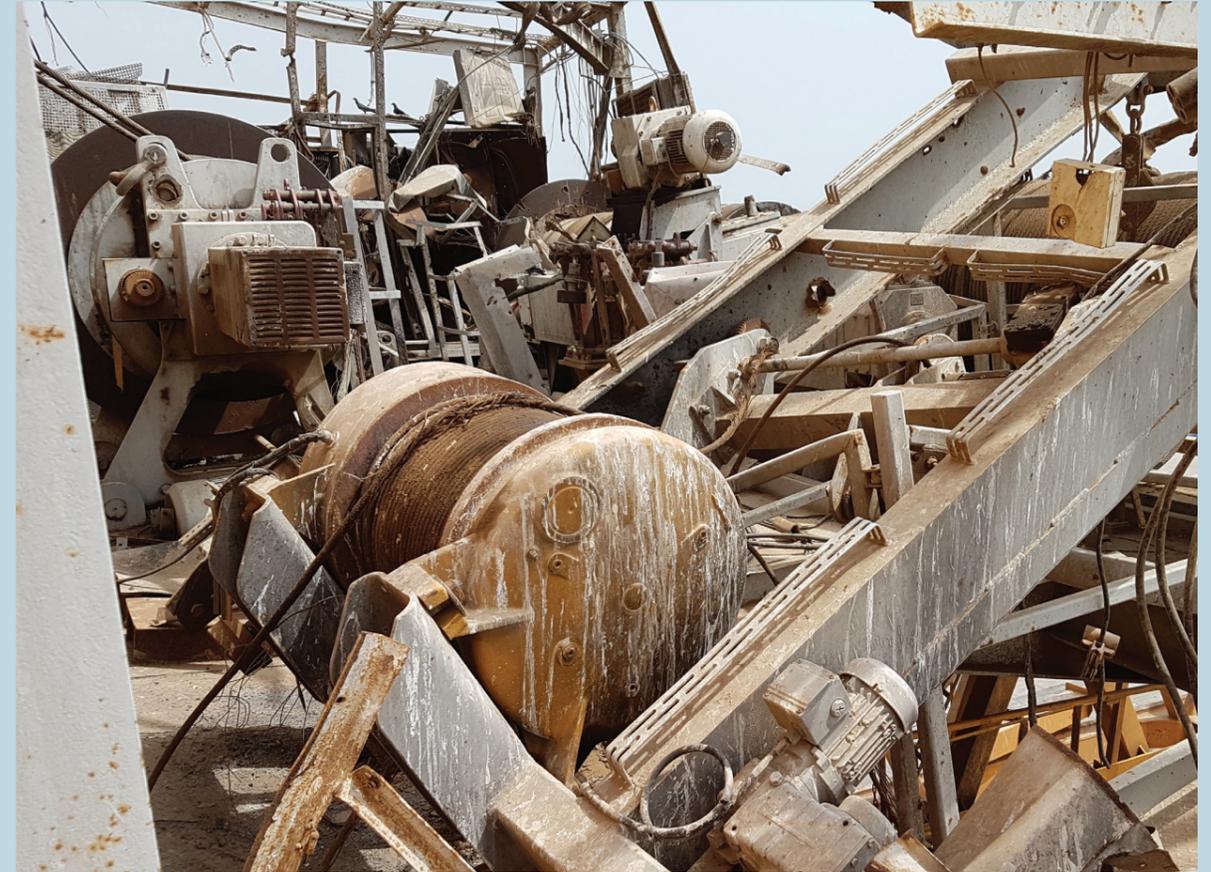
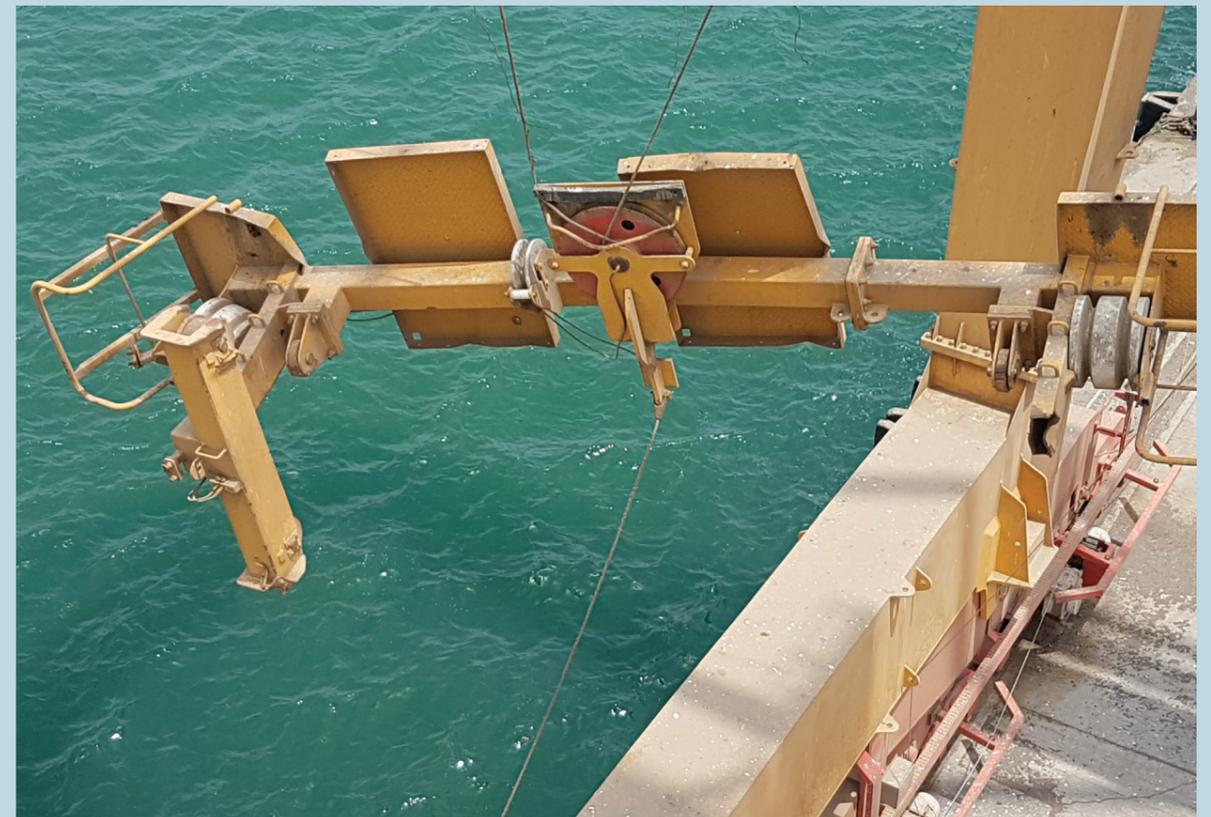
Above: Destroyed machine house; below: damaged cable support trolley

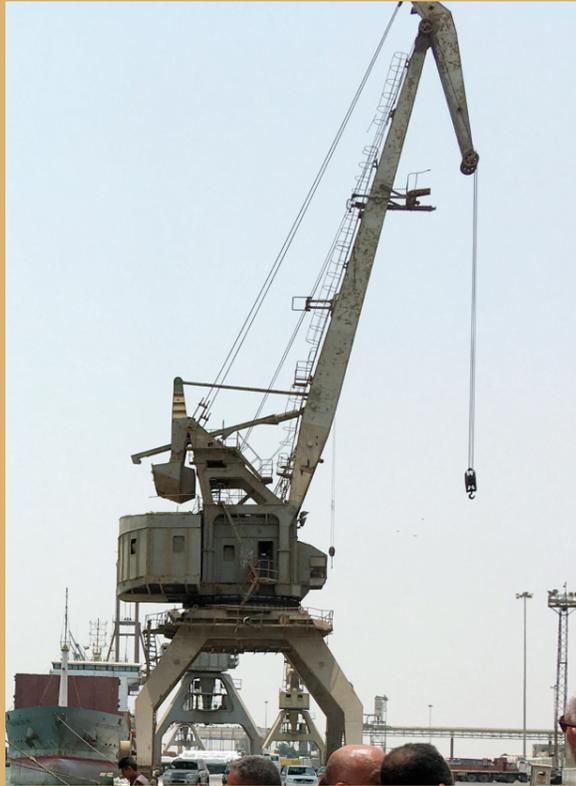
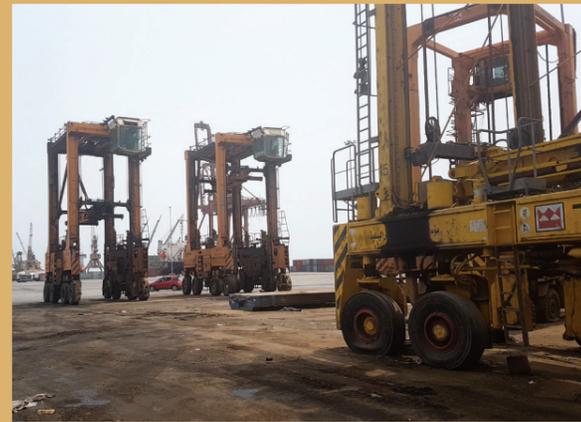
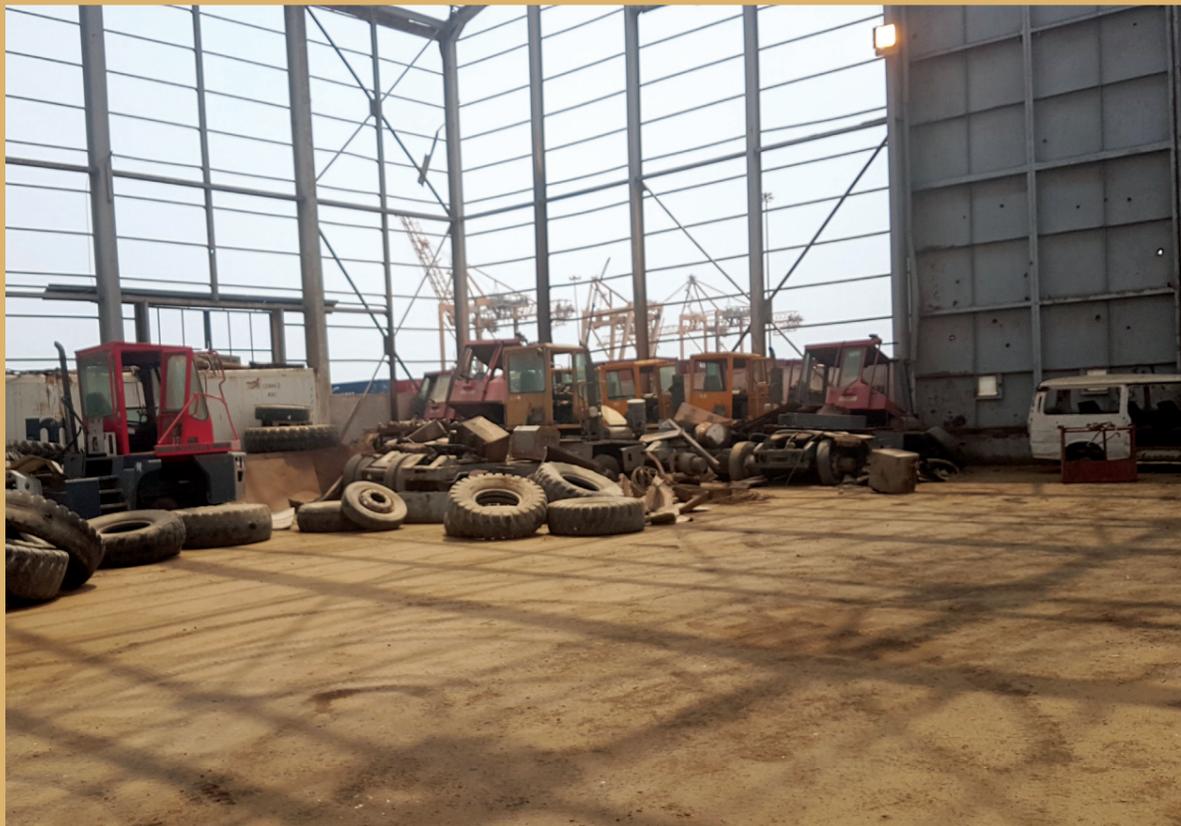
On Berths 1–5, there are five Russian-made portal cranes of which two are fully decommissioned. The other three are working but are in urgent need of maintenance. Replacement of the cranes should be considered as quickly as possible.

All straddle carriers are in urgent need of maintenance to ensure future usability.

Clockwise from top left: a Russian crane at the port; straddle carriers requiring maintenance; tractors requiring maintenance.

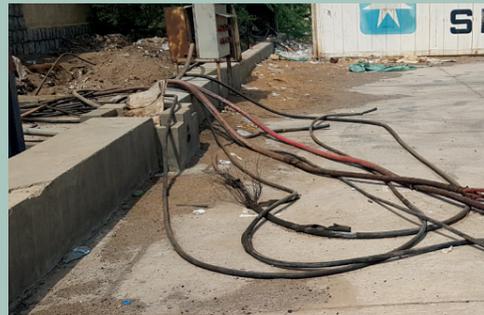
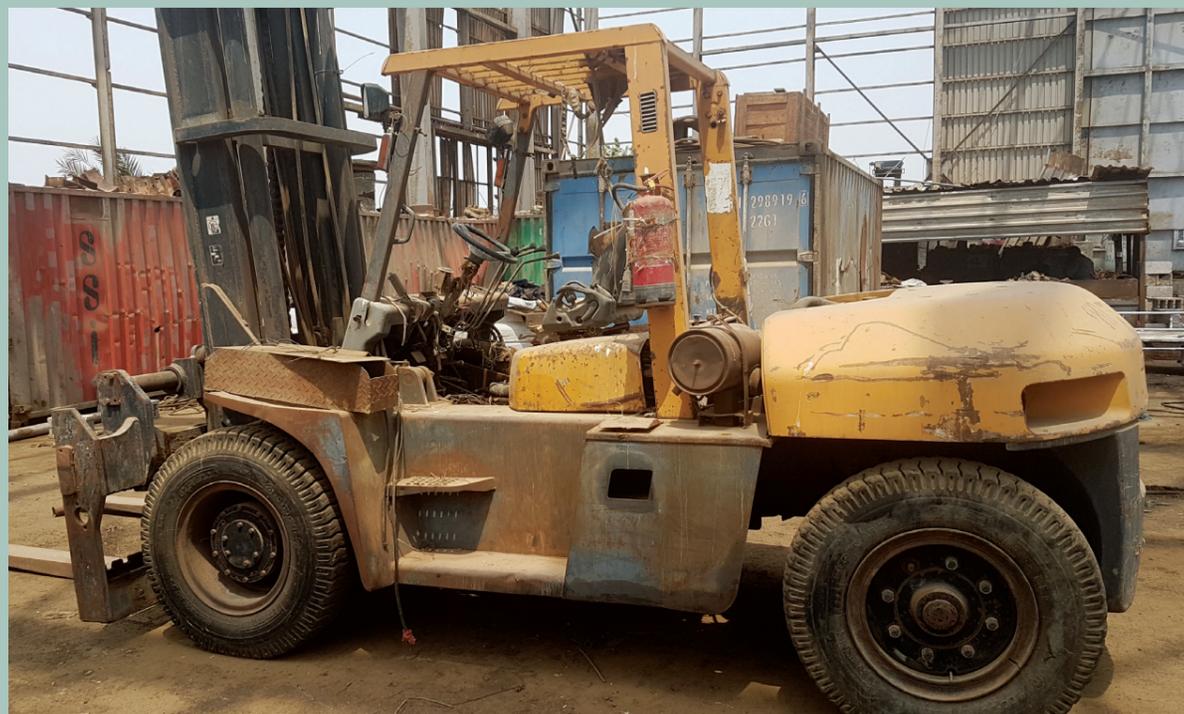
A second, heavily damaged workshop is not being used for fear of collapse.

Top to bottom: Reefer connection station; forklift in use by the port; damage to roof of workshop; maintenance workshop

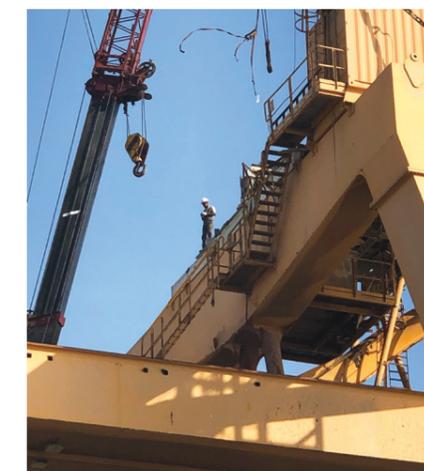
Staff working on height without securing measurements

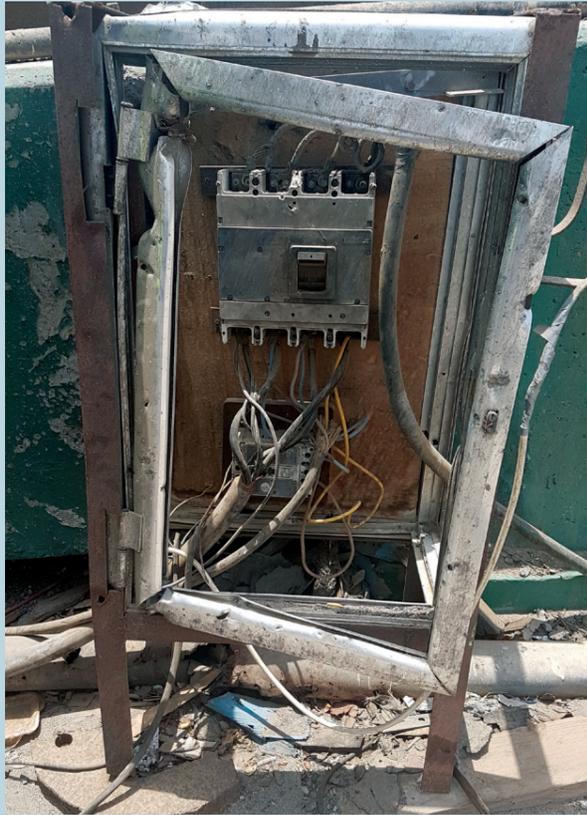
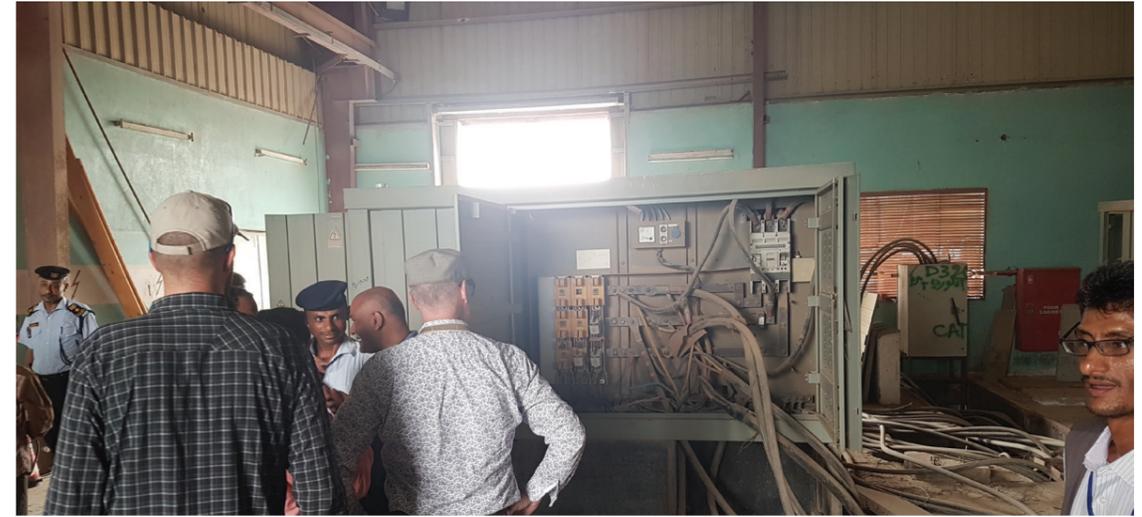
Transformer connections in Salif Port

It is suggested that all electrical connections be covered. However, if it is too hot, then the connections must be under lock and key, accessible only for staff who possess detailed knowledge of the electrical shock risks.

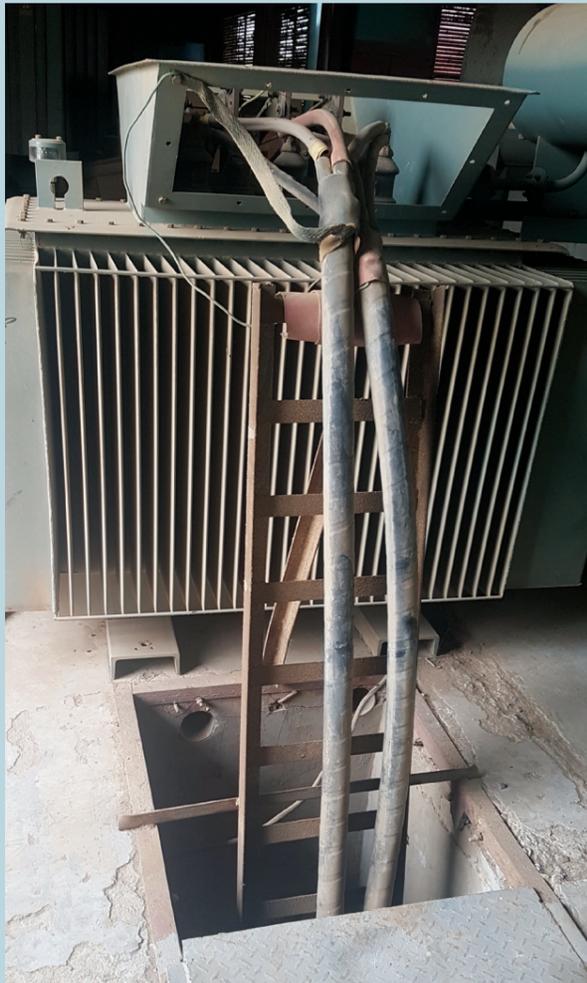
Both images: Electrical connections in Hodeidah Port

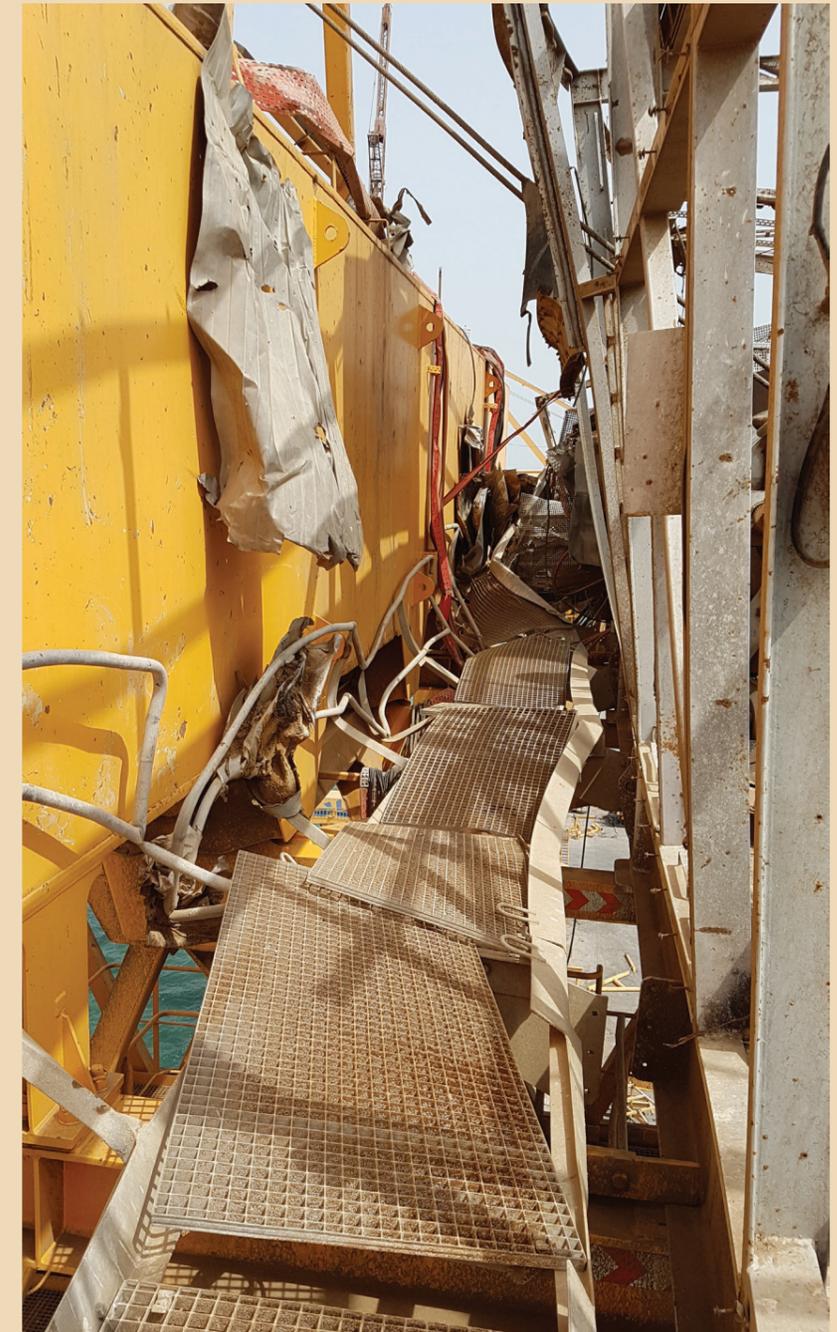
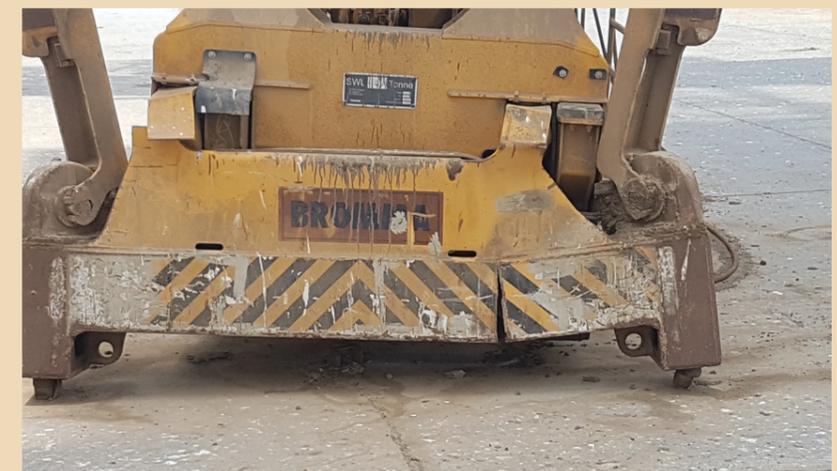
Top: Damaged walkway next to machine house; bottom: damaged spreader
