Reducing Landslide Risk Using Cut Slope Stability Maps:

Excavating for Safe Development in the British Virgin Islands

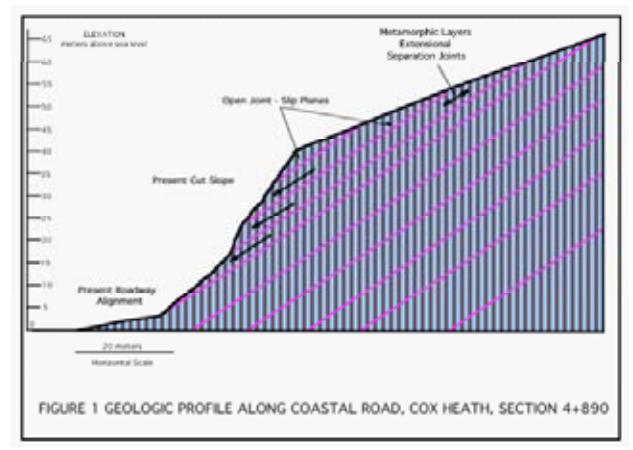
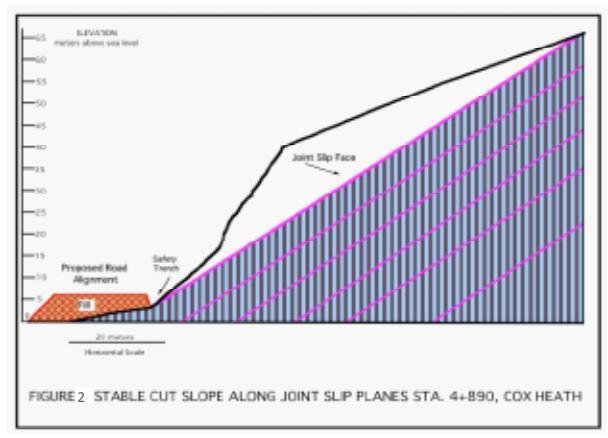
Coastal erosion and cut slope excavation created slopes steeper than the joint inclination. The overlying rock mass is unsupported and subject to sliding on the joint planes (Figure 1).

The concept of a stable cut slope is simple. If the cut slope can be reduced to the angle of the joint set that is inclined out of the slope then the overlying rock mass will be supported at depth and the slope will remain stable (Figure 2). In cases where there is limited land availability and the stable cut slope angle is low, steeper unstable cuts will be necessary to optimize land use (Figures 3 and 4). Cuts

steeper than the stable cut slope will require cut slope support and/or terracing to maintain the safety of the adjoining properties and infrastructure.

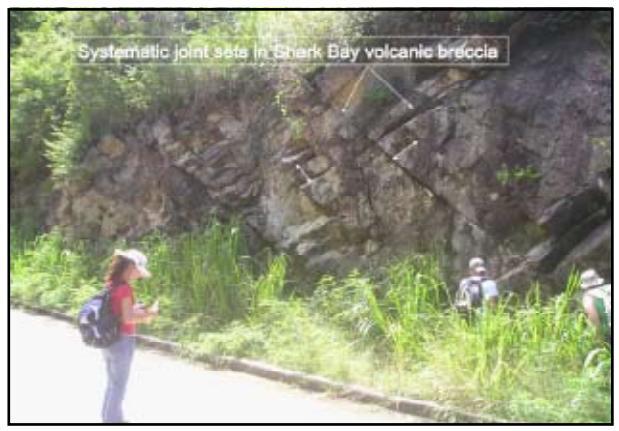
Photo 9: Two oppositely inclined systematic joint sets with consistent spacing shown with double arrows

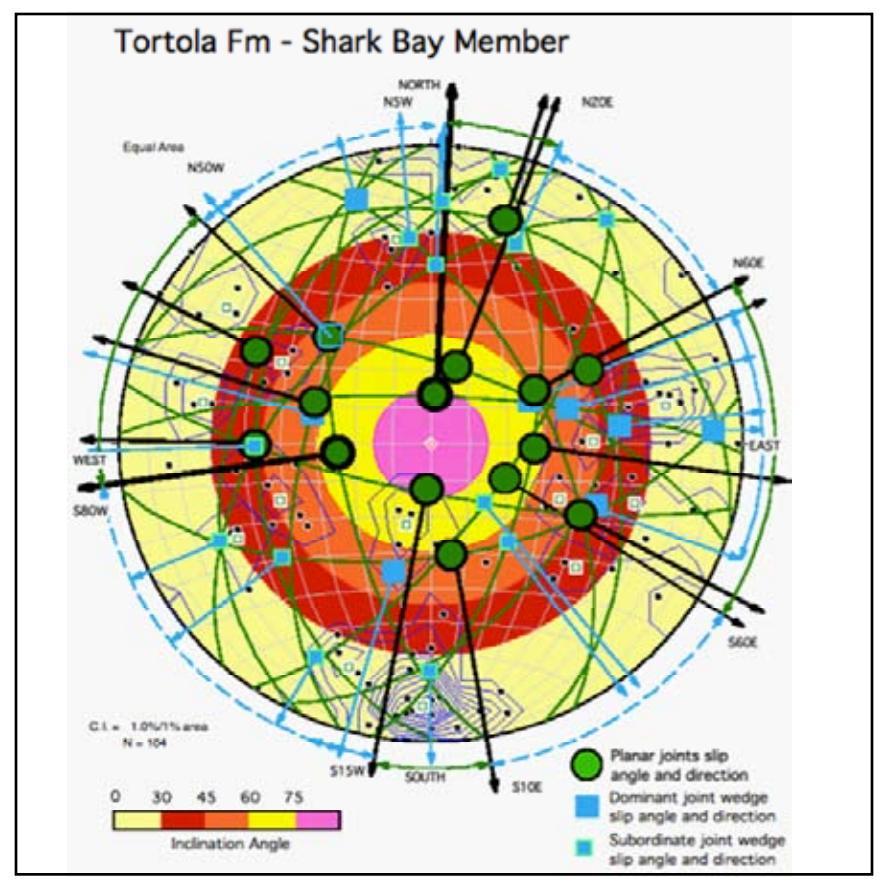
Figure 5: Stereographic projection of systematic joint set data and vulnerability table

Shark Bay Member of the Tortola Formation is composed of thick massive volcanic breccia interlayered with thin-bedded finer grained tuffs and showed the most consistent systematic joint data of all the geologic units. Stereographic analysis of joint data from this member showed that systematic joint sets were dominantly steeply inclined >60° to the North and West.

Subordinate joint sets were inclined moderately east-northeast to east-southeast and west to northwest and steeply inclined to the south. The joint set intersection directions were similar (Figure 5).

Stereographic analysis of the systematic joint data indicated a generally regular distribution of the systematic joint sets. Natural slope vulnerability was established based on topographic slope orientation and angle relative to the orientation and angle of systematic joint set planes show as green circles with black arrows and intersection wedges shown as blue boxes with arrows. The data interpretation was used to create the GIS based landslide susceptibility maps.

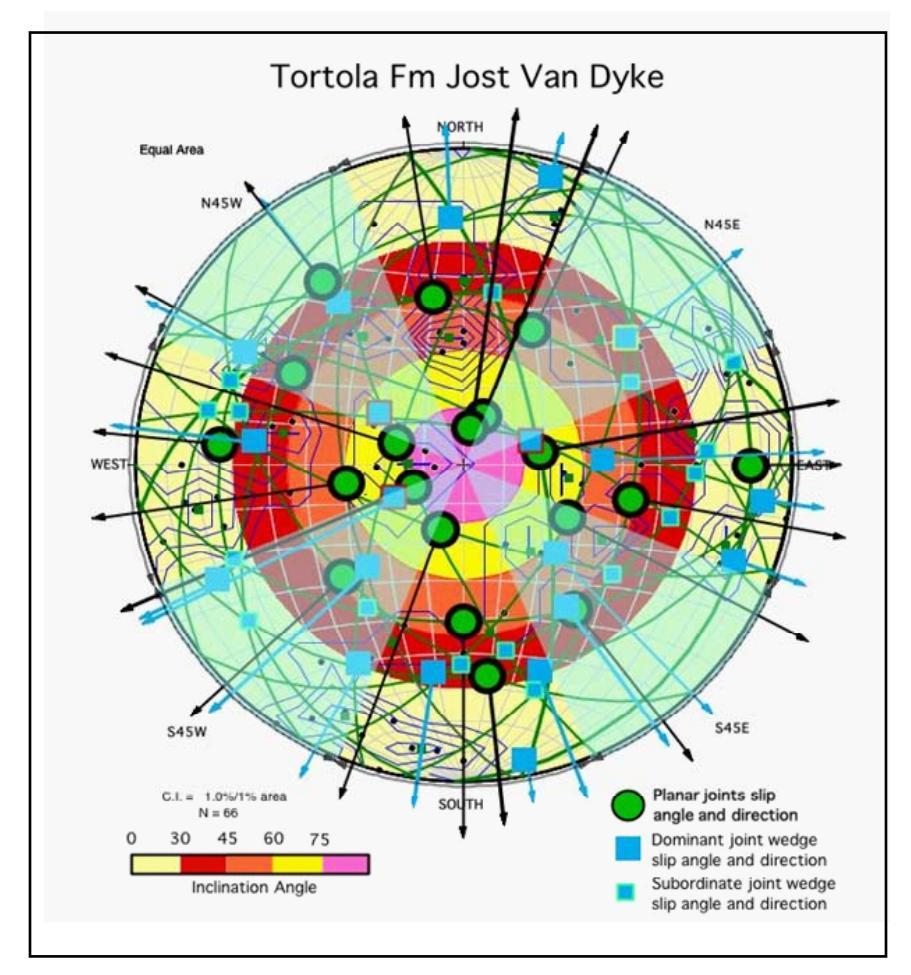
Figure 6: Stereographic projection of systematic joint set data for the cut slope analysis

from roadways. Although cut slope recommendations formed part of the landslide study the data was limited to tables and not readily accessible. In order to address the more serious problem of cut slope failures joint orientation and inclination data collected for the QRAP landslide vulnerability analysis and subsequent field studies were utilized in the cut slope map analyses. Stable cut slope and vulnerability were analyzed for directional segments of 45° in order to be incorporated into the BVI GIS program (Figure 6).

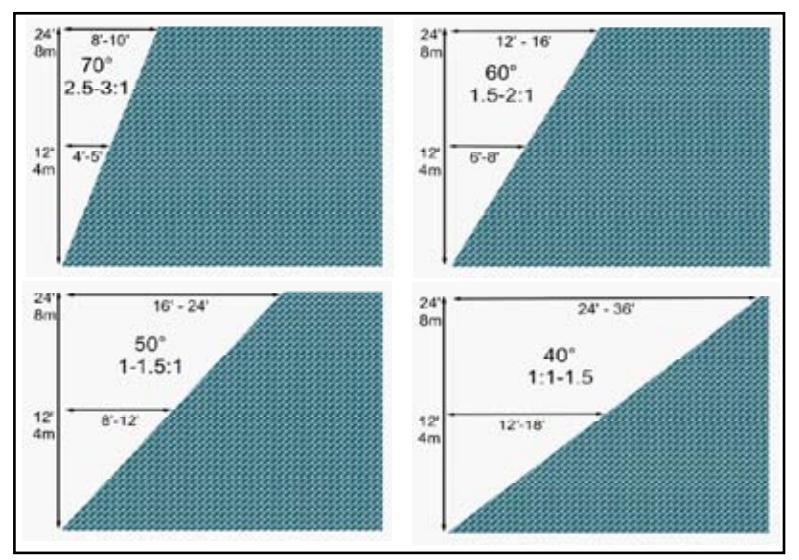
Figure 7: Recommended cut slope angles and vertical to horizontal ratios

Stable recommended cut slope angle was based on the inclination angle of planar joints, shown as green circles with black arrows, and joint wedge intersections, shown as blue boxes with arrows, in the cut slope directional segment of Figure 6. Cut slope vulnerability was based on the number of joint measurements, shown as black dots and quantity contoured with blue lines, which are inclined in any given directional segment. The vulnerability and stable recommended cut slope angles were separated by formations, rock type and location and tabulated for easy incorporation into the established BVI GIS system (Figure 7 and Table 1). Vulnerability and cut slope stability maps were created through the GIS program for the major islands of the BVI.
