Akhaldaba Landslide (Photo courtesy of GeoGraphics GIS and Remote Sensing Consulting Center)

Tbilisi Flood 2015

Initial Findings and Response Actions

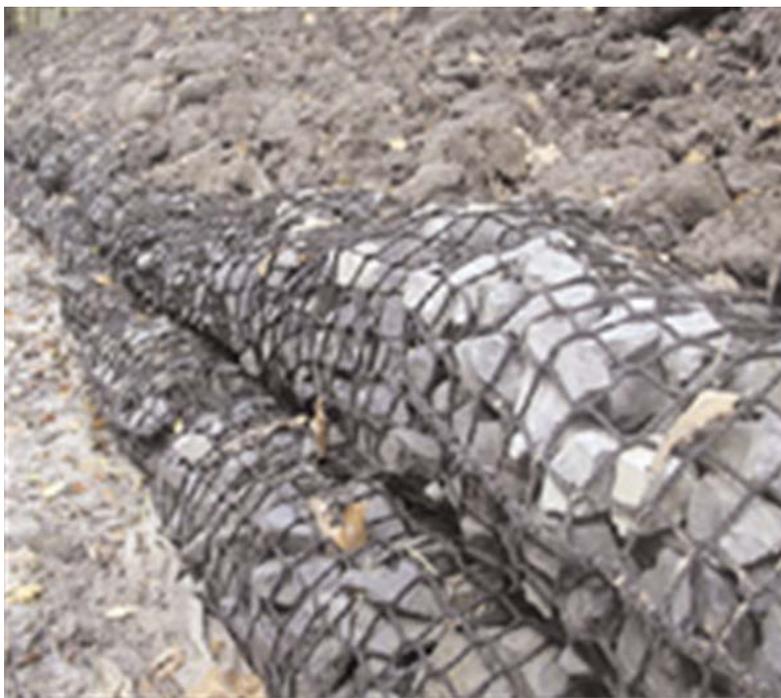
Figure 21: A simple rock filled buttress to increase slope stability using gabion or a rock roll which are flexible 'sausages' of crushed rock that are place embedded into the bank toe to prevent undercutting and fluvial scour.

The slide area just upstream of the Electrical Plant poses another very difficult problem due to the narrow ravine for access. Evaluate the engineering feasibility of removing the rock slide and building a buttress at the toe with rock. It appears to be feasible to bring a road in from the top by the power lines to first topple and then remove the rock slide material until the bankfull width of the stream channel is attained and the slide is buttressed and stable. A stable storage area for the rock that is removed will need to be found. If the rock is suitable for construction projects, it could be sold.

We recommend removal of the slide top by excavation to the depth of the fissures and building a buttress at the toe with rock. The purpose is to remove weight from the top and add weight to the toe. It is also recommended that the top area be graded to eliminate water penetration. The toe buttress can be constructed with large diameter rock blanketed together or with a gabion type structure (Figure 21).
