2015

# Climate Vulnerability and Capacity Assessment : A Baseline Report

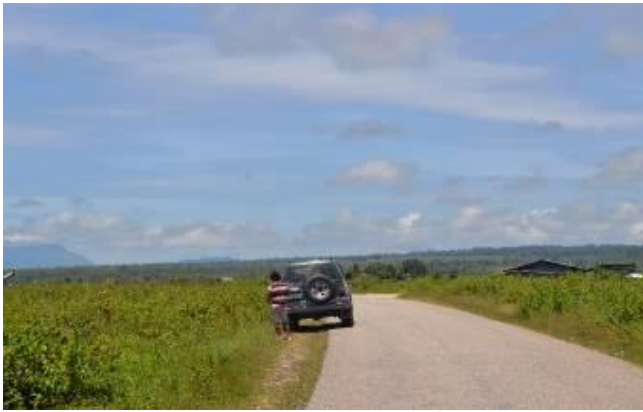
Figure 3 – Very low risk for erosion near the airport on the Baucau Plateau. Tirilolo Suco, Seiçal River Catchment

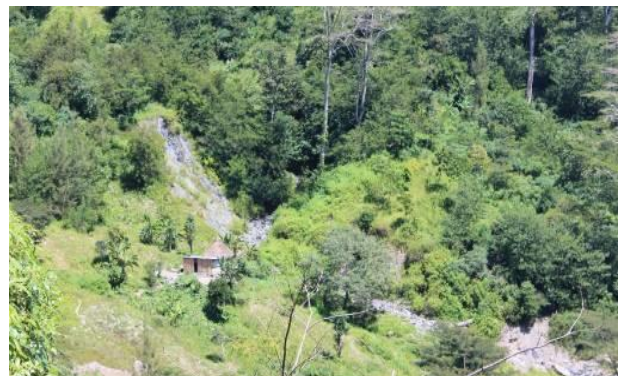
*Figure 20 – The nature of Ermera landslides – small, isolated, right next to a house. Poetete*

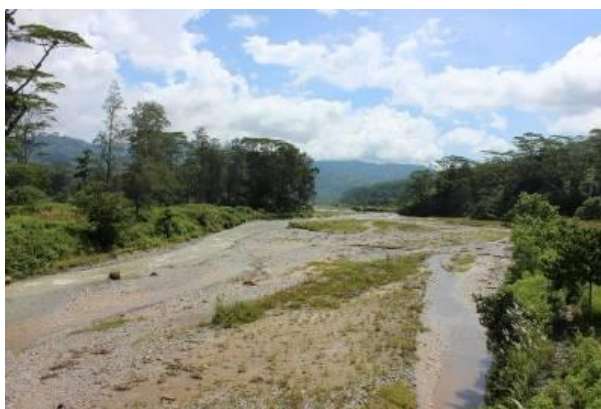
Figure 22 – Sediment deposited by Gleno River; evidence of heavy erosion upstream. Riheu Suco, Lois

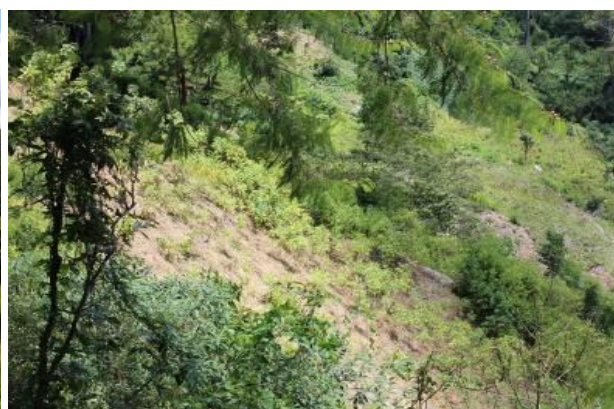
Figure 23 – Soil eroding from very steep cassava field. Mertutu Suco, Lois River Catchment

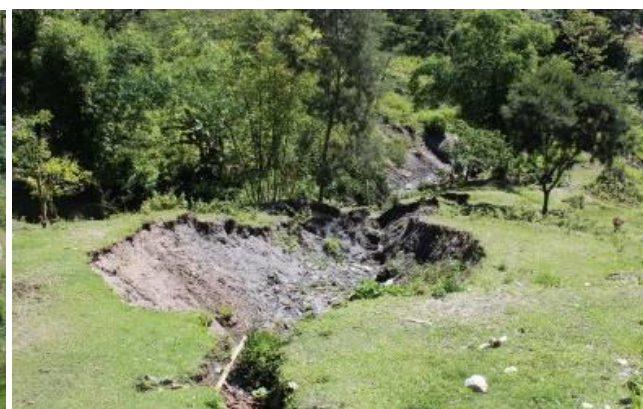
Figure 24 – Gully erosion on sparsely vegetated pasture. Mertutu Suco, Lois River Catchment

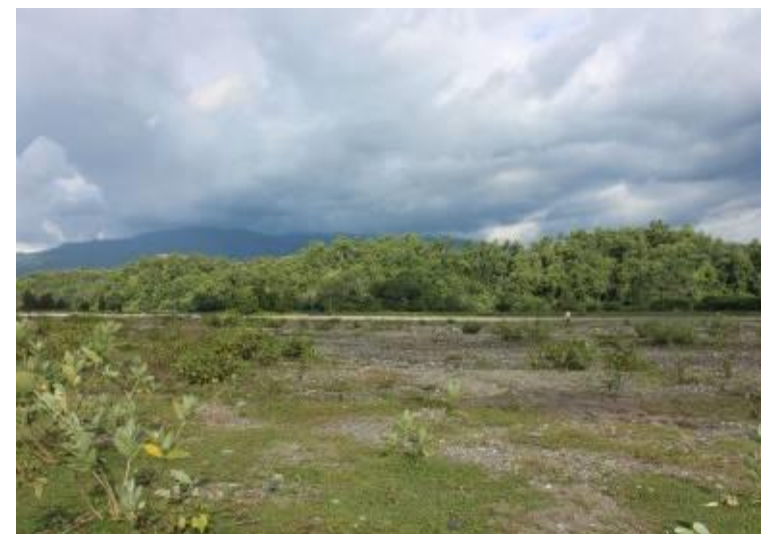
**Figure 25 – Elevated above the floodplain - one of the few places near a river in Aculau Suco not prone to flooding. Aculau Suco, Lois River Catchment**

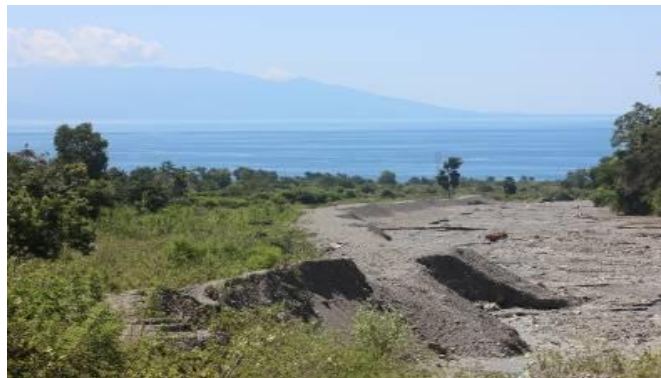
*Figure 29 – Engineering works attempt to contain the Moraelloa River. Lauhata Suco, Moraelloa River*

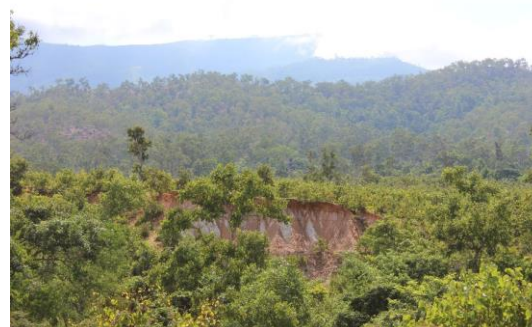
**Figure 32. High risk for landslides and erosion. This is the best vegetation here all year. Ulmera Suco, Comoro River Catchment**

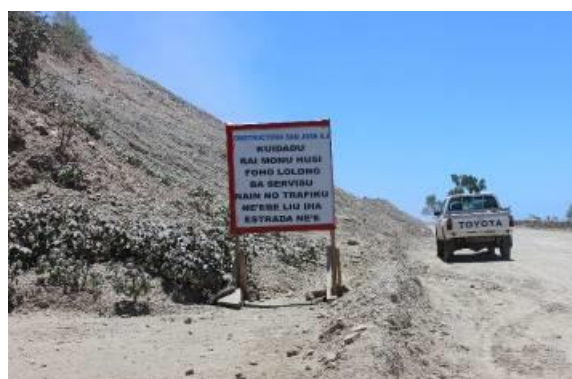
**Figure 33 – Recently re-opened road after landslide clean-up. Ulmera Suco, Comluli Aggregate**

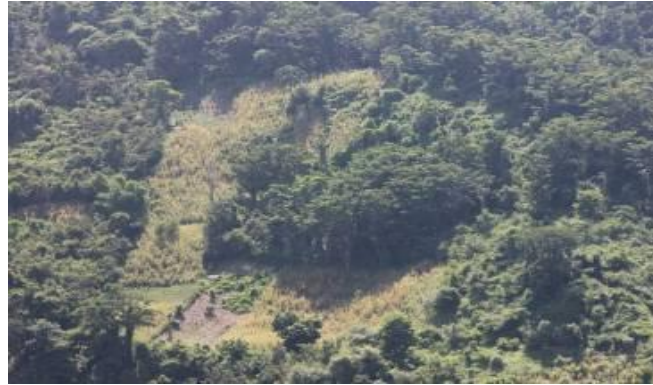
**Figure 35 – Extremely steep, cleared forest cover, cultivated fields in high-risk area for erosion. Metagou Suco, Carbutaeloa River Catchment**

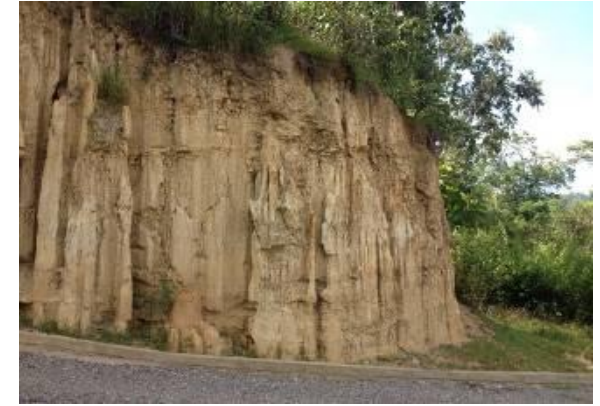
**Figure 36 – Sparse vegetation on highly erodible soils. Near Lebulua, Ulmera Suco, Comoro**

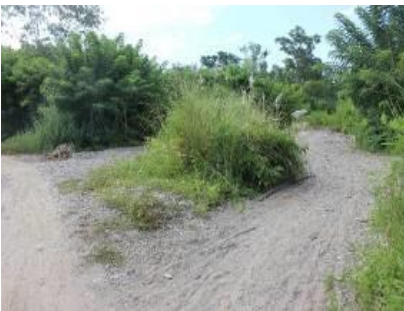
Figure 37 – Road in flood zone. Suco Guico

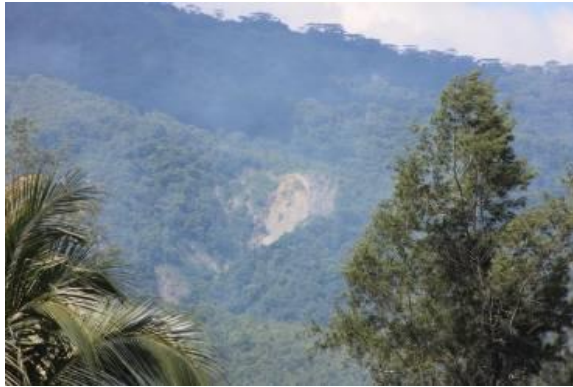
Figure 41 – Large landslide in high-risk area. Guíço Suco, Lois River Catchment

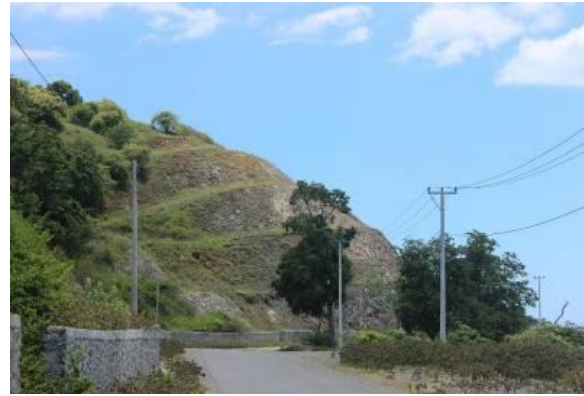
Figure 39 – Terracing to strengthen and reduce steepness of slope and thus lessen threat to road from landslides and erosion. Gualeur Suco, Kaikasa
