# Development of Ecosystem based Sediment Control Techniques & Design of Siltation Dam to Protect Phewa Lake

HARPAN KHOLA WATERSHED KASKI

**SUMMARY REPORT**

DECEMBER 2015

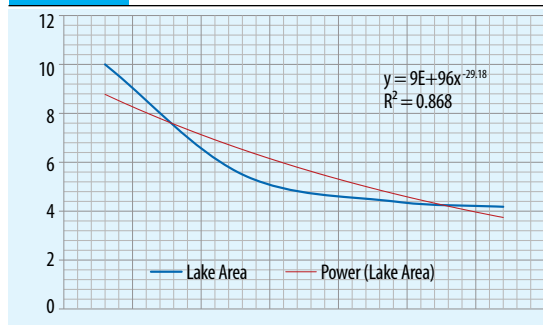
**FIGURE 1: TRENDS OF PHEWA LAKE AREA REDUCTION (1956-2014)**

Physical shape and size of Phewa Lake has been decreasing due to sedimentation and land encroachment along the lake shore. JICA in 1998 had carried out a time series map analysis and stated that the lake area decreased from 10 km<sup>2</sup> (1956/57) to 5.5 km<sup>2</sup> (1976) and, then, 4.4 km<sup>2</sup> (1998). Within a time frame of 5 decades the area of the lake has reduced by more than 50% (JICA, 2002). In this study an effort was made to map the Lake's area, which was found to be 4.2 km<sup>2</sup> in 2014. The figure below presents how the lake area has been reduced over the period.

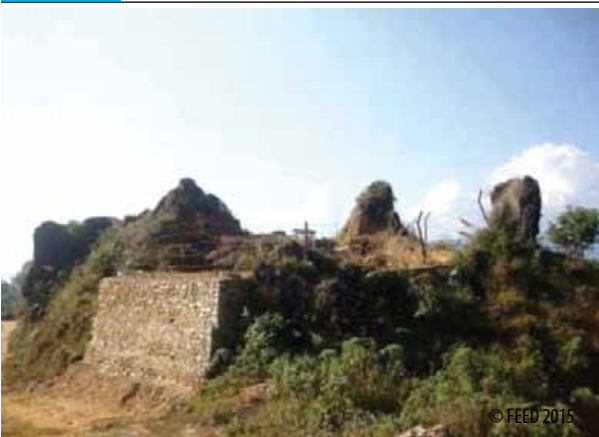
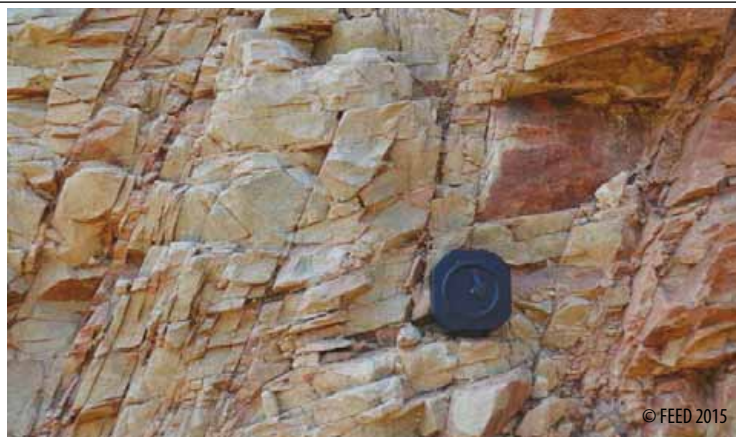
**FIGURE 6:** GLACIAL TILL OBSERVED ON THE PEAK OF MANTHALI VILLAGE (LEFT) EXPOSURE OF FAGFOG QUARTZITE IN GHATICHHINA-PANCHASE AREA (RIGHT)

The top of the Manthali peak is marked sharply by the glacial till (Figure 5), which extends west towards the Sarangkot peak. The phyllites are usually deeply weathered, up to 2m. Gullies develop easily in weathered rocks. Mass wasting is common in both the limbs. The high hill slope, ranging from 37-60 degree could be a prime factor in mass wasting.

Fagfog quartzite is represented by white, medium-to-thick beds with coarse-grained and fractured (three sets of joint prominent) quartzite (Figure 5). The quartzites of this formation are marked with massive beds and current ripples. The thin joint, medium beds of quartzites of this formation are extensively observed around Bhadaure, Tamagi, Kudbidada, Damdame, Makawanpur, Himde, Philinghari, Tarebhir, Villages of Bhadaure Tamagi and Chapakot VDC's. The general attitude of the quartzite is N650W/ 400 SW. The quartzite forms the base of the anticline along with the Kuncha Formation in the watershed. Fracturing is a common feature of the quartzite resulting in deep weathering of the rocks in Tamagi and Makawanpur. The quartzite forms steep slopes at Bhadaure Tamagi. A small band of intercalating greenish-grey phyllites and quartzites form a syncline around Kudbidada and Tamagi Villages. The phyllite band is prominent in the south and pinches around Bhadaure in the north. The proportion of phyllite gradually increases in the upper reaches of the hill.

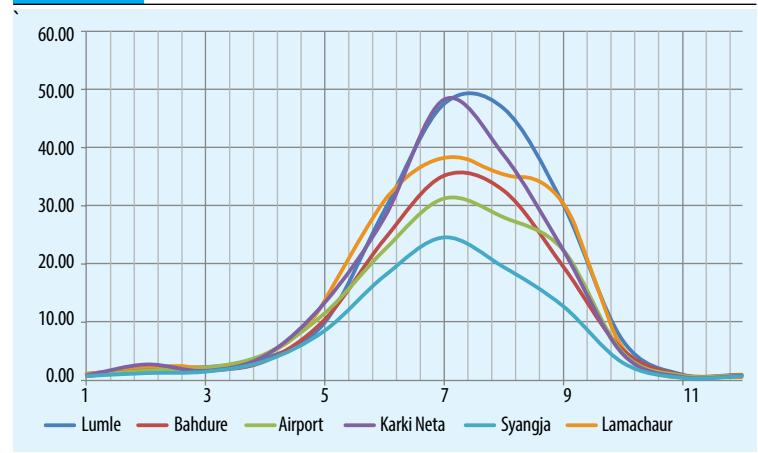
**FIGURE 10: DAILY AVERAGE RAINFALL OF THE STATIONS SURROUNDING PHEWA WATERSHED**

Analysis of precipitation data shows an increase in the number of dry days and a corresponding decrease in the number of wet days; however, the annual average precipitation has remained the same. This means that the rainfall is more intensive within a shorter timeframe. Shorter duration storm rainfall usually increases surface runoff. The accumulated runoff over the steep and fragile lithology starts forming rills and gullies. Bank under-cutting and toe-cutting are some of the common phenomena observed in the field all resulting from a high surface runoff. This process will end only when the slope collapses completely, generating a significant amount of sediment flow towards the valley. The following figure (Figure 9) presents the general trend of mean monthly precipitation summarized from the daily records over the last 30 year period (1982-2012) at six stations that have been taken into consideration.

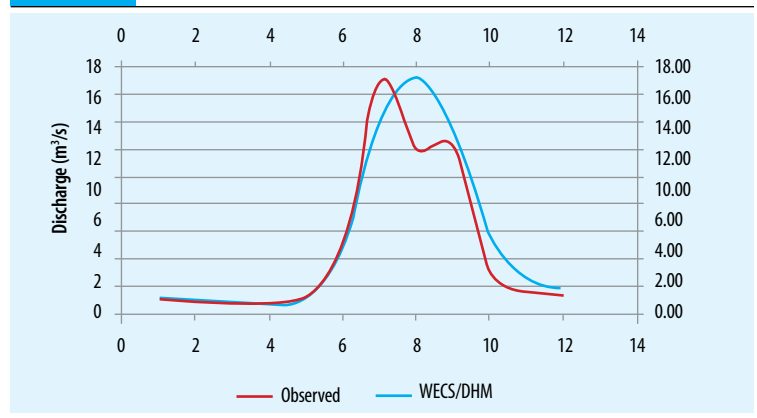
**FIGURE 15: COMPARISON OF FLOW AT HARPAN KHOLA AT OUTLET**

The reason behind could be due the precipitation in the year 1983/84 was higher than the other years. Since, the basin is ungauged and discharge

measurement at the outlet of the Harpan Khola is only for two years, there is not enough data to model the flow of the stream for long term time series data. Thus, WECS/DHM information was used to estimate the sediment accumulation at the watershed.

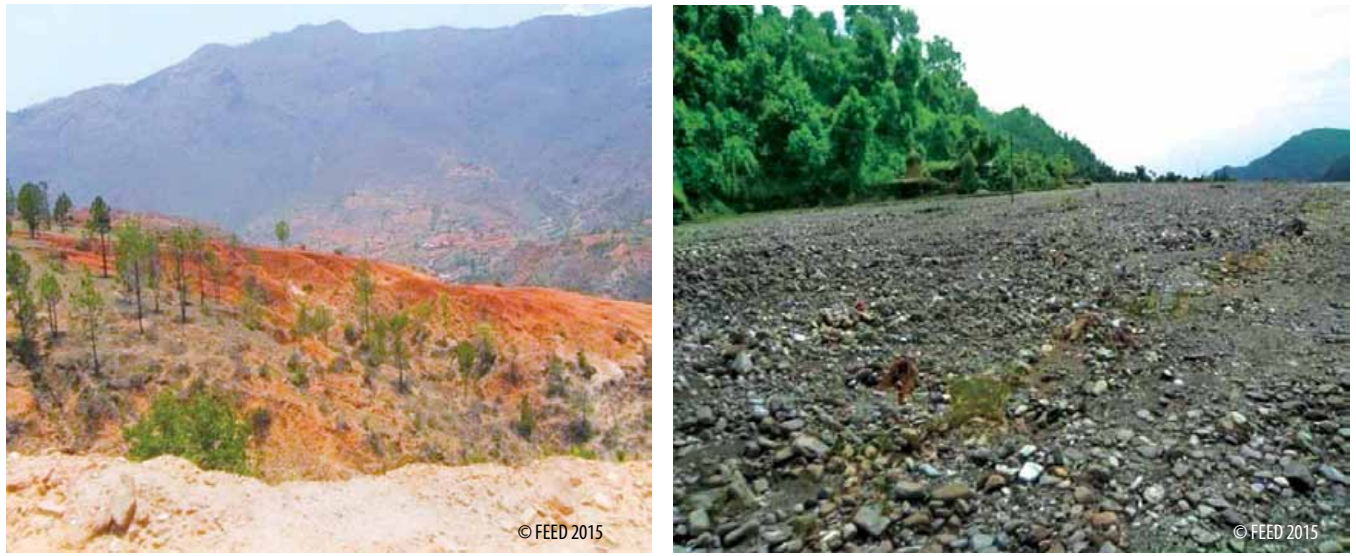
**FIGURE 18: VIEW OF DEGRADED LAND (LEFT) AND SEDIMENTATION IN KAHARE VALLEY (RIGHT)**

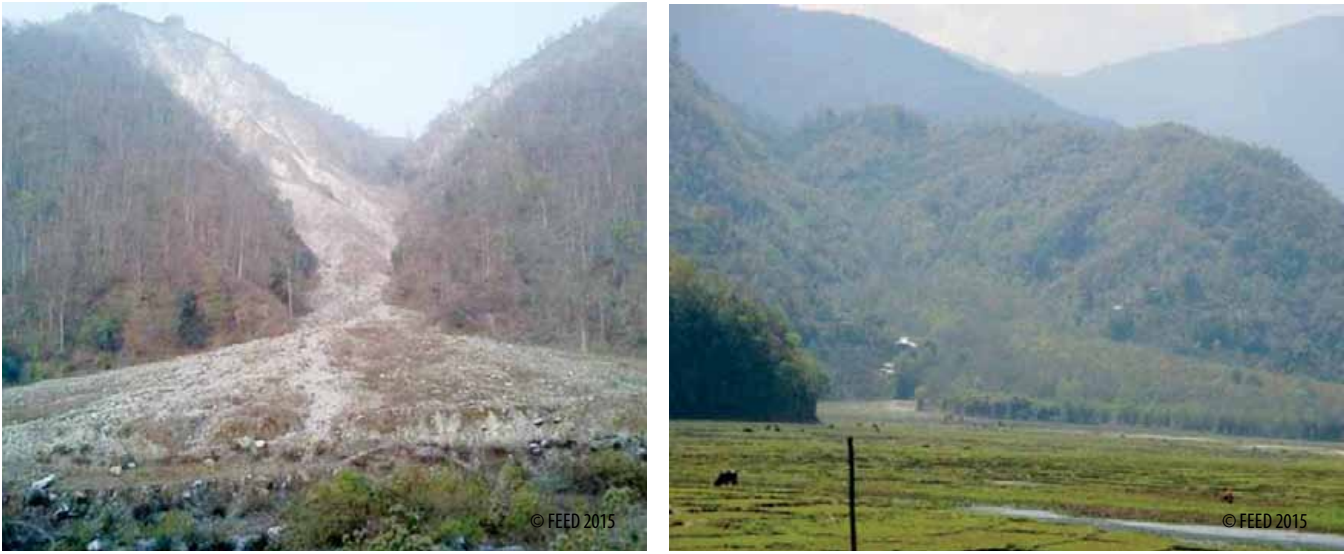
**FIGURE 19: VIEW OF BAMDI LANDSLIDE 1974 (LEFT) BAMDI AT PRESENT (RIGHT)**

there were severe natural events in conjunction with excessive human interventions that caused lake area to shrink. The catastrophic event of 1974 was the cause of the Phewa dam failure (CBDRM/UNDP, 2012). Around the same time, numerous large to small size landslides were mapped by the Department of Mining and Geology, which also included the Bamdi landslide. The figure below (Figure 18) presents the view of Bamdi landslide. Various studies have revealed that the basin is highly exposed to the natural hazards such as landslide, debris flow and soil erosion on the hill slope and sedimentation in the valley bottom. The agriculture-dominated basin and the hilly areas under intensive monsoonal rain, yield excessive sediment from the streams and rivulets.

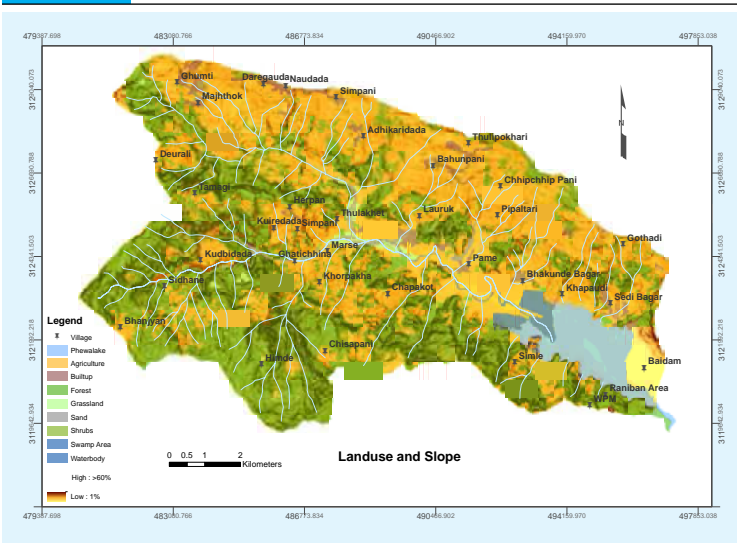
**FIGURE 22: LAND USE OVERLAID ON SLOPE MAP**

Analysis of the slope map, land-use map and recent Remote Sensing Imagery followed by field verification indicates that the hill slope of the watershed varies with fairly high internal relief and narrow valleys. About 10% of the basin is flat to rolling (0-10% slope), 60% has slope of 20% to 60% (average 40%) and 25% is very steep (60% to 100% slope). The rainfall pattern is monsoonal with 85% of annual total is falling between June and September, often in the form of brief, intense and erosive storms (Fleming, 1985). Analysis of daily rainfall pattern has shown that the rainfall has been decreasing with increased intensity which has caused slope failure and debris flow. The situation has become more pronounced due to poorly engineered rural roads.

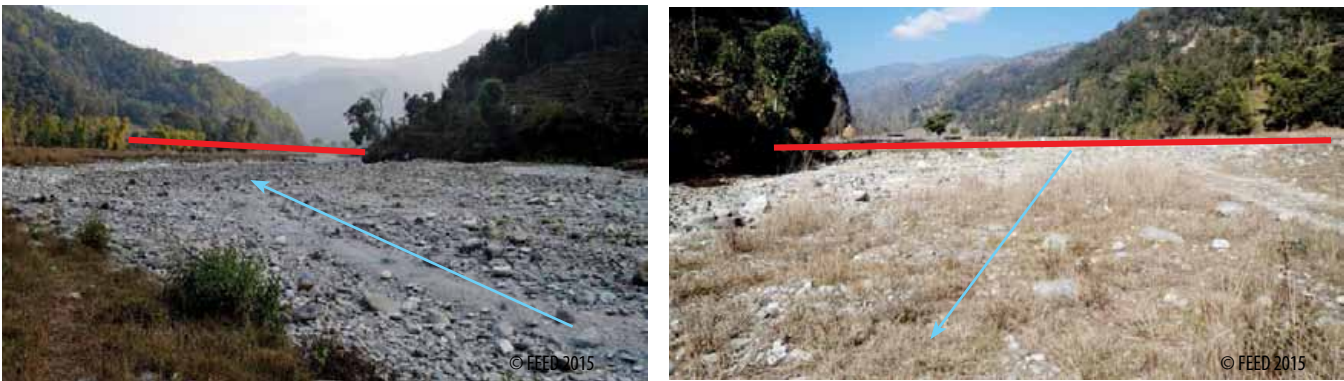
**FIGURE 27: PROPOSED SILTATION DAM LOCATION AT KHAHARE KHOLA OPTION 1 (LEFT) AND OPTION 2 (RIGHT)**

The chosen location is wide enough and full of sediments deposited in the past. There is negligible difference in elevation between the farm lands on either side of the streams which means that levees need to be constructed on either sides of the proposed dam axis. Two alternatives were identified and studied applying the basic parameters (c.f. Table 15). The dam is proposed to trap fairly coarse sediments.

Based on the calculation from the input data shown in the above table, the dam is safe against sliding and overturning as the safety factor were 2.51 and 2.24, respectively. The height of rock fill dam is 3.1m above ground and 6.74m at base. The recommended dam will be of 39,727 sqm in area and can retain 143,812 cum of the sediments. The dam should be cleared after every monsoon to trap the sediments in next year.

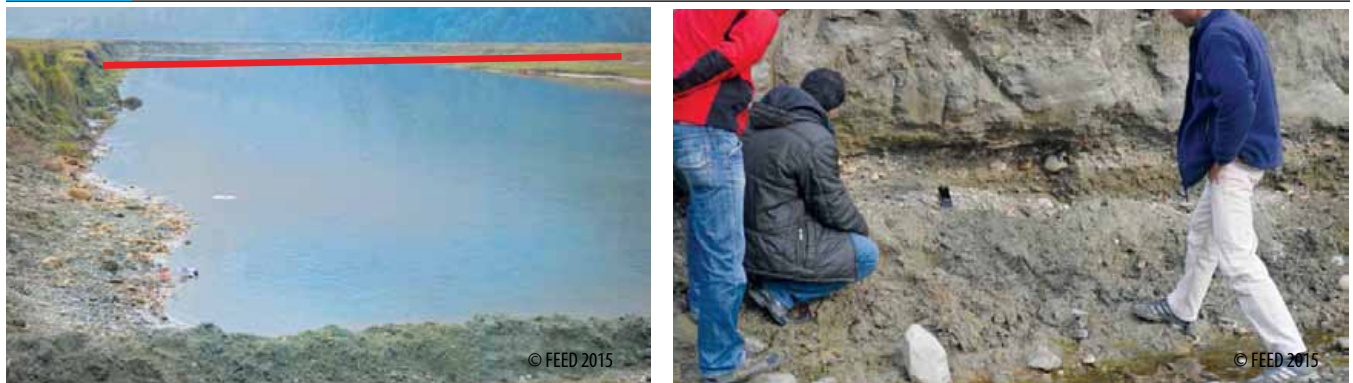
**FIGURE 28: PROPOSED LOCATION FOR SETTLING POOL AT HARPAN KHOLA**

This is a very important location to trap fine sediment in the Harpan Khola as the sediment filling up Phewa Lake is mostly clay and fine particles (Fleming 1985). About 300m section of Harpan Khola is widened to 60m and depth increased to 3m from the present level of the river bed to maintain the water level. Fine sediment passing through this stretch gets settled and is dredged periodically after monsoon.

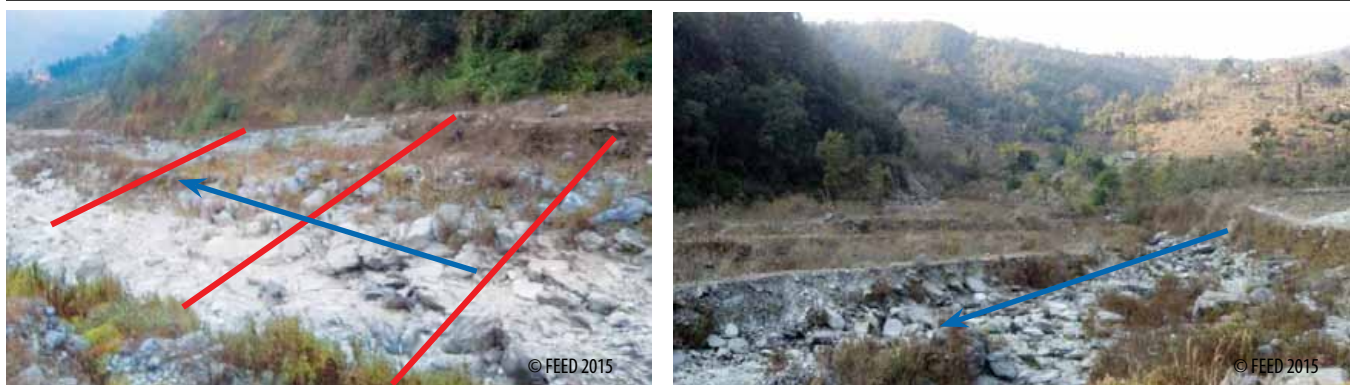
**FIGURE 29: GENERAL VIEW OF BETENI KHOLA AND LOCATION OF CHECK DAMS**

Four check dams have been proposed to protect the stream from under cutting and bank protection (left bank) work has been recommended to protect the bank failure during monsoon.
