2015

# Climate Vulnerability and Capacity Assessment : A Baseline Report

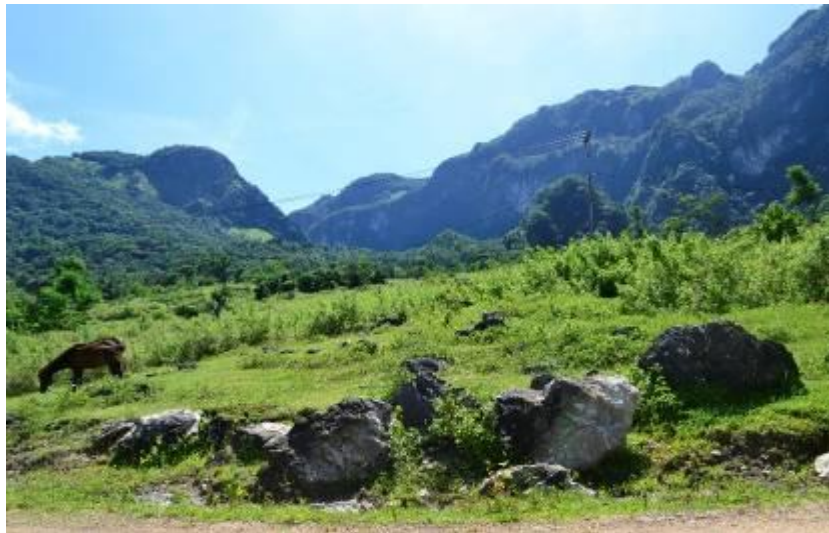
*Figure 6 – Why Quelicai AP doesn't flood – nowhere is flat!*

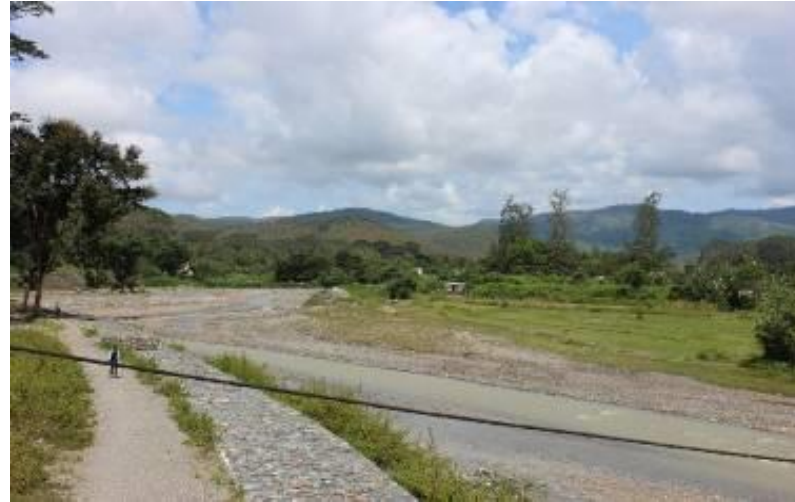
Figure 18 – Floodplain of the Gleno River. Lauala Suco, Lois River Catchment

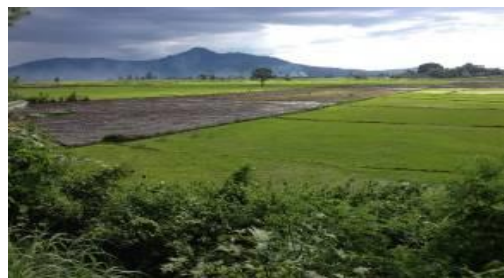
Figure 38 – Rice growing in a high-risk area for flooding. Lissadila Suco

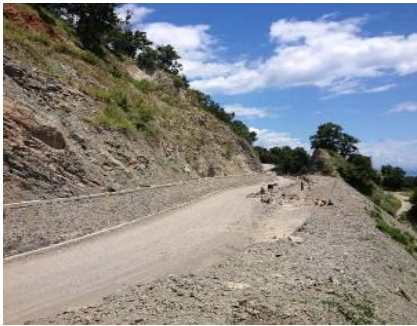
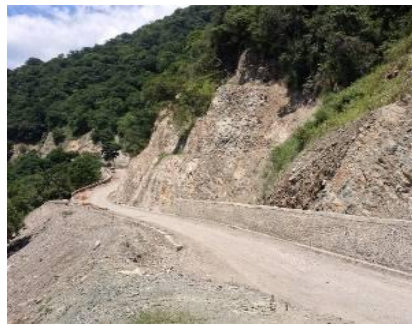
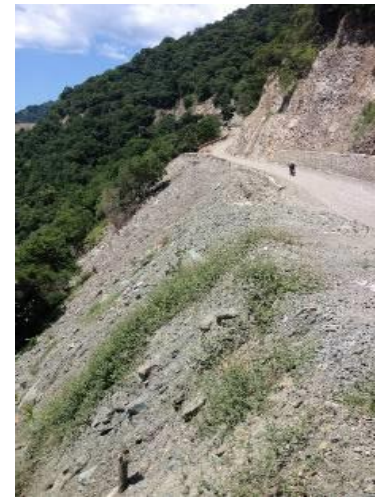
The Sanakiana Aggregate Catchment lies entirely within Vatuboro *Suco*, and it is here that the potential for landslides damaging or destroying roads is greatest. Of Maubara AP's 9.4km of at-risk road, 4.1km (44%) are in the Vatuboro-Sanakiana *Suco*-Catchment. Most of this 4.1km is considered to be at medium or high risk, and most of it is part of the main road linking Dili to Kupang in Indonesia, and to the exclave of Oecusse Municipality.

Figure 40 – Three images showing the challenges faced by road-builders on the main Dili – Batugade Road. Vatuboro *Suco*, Sanakiana Aggregate Catchment
